# MILLARD-LEE HOUSE HISTORIC STRUCTURE REPORT

Written and Compiled by  
Christopher Elzen and Sara Baker

Department of History  
Stephen F. Austin State University

8 December 2008

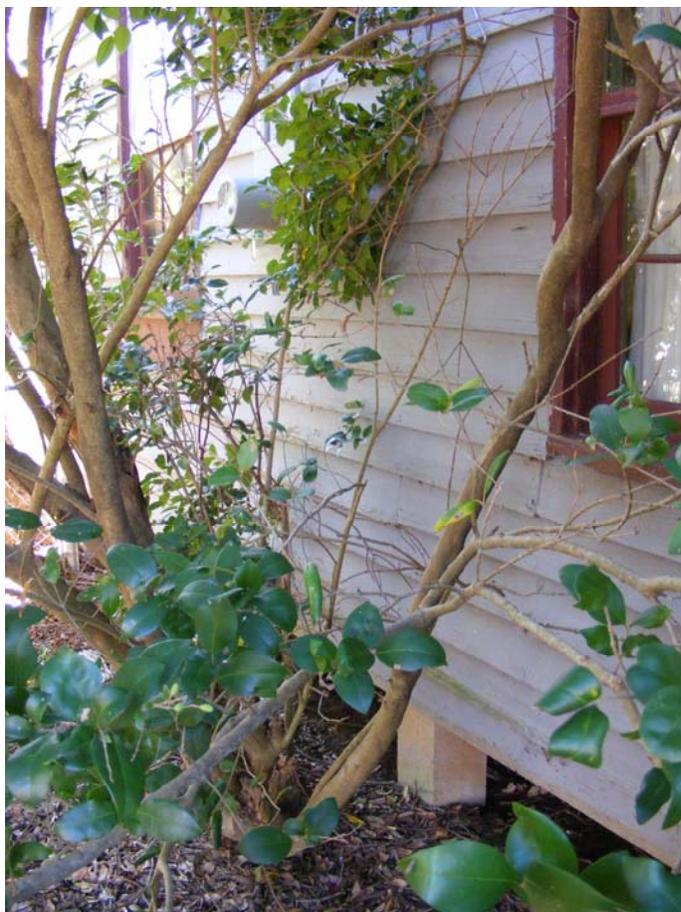
Fig. 2.004

The plants which cause the most concern are growing on the east side of the house. There are four Wax Leaf Ligustrum shrubs growing close to the east wall.<sup>33</sup> The closest is less than a foot away from a foundation support, and its branches are growing up against the wall and window.<sup>34</sup> Although these branches do a good job of concealing some of the external electricity equipment, and thus help maintain the historic character visually, they also create a place for

moisture to collect on the side of the house. These branches should be trimmed back for these reasons, but given how close the tree is to the support, complete removal of the plant may be in order. If this is removed, great care must be taken that the roots do not upset the supports, and some shifting in the ground should be expected as the roots die and decay. The next closest of these shrubs is approximately eight feet away.

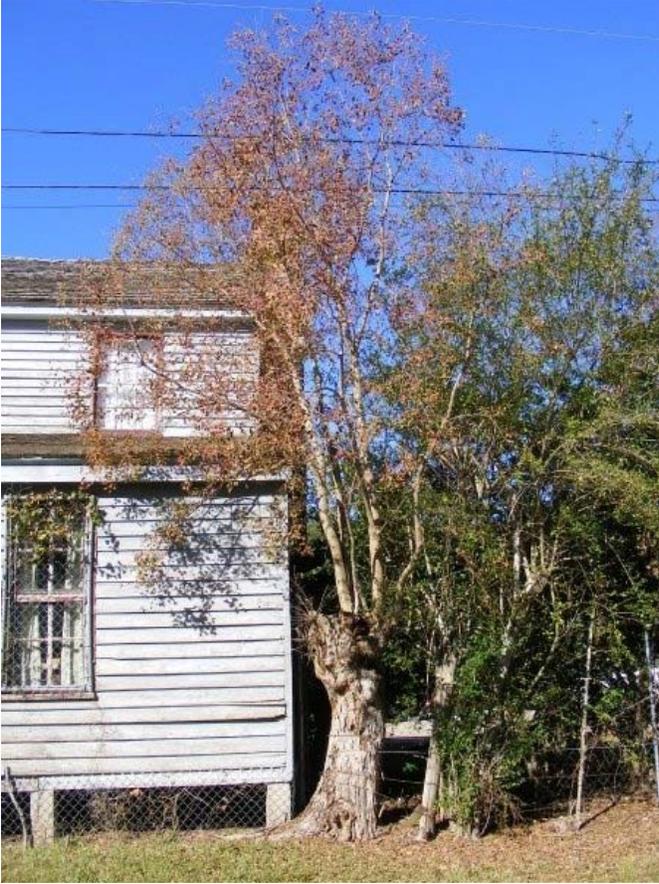
Fig. 2.005

Another tree is growing on the adjacent property and is threatening the southeast corner support. This tree is no more than three inches from the support and is thus a cause for great concern.<sup>35</sup> Along the back of the house there are several stumps of plants which have been cut down. Most of these are pinched between the house and the chain link fence which separates the properties.<sup>36</sup> Many of the concrete block supports are leaning, presumably due in part to the proximity of the roots. This problem needs to be addressed soon because it threatens the structural integrity of the entire house.

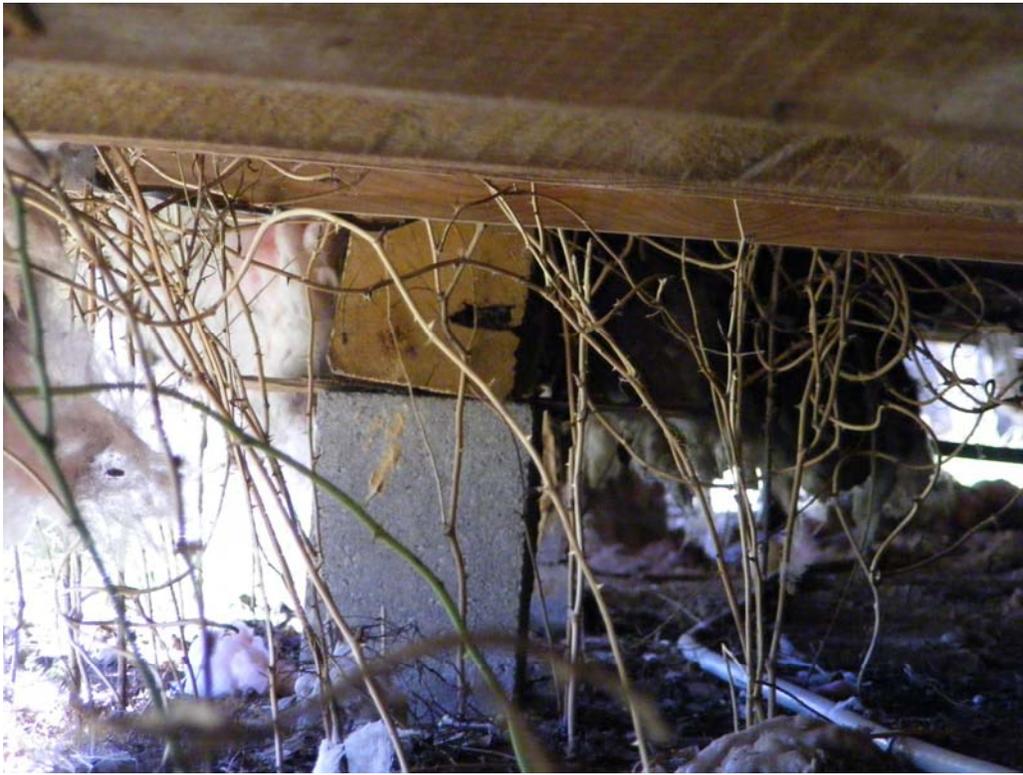
Fig. 3.001

The house is pier and beam, and sits on concrete blocks. Though the blocks are not as visible from the front of the house where the porch sill sits very close to the ground, they do not lend to the house's historical character. More important and alarming, however, is that many of the blocks are leaning.<sup>39</sup> As mentioned above, some of these appear to be leaning because of nearby plant roots, but part of the problem seems to be that many of the blocks are not in the ground, but sitting on the surface. This will cause serious stability issues if not addressed. When viewed from the back, it is evident that the house sags in the center.<sup>40</sup> The foundation supports need to be reinforced to relieve the strain on the structure.

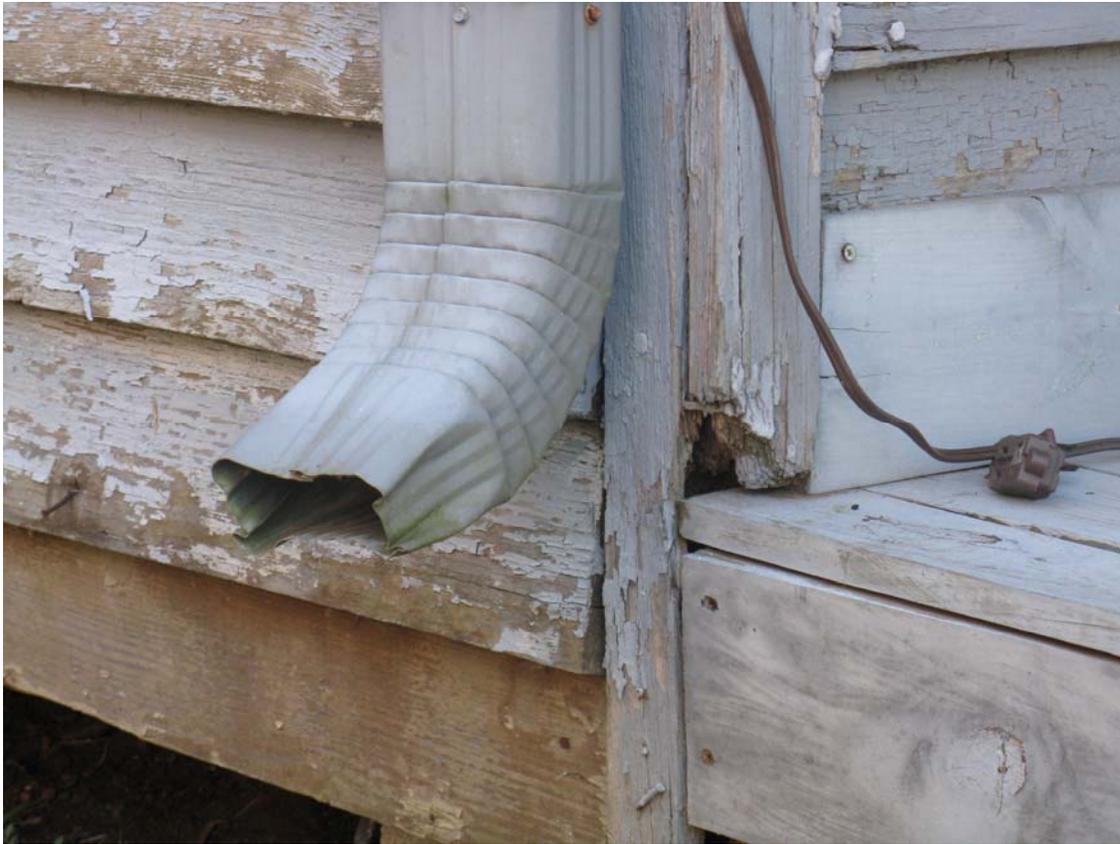
Fig. 3.016

The drainage system of the Millard-Lee House is comprised of flashing on the roof at each chimney, a gutter in front, and downspouts on either side of the porch.<sup>45</sup> These should be routinely inspected for build-up and deterioration. Keeping the roof clear of excess moisture is key to prolonging its life, and a clogged drainage system will exacerbate problems by holding moisture. Another problem to look for is the deterioration of the metal, which can also damage the wood.<sup>46</sup>

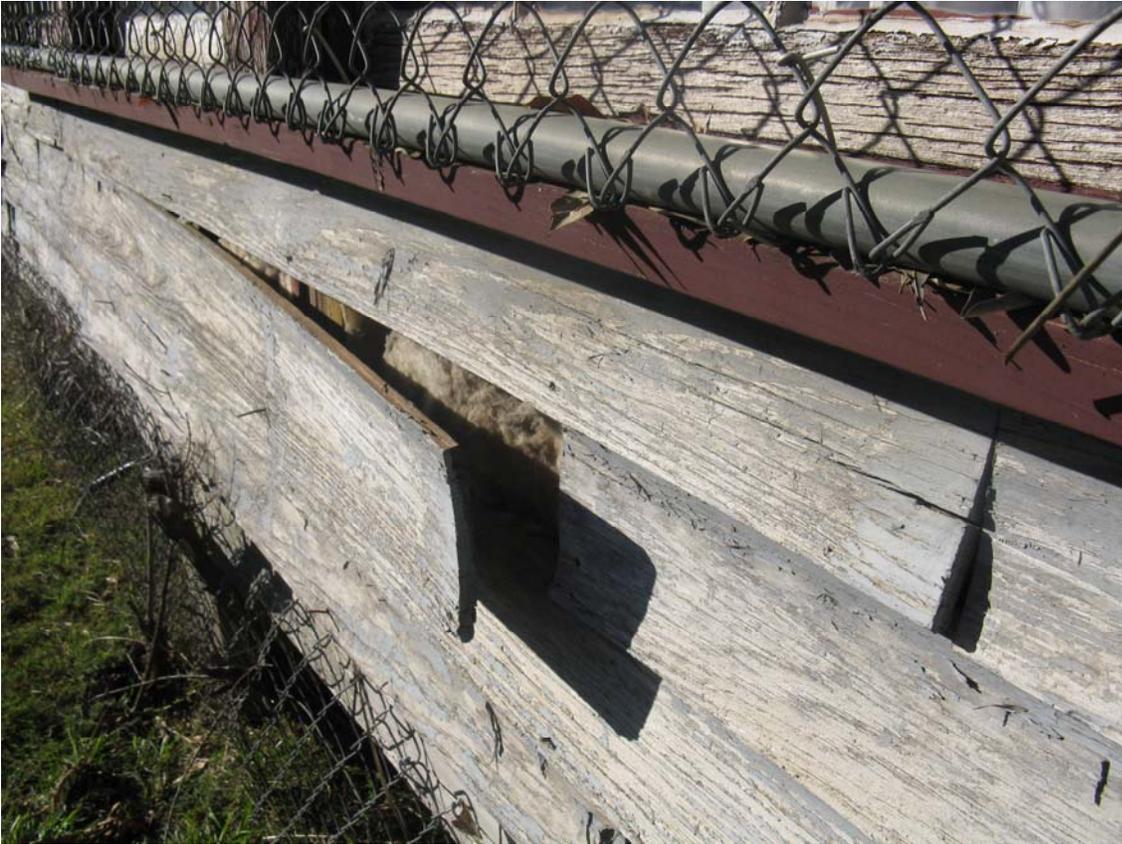
Fig. 4.001

The house is a balloon frame with pine siding. The siding is, for the most part, in poor to fair condition. In some places there are only concerns with badly peeling paint. However, several boards of siding, particularly on the back of the house, are deteriorating and pulling away, exposing insulation and allowing water penetration in the walls.<sup>49</sup> The siding is also considerably worse around many of the wooden windows, which are in very poor condition. These are all great causes for concern because they allow moisture penetration. New siding is required in places where the boards are either warped or falling apart. The current insulation is exposed and should be replaced, and the siding on the entire house needs fresh paint. Weather-

tight siding and paint, along with repairs of the windows, will do much to block moisture from entering the structure.<sup>50</sup>

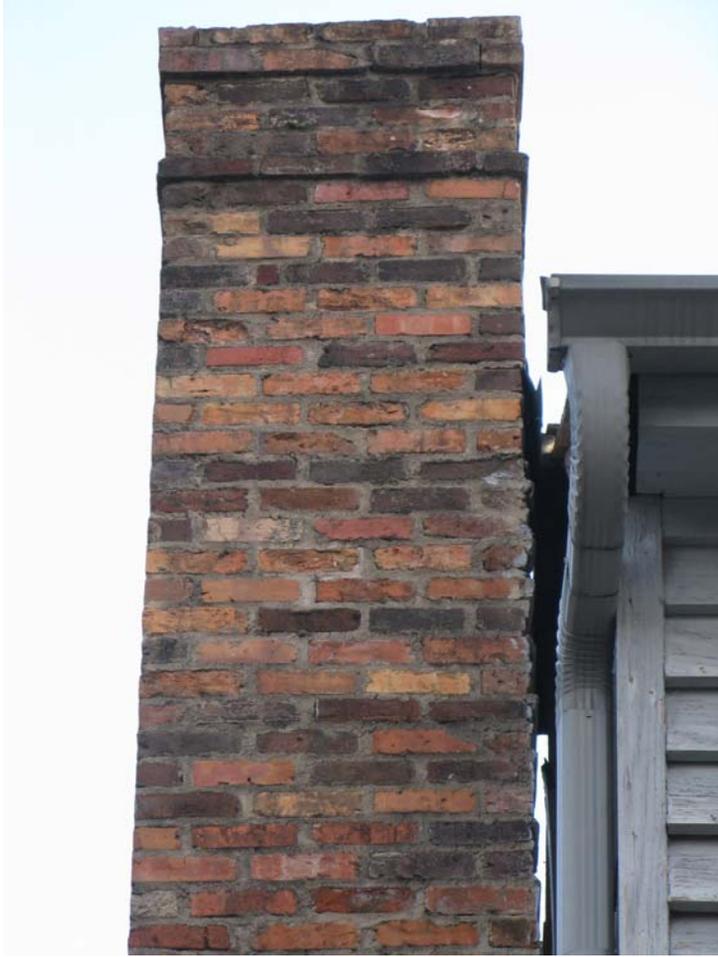
Fig. 4.007

The chimneys are made of brick which is in fairly good condition, although there is some spalling and weathering in some places. The east chimney appears to be pulling away from the house along the second story.<sup>51</sup> Structurally speaking, this is a potentially dangerous situation, and would complicate any attempts to repoint the mortar of the chimney. Without going as far as rebuilding the chimney, it may be possible to secure the chimney with a metal bracket like the one on the west chimney, but the more immediate concern is that there is a narrow space along the wall for moisture to accumulate.<sup>52</sup> Flashing is installed on the roof where the chimneys and the roof meet, which may lessen the threat of moisture on the wall. This flashing needs to be inspected and maintained regularly. The west chimney is also suffering some deterioration on top and missing a few bricks.<sup>53</sup> It may be advisable to replace these and secure the loose bricks which may otherwise fall and create a hazard for people or the wood shingled roof.

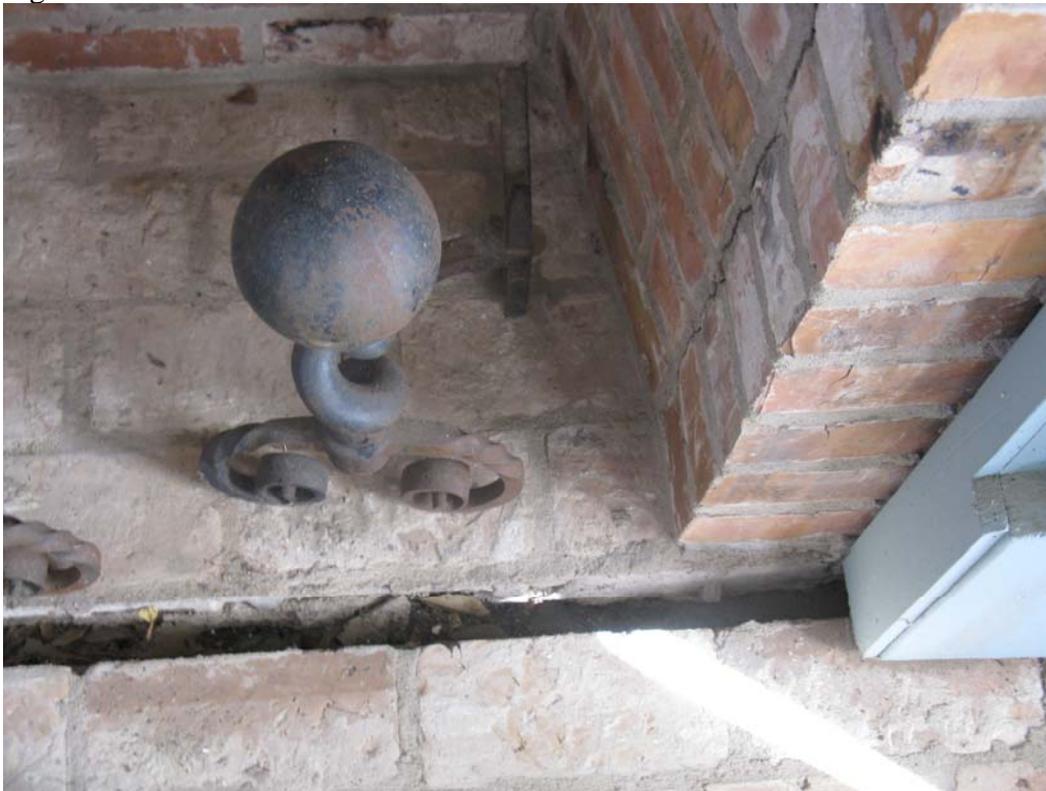
Fig. 4.015

There are four fireplaces in all: two downstairs and two upstairs, at the gable ends of the house. They are brick and have decorative, painted wooden mantles.<sup>54</sup> In the downstairs fireplaces there is a little cracking in the mortar, but otherwise they are in fairly good condition.<sup>55</sup> Since the upstairs flues were closed off, the fireplaces upstairs are no longer functional. The masonry of these chimneys shows considerable cracking, especially along mortar lines.<sup>56</sup> This may be related to the chimneys pulling away from the house.

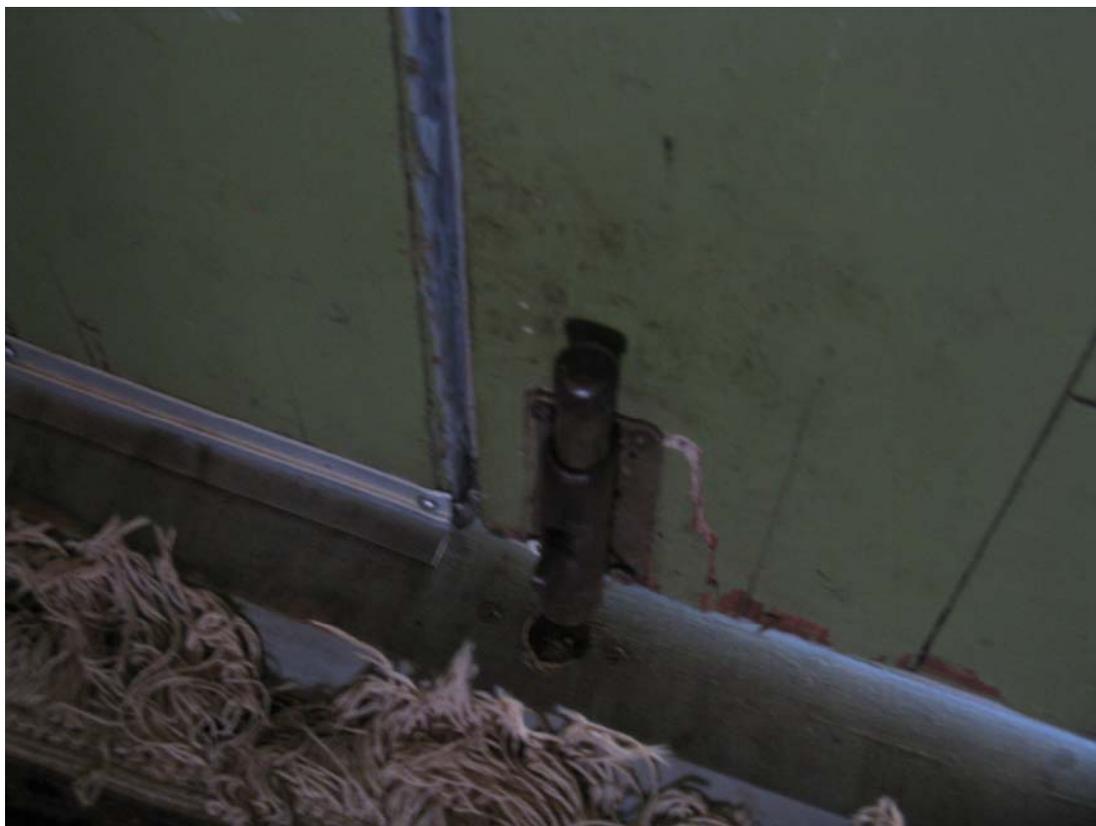
Fig. 4.020

The only exterior doors on the house are the double doors in front. The doors are in fair condition, painted to match the doors inside, and are secured by a door knob, a small latch, a latch securing the door at the floor, and a pull chain latch at the top of the door which features intricate decorative detail.<sup>57</sup> The latches are in good condition, but should be cleaned. They do not appear to have been replaced, and lend well to the historic character of the house. The doors do not hang perfectly square and do not make a good seal, and there is some damage near the bottom of the doors.<sup>58</sup> There is only weather stripping on one door, which is the only door of the two used by the interpreters at Millard's Crossing. The damage at the bottom of the doors appears to be superficial, and they could use a cleaning and fresh paint. In order to get a better seal and prevent further weather damage weather stripping should be added to the second door,

and the hinges may need to be replaced so that the doors will hang straight.

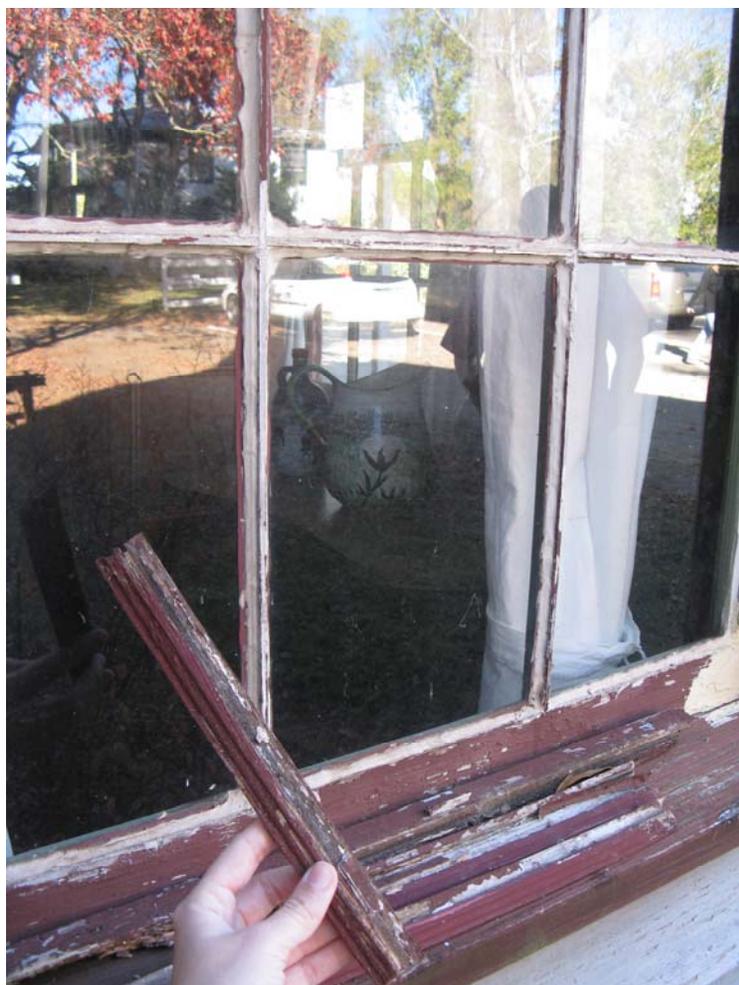
Fig. 4.030

house was moved many of the windows had been broken out by vandals.<sup>63</sup> These were replaced with aged glass which suits the house well.<sup>64</sup> However, the windows now require a great deal of attention if they are to be preserved. Much of the wood in and around the windows is disintegrating and is vulnerable to further deterioration and moisture penetration.<sup>65</sup> The northernmost side window in the east front room has had some obvious work which was executed fairly poorly. The lower sash does not fit properly, and a great deal of caulk was used to seal the discrepancies and where the most rotting has occurred.<sup>66</sup>

Treating the windows is likely to be an involved process. It is possible that the deteriorated wood may be patched and treated, using waterproofing, fungicide and wood putty. If these windows can survive patching, it will then be necessary to apply fresh paint to block out moisture. It is likely, however, that professional help is needed to replace much of the woodwork on these windows. Great care should be taken when handling the windows, and when replaced the joints should be sealed carefully with caulk. The condition of these windows is in part dependent on the condition of the siding, and vice versa. These two weaknesses must be addressed because each causes further deterioration of the other.<sup>70</sup>

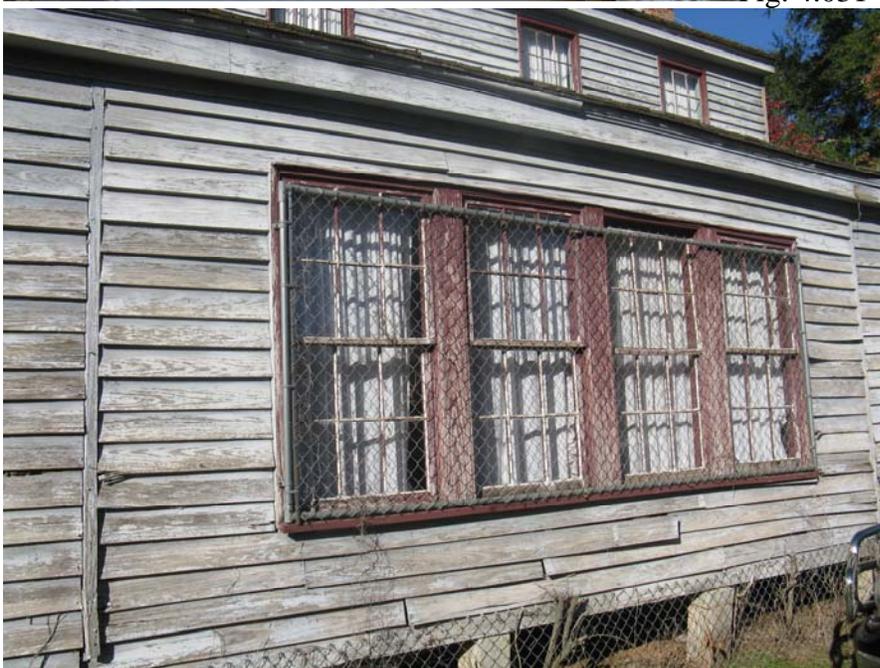
Fig. 4.032

Another issue is the chain link fence which has been attached to the first story back windows. This fencing was placed here for protection against the adjacent property where a flea market is held. The fencing is bolted into the window framing and alters considerably the visual character of the building.<sup>67</sup> Undoubtedly this was placed here to protect the windows from vandals or damage from automobile traffic at the flea market. A better solution might be to seek cooperation from the owner of the adjacent property and reach an alternative solution, such as a privacy fence. This is only one of many issues on the back of the house due to the position of the

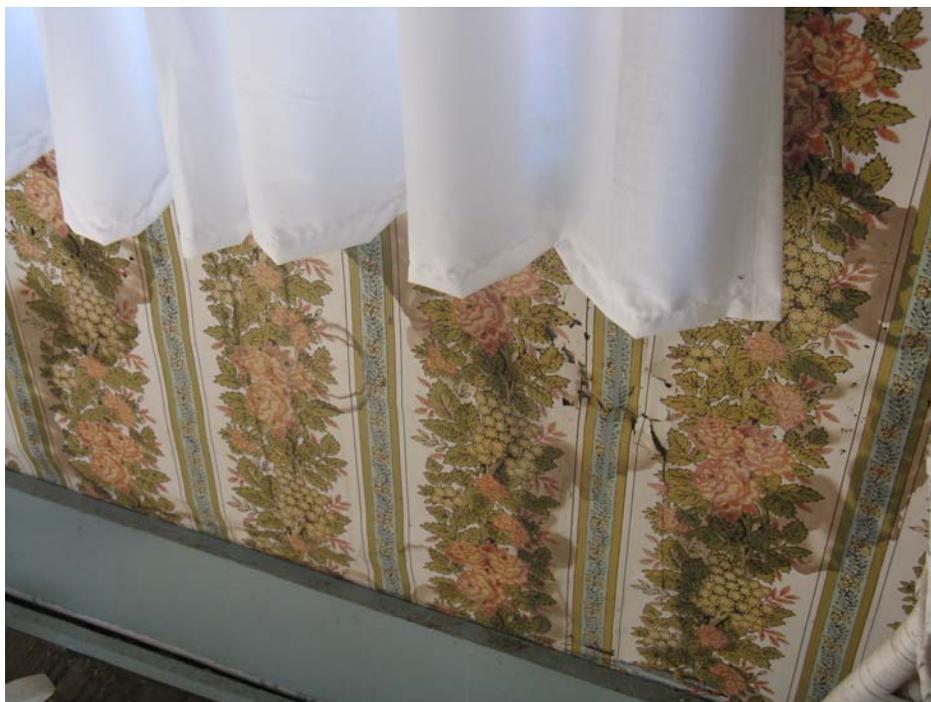
Fig. 4.033

Inside the house, particularly upstairs, water damage is very evident around the windows.<sup>68</sup> There is a great deal of staining and wrinkling of wallpaper in the Wicker room and the upstairs hall. This is most prominent around the windows, although it is also evident in some corners and around some doorways. In the child's bedroom, where there is no wallpaper, there is a good deal of cracking in the sheet rock around the windows and vents.<sup>69</sup>

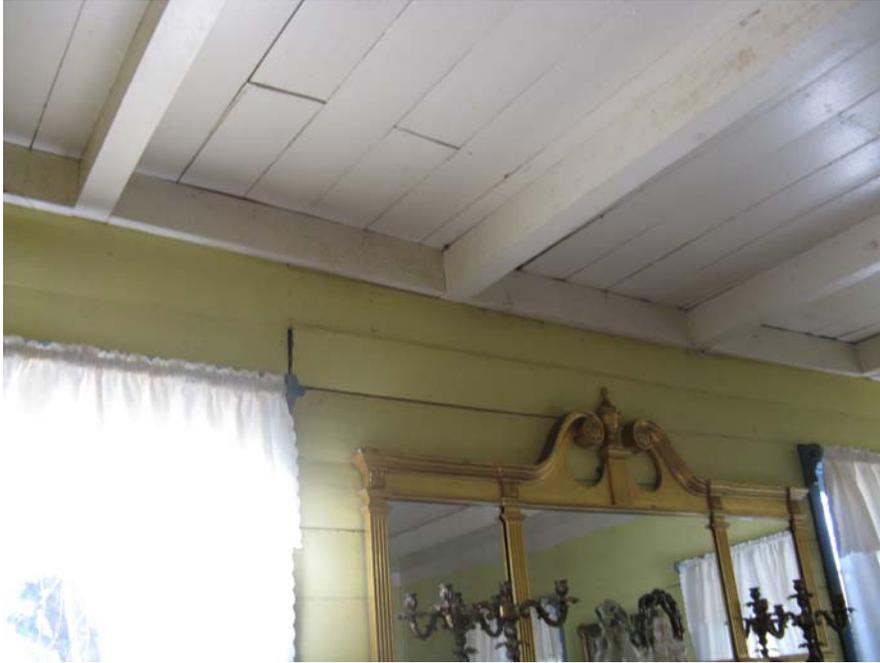
Fig. 4.035

house, this is most likely caused by moisture penetration. Some of the wall timbers are situated awkwardly and are pulling away as well.<sup>72</sup> These may be best dealt with when the siding is repaired or replaced. After the moisture issues with the roof, siding and windows are addressed, it would be wise to repaint. When this is done it may be possible to analyze previous layers of paint and determine what the original colors of the interior were. This would lend to the historical character of the house and the authenticity of the house. Even if it is not possible, however, fresh paint would clean up the look of the house and help prevent damage caused by moisture. There is some floral print wallpaper upstairs in the center room and wicker room which does little for the historic character of the house, but is a dramatic indicator of water damage, particularly around the upstairs windows. Around windows, in corners, the fireplace and even the door jamb of the wicker room, there is a great deal of wrinkling, cracking and staining. It has been many years since the wallpaper was replaced, and some of this damage occurred before the roof was last replaced. The areas to be most concerned about now are around the windows. In the back rooms of the house, the wall timbers appear to have been stained or treated, but not painted. The character of these rooms is somewhat more rustic than the rest of the house. The back porch which was enclosed is painted with paint to match the color of the outside of the house, but it is in considerably better shape than the exterior paint. In these back rooms daylight penetrates some of the wider crevices between timbers.<sup>73</sup> In the Document Room there is a
