Sitton Dogtrot at Millard's Crossing

Historic Structures Report

By Paul Maleski
Stephen F. Austin State University

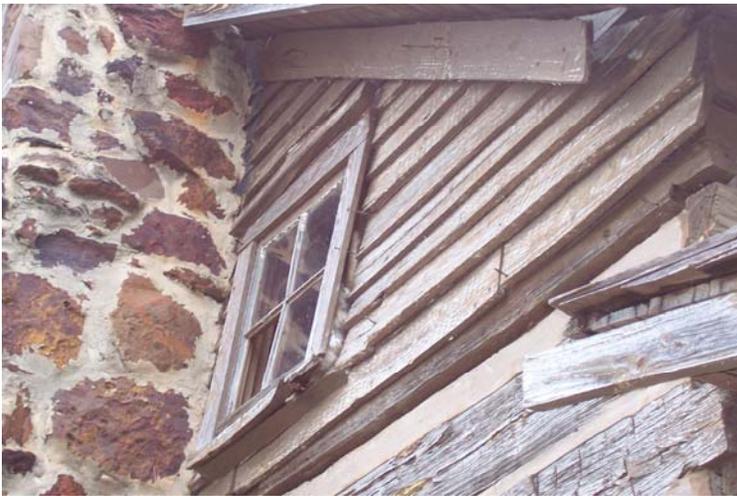
Figure 1.2. The siding on the second story is mismatched to the original log construction and does not fit snugly to the original structure. The window in the picture seems ready to fall out as well.

The second story of the building needs to be fixed. The wood siding needs to be replaced with a more historic log siding. The original siding was probably replaced when the roof was redone during the additional work that added the rear section, as the wood is the same as that addition. Cleaning the white rot with bleach will kill it and prevent any damage from occurring, and making the windows plumb and after the siding is replaced will restore the historic feel.

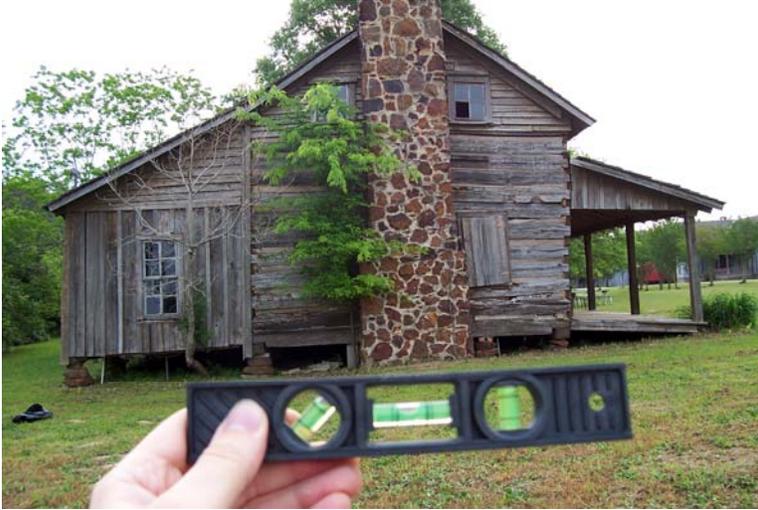
The other addition is an extension of the structure in the rear of the building (Fig 1.3). The additional 10 feet that has been added and this section is quite noticeable. The materials of this addition do not line up with the original structure and the addition is not secured very well either, for section of siding are coming away from the building (fig. 1.4). This rear addition is beginning to separate from the original structure and its weight is pulling the original building apart. Direct evidence can be seen throughout the house of the strain the addition has added to the original structure. The roof is separating down the middle and the separation can be seen down almost the entire peak from the

Figure 1.3. The rear addition begins where the vertical siding is located on the left side of the picture. All three areas of modern construction can be seen in this picture; the porch, the second story siding that does not match up, and the rear addition with its vertical siding similar to the material used on the second story.

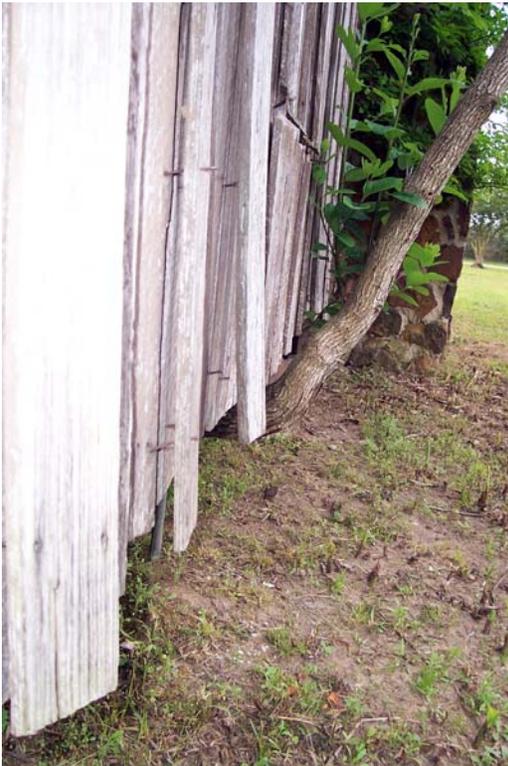
Figure 1.4 displays evidence of the siding on the rear addition of the building coming off.

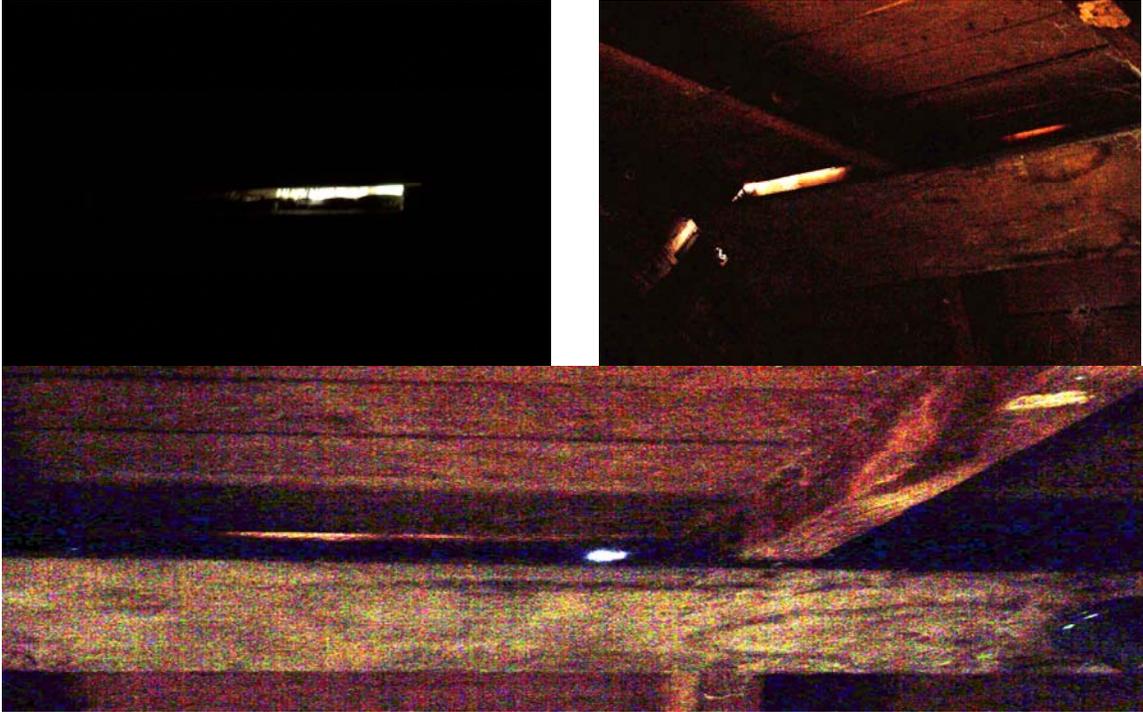
inside (Fig 1.5-7). The two halves of the roof are pulling apart from each other, which creates more problems than just the rear addition coming off. Water enters freely into the house and is creating significant water damage throughout (Fig 1.8). Further evidence of the strain the addition is causing can be seen in the second story windows and siding. While the front side windows are squared and plumb, the rear side windows are tilted towards the rear of the house (Fig 1.9). This shows a lean towards the rear of the house on the second story, and this can also be seen within the addition, as the side windows inside the addition are also leaning towards the rear and losing their square alignment (Fig 1.10).

Figures 1.5, 1.6, and 1.7 (above) reveal the light that shines through the peak of the roof where separation is occurring. The two sides of the roof are pulling apart from each other.

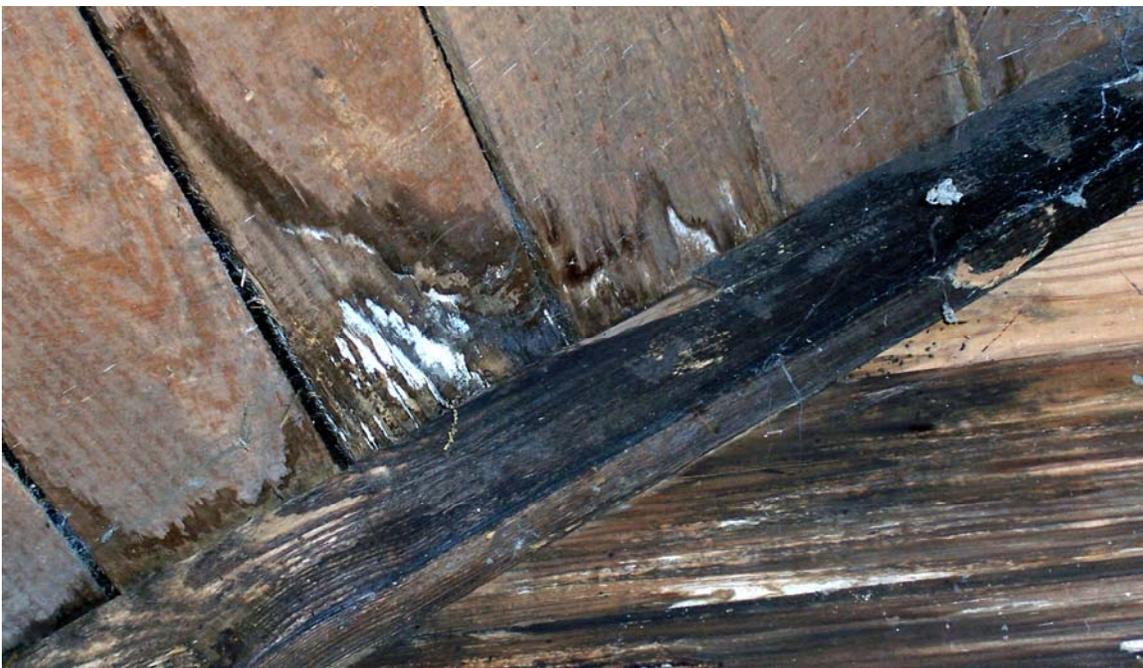
Figure 1.8 (below) shows the significant water damage that is occurring in the roofing materials. This shows damage to the sheathing and rafters and extensive black rot.

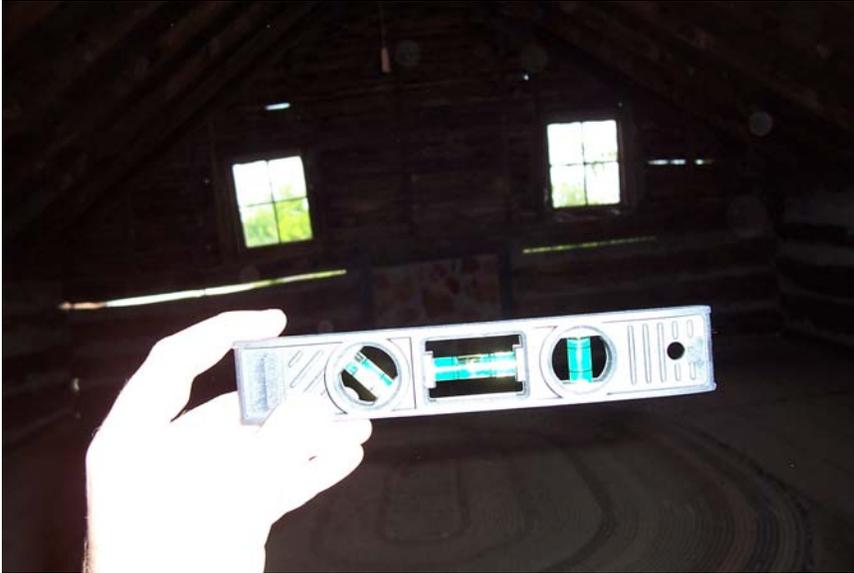
Figure 1.9 reveals the slant towards the rear of the house. This is the west side of the building and the window on the left is slanting towards the rear of the building.

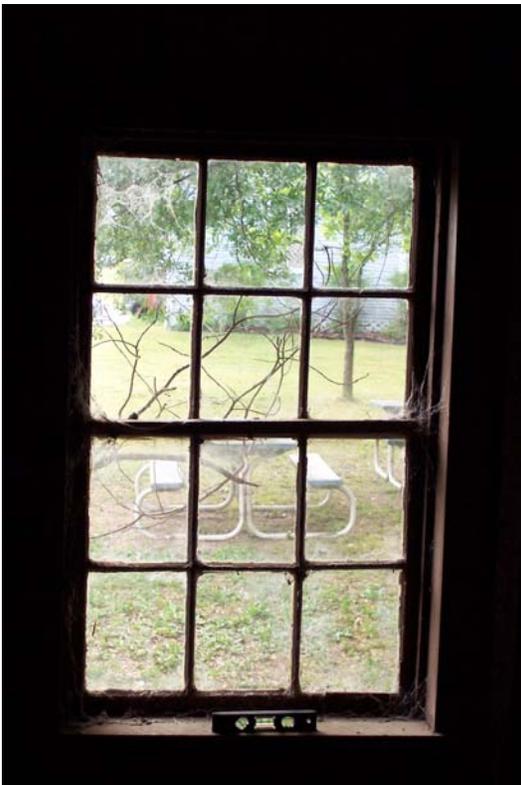
Figure 1.10 shows a view from east side inside the rear addition. The window is slanted towards the rear of the building.

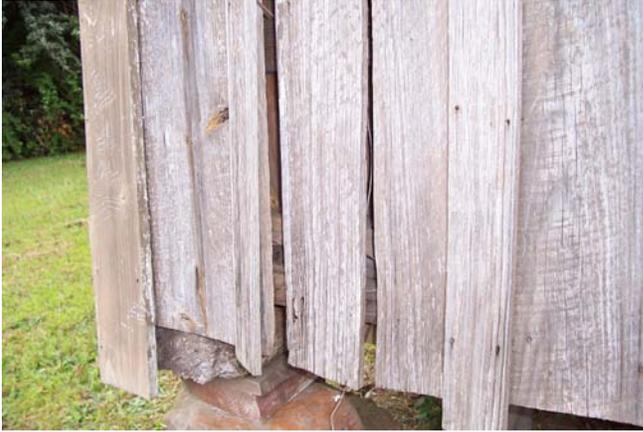
From the exterior the rear addition can be seen pulling itself apart. One can look directly into the rear addition from the outside of the house (Fig.1.11). The siding is pulling apart and separating from the original structure as it leans towards the rear of the house. The rear addition does not create a level line when one views the bottom support beams from the original structure to the rear addition. The rear addition is slightly slanted down and away from the original structures alignment, and is further evidence that it is beginning to pull away from the original and creating strain on the general structure.

Figure 1.11 shows the large gaps in the siding of the rear addition, through which the interior can be seen.

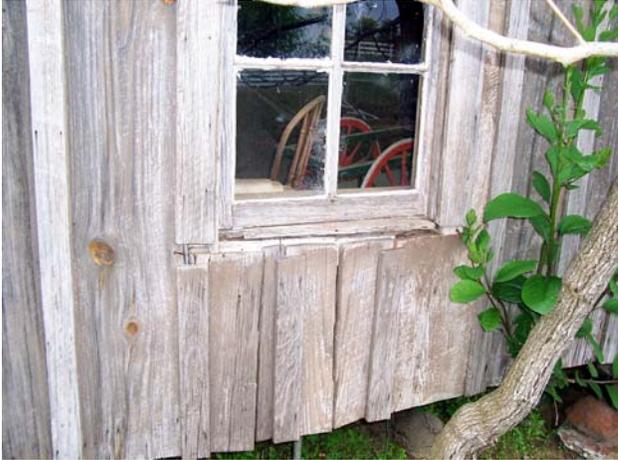
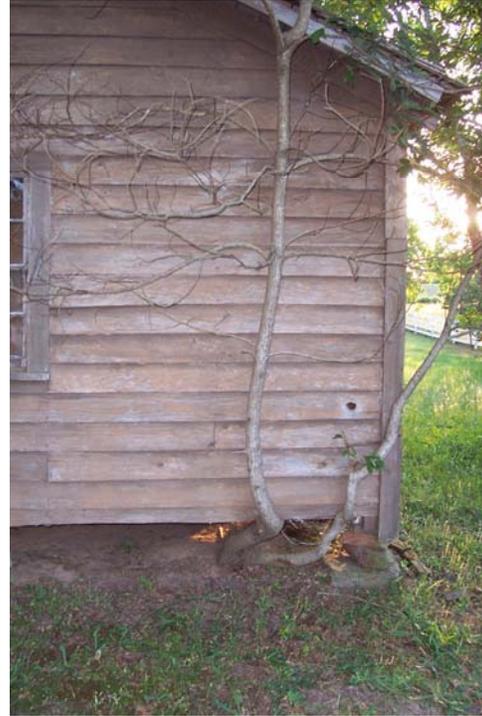
With the exception of the porch, the house is also far enough off the ground to allow enough air flow that any moisture is easily dried out. However, vegetation is an issue. There are two trees growing up from underneath the house (Figs. 2.2-3), and while one does not touch the building at all the root system may cause problems for the stone piers that hold up the house. Another tree is growing up along the side of the west chimney (Fig. 2.4), and while the tree is still relatively small it needs to be taken care of immediately before it grows and begins to cause major damage to the building. This tree's proximity to the house can lead to trapping more moisture on the side of the building and create further deterioration of the original logs. There is a tree located near the east side of the structure (Fig 2.5), and this tree poses a threat to damaging the roofing material. It can act as a condenser to provide a place for moisture to build and allow the growth of fungus and molds, as well as a place where the branches can cause harm to the roof during a severe storm. Another tree that poses the same threat is growing on the North side of the building, and it is also hanging over the structure (fig. 2.6). There is also a row of trees 20 feet in front of the house in a line along the entry way to the village in front of the house, which poses no threat to the structure, and does not obstruct the view of the structure. With the exception of the two trees the grass and other vegetation is well controlled and

Figures 2.2 and 2.3 show trees growing from underneath the house.

Preservation treatments should be started as soon as possible. The water damage is extensive and will only continue to worsen if not taken care of. Water is your greatest enemy in a building and it should be the first problem dealt with. The roof needs to be made waterproof as a first step in this process. The wooden shingles need to be replaced and treated with fire retardant. The trees that overhang the structure need to be trimmed before any more damage can occur, whether through physical damage or the trapping of moisture on the wooden shingles leading to mold and fungal growth. The trees that are growing out from underneath the building need to be cut down immediately before their root systems can displace the stone pillars or damage the chimneys.

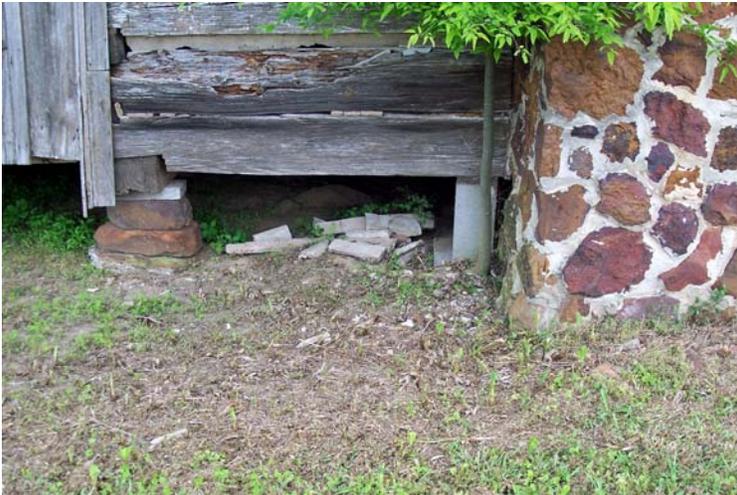
There is plant growth on the exterior stone work, and over time this will break apart the mortar and weaken the towers. The two trees that are located under the building are also close to the base of the chimneys. The removal of the trees is of even more important when considering the root system that may go under the chimneys. However, once the trees are removed the chimneys much be watched for shifting in the soil beneath due to the decay of the tree's root system.

Figure 2.4 shows the base of the smaller tree growing along the west chimney. This tree can also be seen in figures 2.1 and 1.3.

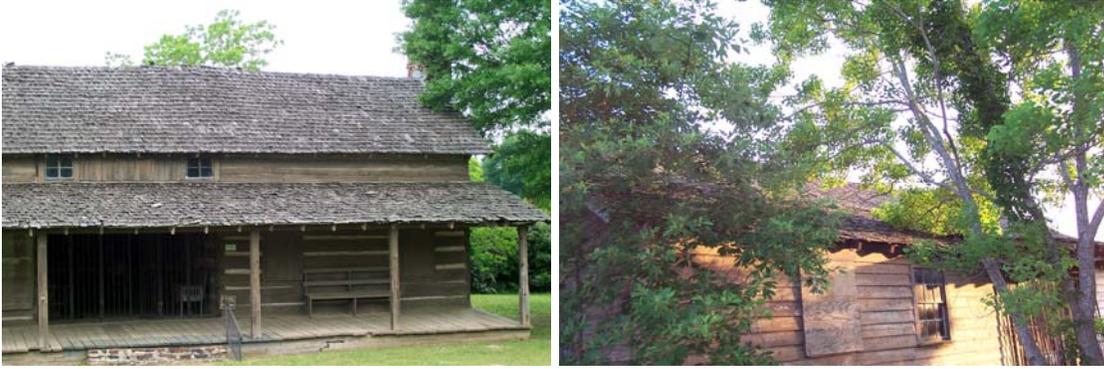
Figure 2.5 shows the tree on the right side of the picture with branches extending over and touching the roof of the building. Figure 2.6 shows the tree on the North side of the building. This can cause damage during severe weather, and trap moisture on the wooden shingles, which will lead to mold and fungal rot on the roof.

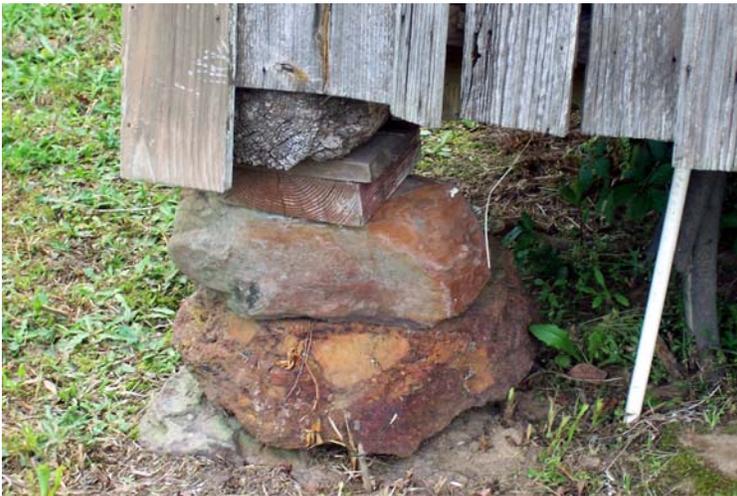
Figure 3.1 shows the stone pillars that support the building. In this picture you can see that three pieces of wood are used on this support. The wood is also splitting and can possibly fail from the weight bearing down upon it and puts the entire structure in danger of collapsing if the wood should fail.

Restoration Plan 1 is the most recommended, yet extensive plan. This recommends that the building be restored to the original 1842 appearance as much as possible. To do this a series of steps will need to be followed. First, as recommended in the treatment and use section, the roof needs to be fixed. This is a main priority for any work that will be done to the building, but the materials used need to be consistent with the original materials. Many rafters need to be replaced due to the extensive damage and black rot, so modern machine sawed 2X4 rafters should be replaced with logs. The sheathing that is water damaged needs to be replaced, but it is ok to keep modern machine sawed sheathing as it will fit tighter than hand hewed and not have that noticeable of a difference visually. The wooden shingles need to be replaced, as they are the first line of defense in the battle against water. They need to be treated shingles with fire retardants. The retardant will make them more brittle, but where water damage may be fixable, a fire burned out building is not. The foundation stones need to be leveled. The building needs to be jacked up in location to level it out and all pieces of wood and cinder blocks/red bricks need to be replaced with large flat stones. This will add to the stability of the structure,

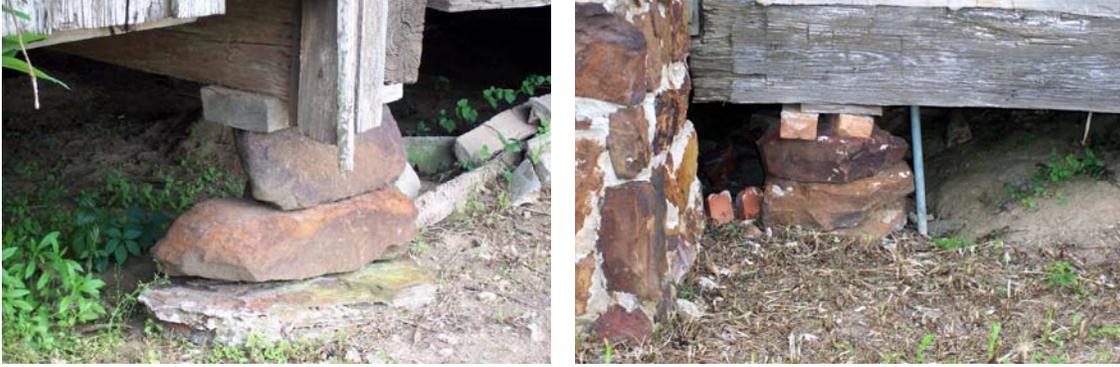
Figures 3.2 and 3.3 show another piece of wood in a precarious position and two red bricks support the weight of the house.

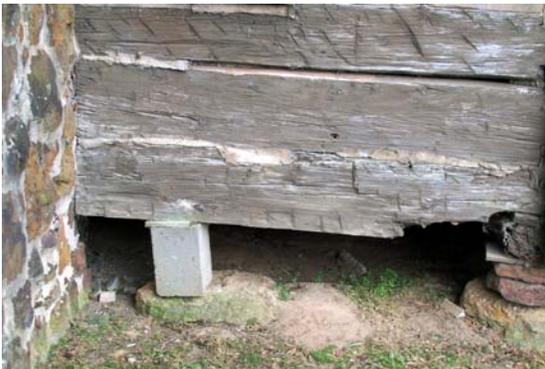
Figure 3.4 shows a cinder block being used as support and a distinct lean to the pillar causing uneven pressure on the support.

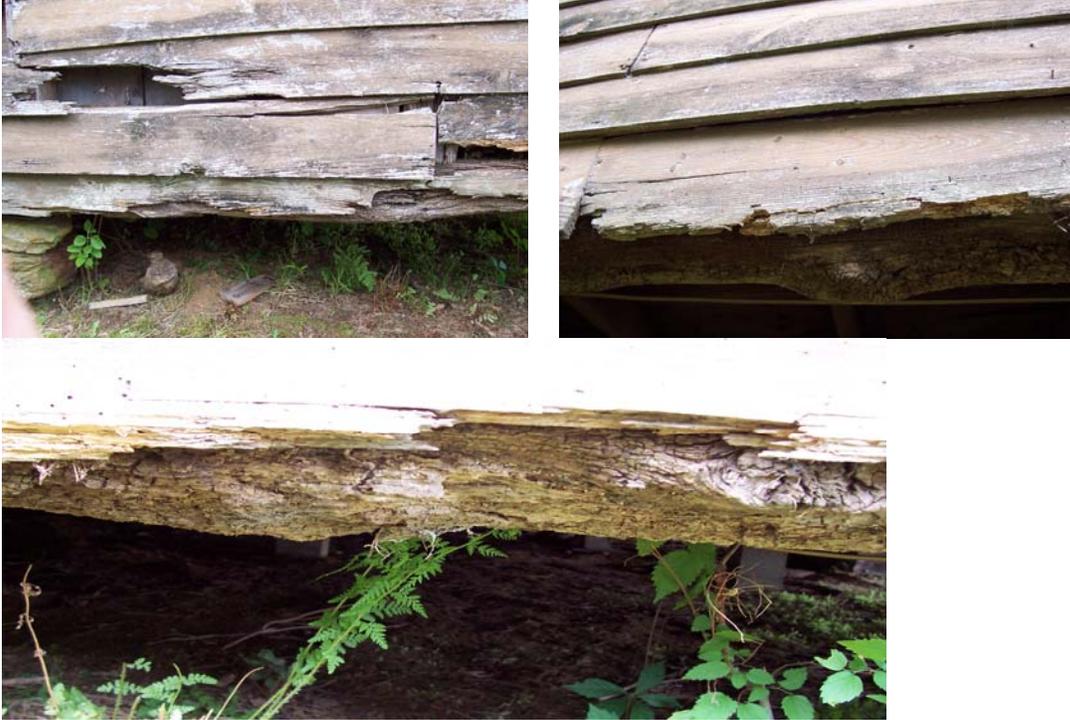
The support sills (or beams) need to be replaced, for they are deteriorating (Fig 3.6-8). The sills are in such a state, that in some locations half of the beam has rotted away. Along the entire structure, there are significant signs of rot along

the support sills and if not taken care of soon will lead to a failing of the support for the entire structure.

Figures 3.6, 3.7, and 3.8 show the support sills' deterioration. These sills are typical of all the sills that support the house. Every sill should be replaced with new, treated timber before long to provide a strong support system for the house.

which is in danger of falling down if a pillar collapses, and it will return the look of the foundation to an original appearance. The support sills also need replacing. They bear the load of the entire building and must be in prime condition. Weak half rotted logs should be replaced when foundation work is being done with hand hewn squared logs for historical accuracy.

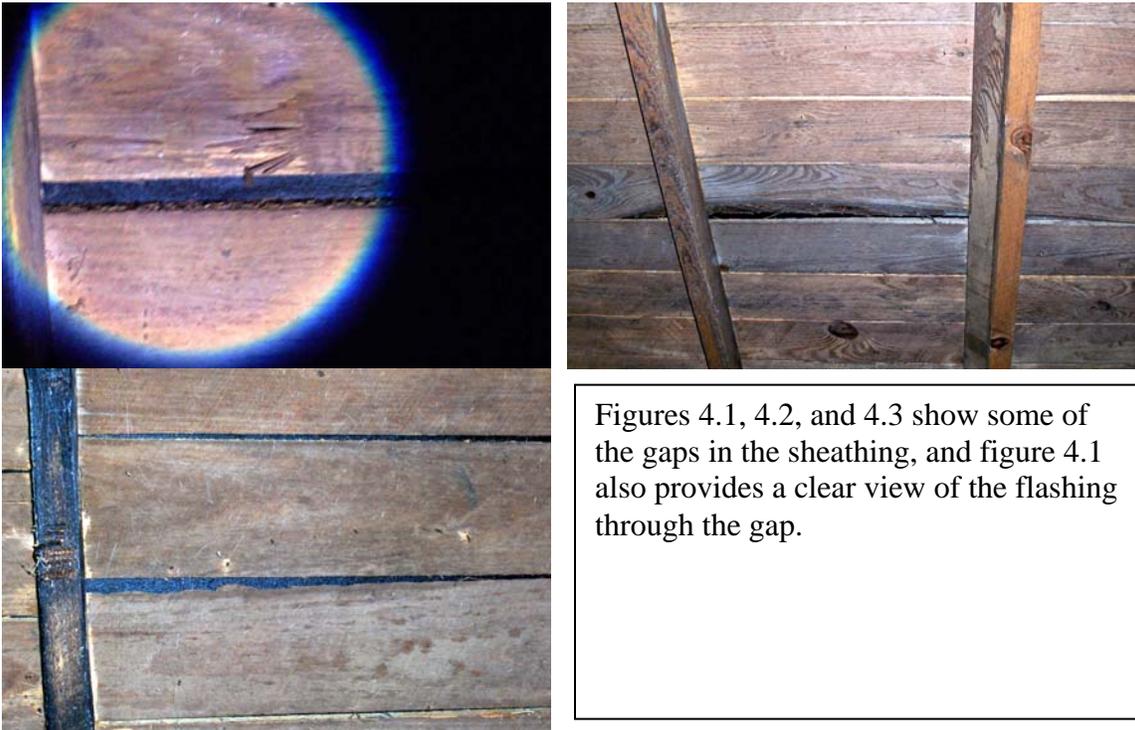
The sheathing appears to be of the same age as the additions. It also appears to be in the same condition. There are many gaps in the sheathing along both the front and rear of the house (Fig 4.1-3). Some planks suffer from splitting and many have cracks that run along the length of the sheathing. In some spots one can see light coming through the gaps in the sheathings and these holes in the sheathing and the flashing allow water to easily penetrate the buildings interior (Fig 4.4), and in many places the roof does not meet in the middle to form a seal (Fig . 1.5-7) There is also a heavy amount of rot in sheathing that is located further up towards the roofs peak. The closer proximity to the middle of the roof where the water leakage is bad, the more rot the wood has (Fig 1.8). The rafters also suffer from this severe rot, and in many locations the black rot is so severe the rafters need to be replaced (Fig 4.5-7). Due to the gaps that run along the center of the roof the water damage to the sheathing and rafters is significant, and this added moisture is also leading to mold and fungus growing throughout the second story addition (Fig. 4.8-10).

Figures 4.1, 4.2, and 4.3 show some of the gaps in the sheathing, and figure 4.1 also provides a clear view of the flashing through the gap.

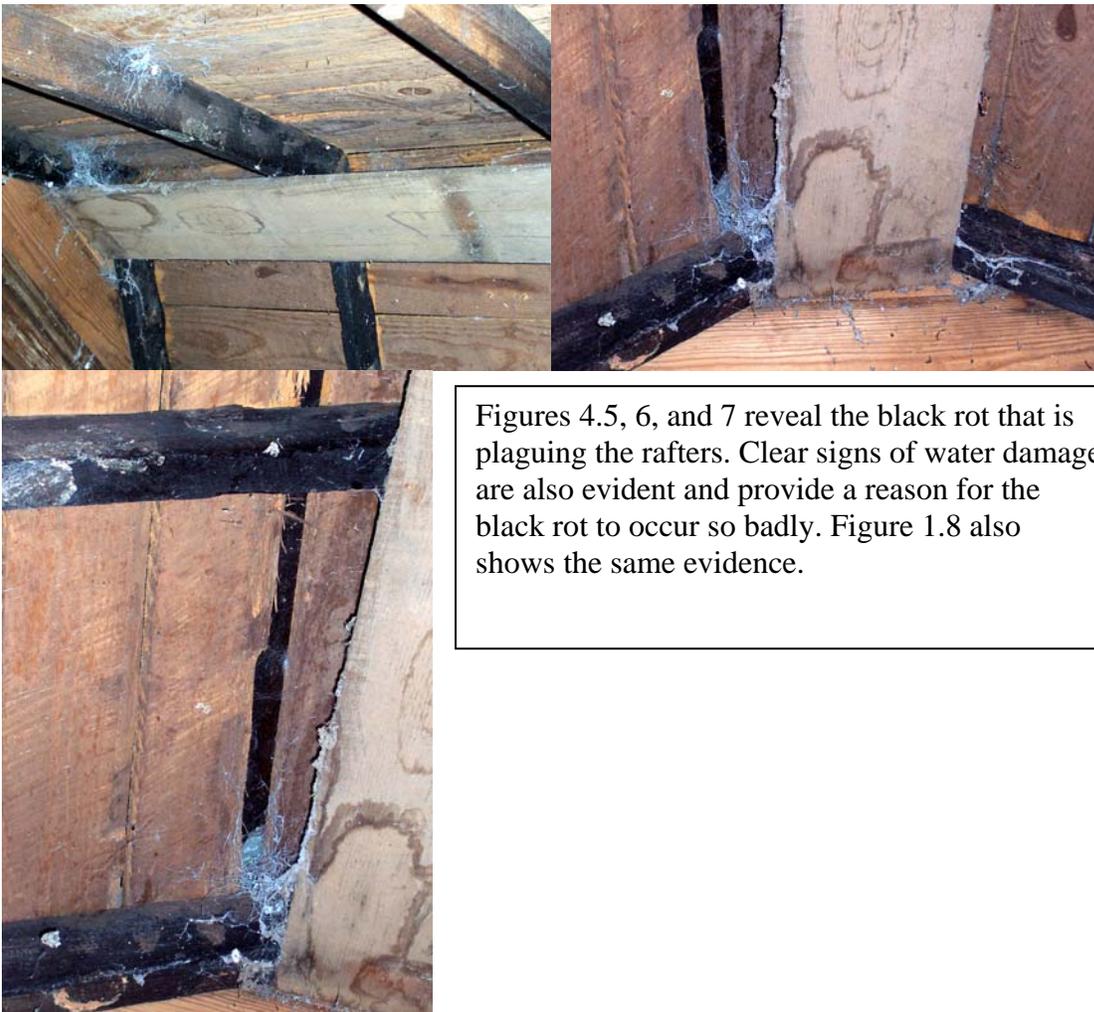
Figures 4.5, 6, and 7 reveal the black rot that is plaguing the rafters. Clear signs of water damage are also evident and provide a reason for the black rot to occur so badly. Figure 1.8 also shows the same evidence.

The roofing materials can also be modern, with the exception of the wooden shingles. The rafters can stay as 2X4s but the rotted ones will still need to be replaced as soon as possible.

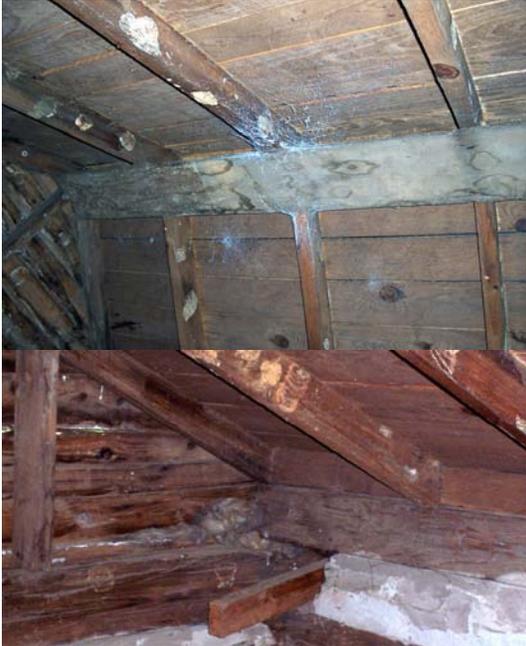
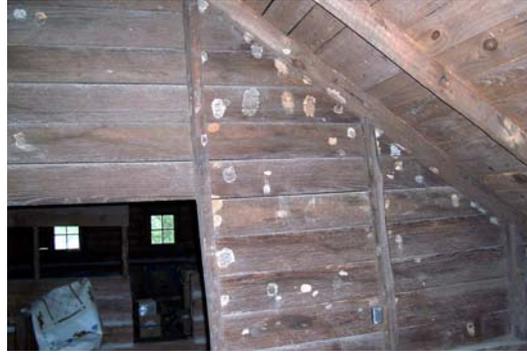
Figures 4.8, 9 and 10 show the extensive white rot along the interior of the roof. White rot can be seen on the sheathing, rafters and the partition walls of the second floor.

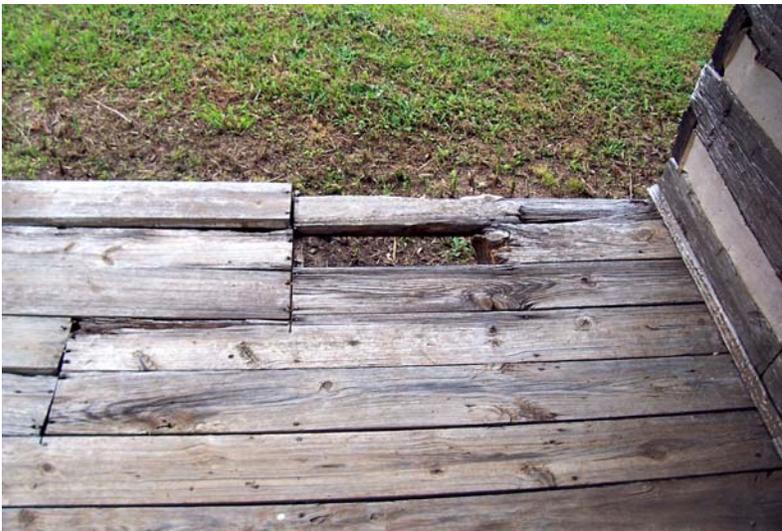
Figure 5.1 shows the deck planks cracked and missing sections. This hole is on the west side of the porch decking.

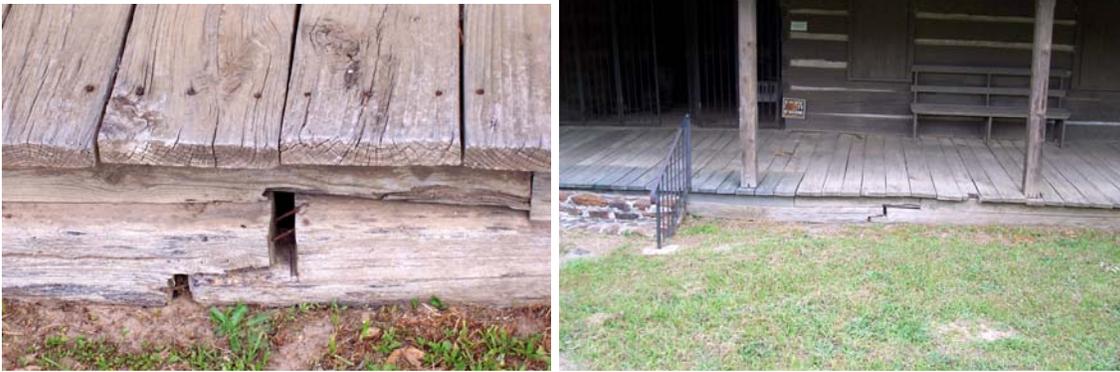
Figure 5.2 and 5.3 show the crack and separation of the front porch's sill.

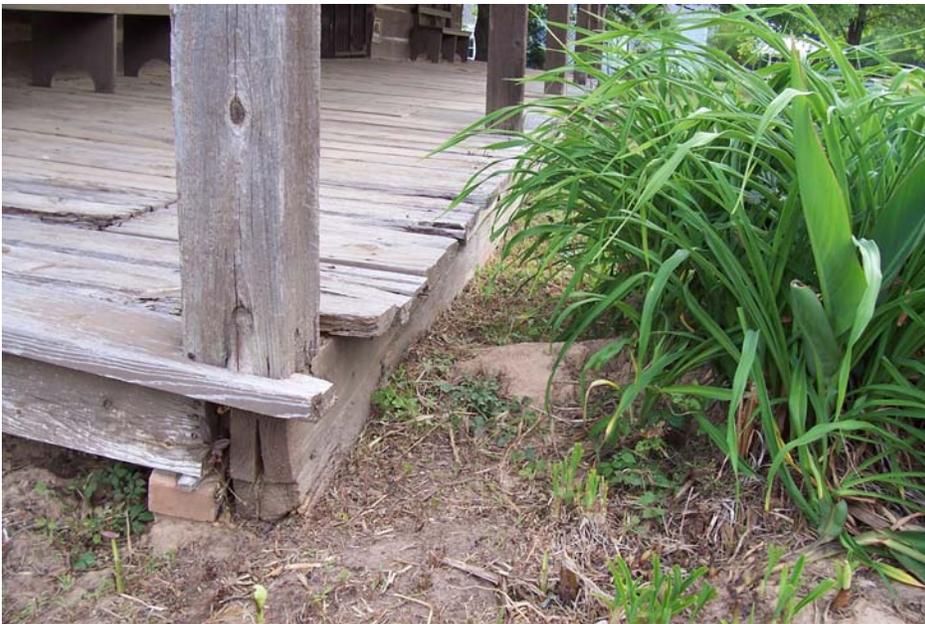
Figure 5.4 shows the modern squared posts, and it also shows the separation of materials along the sill and decking on the western corner of the porch.

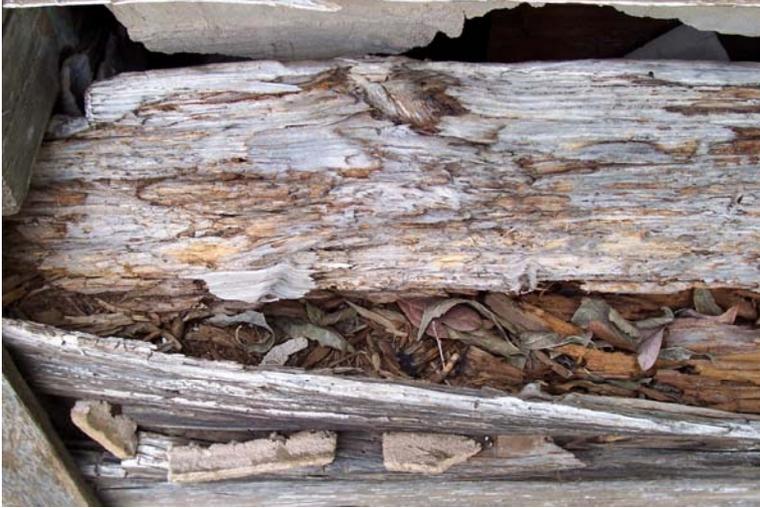
Most of the logs are still in good condition, however there is evidence of insect damage throughout the building (Fig 6.1). These areas indicate two types of insects as the causes of the problems. One is dry wood termites and the other is

Figure 6.1 shows extensive dry wood termite damage along the west side of the building. This is a rare example, as no other logs are in this poor condition.

Another problem that needs to be addressed quickly is the insect problem. While there are relatively few areas of major damage, those areas can spread as the insects spread to new sections of the wood. As much of the original logs needs to be saved as possible and this will require treatment immediately. Techniques for repairing the logs can be found in *Preservation Brief 26*.

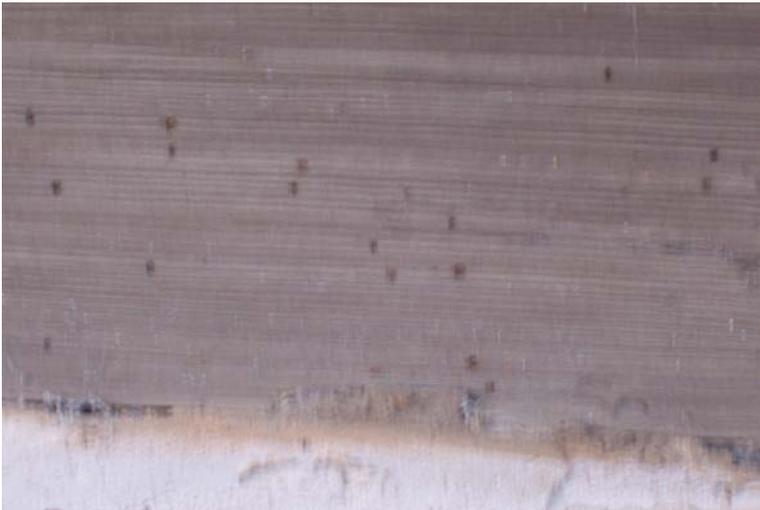
powder post beetles. “Dry wood termites, found primarily in the warmer and moister climates typical of the southeastern states, do not build shelter tubes. However, they can be identified by their fecal pellets, which often appear spilling from cracks in wood. Another telltale sign is the wings that fall from the insects during a period in their life cycle.”⁴ Some logs along the exterior of the building have been severely damaged by dry wood termites, and the building needs to be treated for this pest. “Powder-post beetles are wood borers, and at the active larval stage will tunnel inside wood, causing great damage. Watch for exit holes made by the adults and for powdery dust beneath the holes.”⁵ I witnessed a beetle exist one of these exit holes of the west side of the building in the location in figure 6.2.

Figure 6.2 shows another location along the east side that shows signs of powder-post beetles. These holes can be found throughout the entire structure.

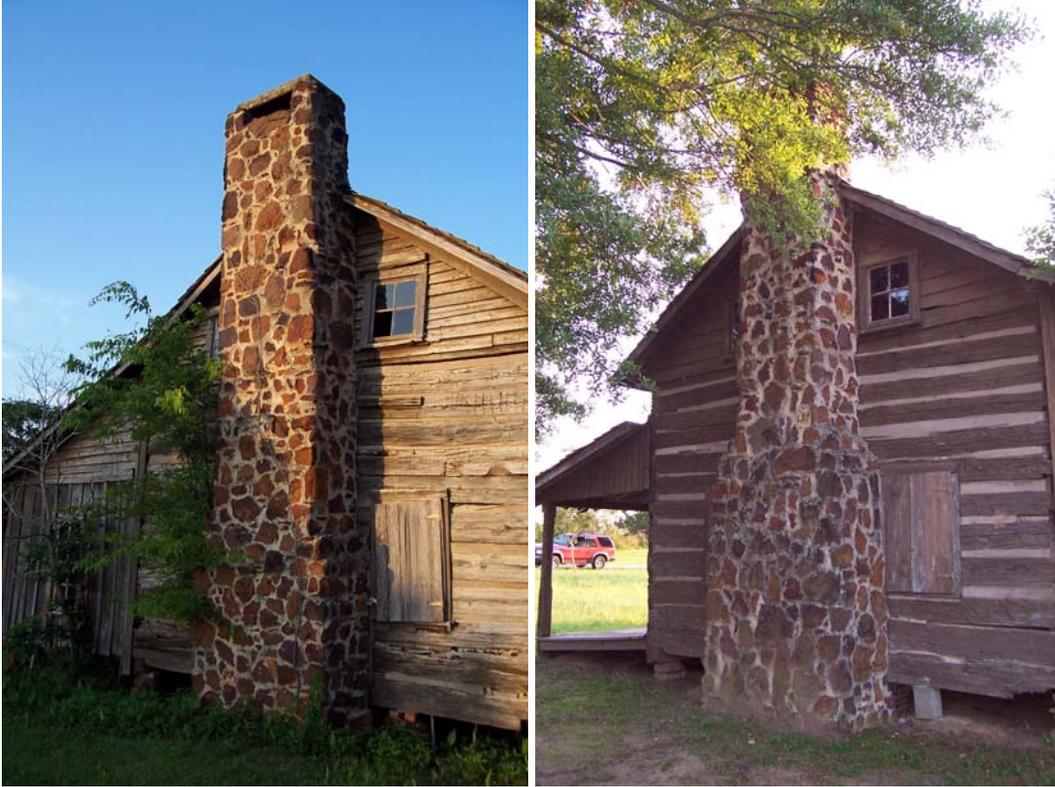
Where the chimneys are supposed to connect to the roof, has come loose. There is large separation from the roof and without this connection the chimneys are subject to instability if an earthquake should occur because there is nothing maintaining their upright position. The chimneys are stable on their own, but need to be secured to the building in a better manner.

Figure 7.1 shows the chimney on the west side of the building, and figure 7.2 shows the chimney on the east side. Both chimneys are in good condition as are evident from the pictures. However, note the vegetation on the west chimney in figure 7.1. A tree is growing along the north side and a vine is growing up the chimney on the north side. These need to be removed.

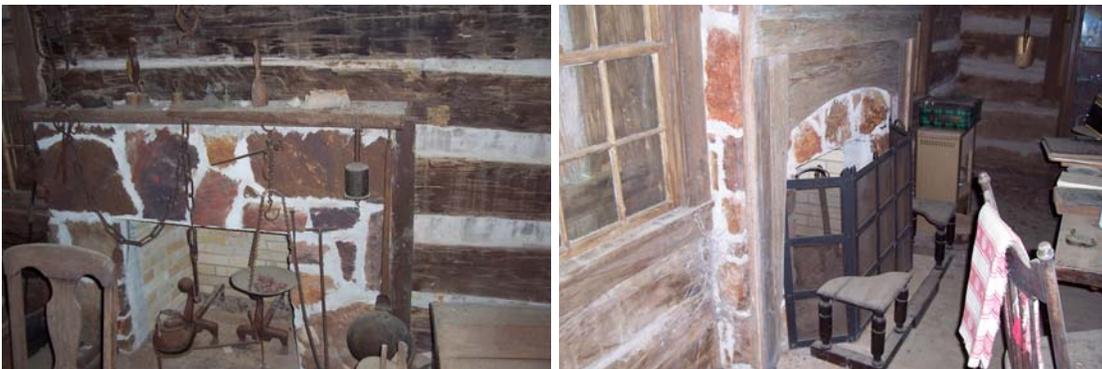
The fire places are in great need of cleaning. Without adequate cleaning of the fireplace, the structure could be susceptible to fire. The fire places are located centrally with the original dog trot structure and reveal the importance of this method of heating. Each side has its own fireplace so that each side of the building can be heated during occupancy. Figure 8.1 shows the condition of the

west sides fireplace, and figure 8.2 shows the general condition of the eastern rooms fireplace. Both fireplaces show no signs of structural problems, and like the chimneys they are part of are in good condition. The interior of the fireplaces has been lined with modern firebricks, and they are not the original materials used.

Figure 8.1 shows the fireplace in the west side front room. Figure 8.2 shows the fireplace in the east side front room. They are both centrally located within their rooms and are in good condition. Note the modern firebricks that are clearly visible in figure 8.1.

The chimneys and fireplaces are in great shape. The fire brick inside the chimneys in not historic, but does not detract from the historic feel greatly. They do add extra fire protection if the chimneys were to be light for reenactments, so the added protection is good. The vegetation should be removed from the chimneys before it can damage the mortar and stone work, and the trees located near the chimneys should also be removed carefully to avoid any damage. The chimneys should also be cleaned, as a chimney fire can be almost impossible to suppress once started. This will make use of the fireplaces a safe practice as long as they are inspected yearly.

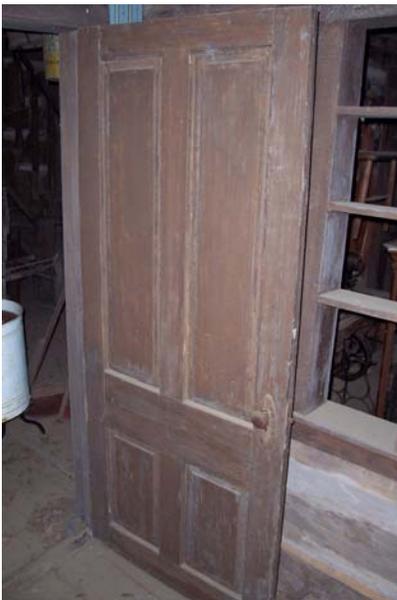
The rear addition also has two entrances into the walkway, and these doors allow an entrance into the rear portion without going through the main section of the structure. These rear doors on both sides are no longer plumb, and show the general state of disrepair of the addition. There is water damage along both entryways and the doors are no longer flush with the structure. Both of these doors are of modern construction, and look nothing like the two doors on the original entrances (fig 9.3).

Figure 9.3 shows the modern style door that contrasts greatly with the historic doors on the original section of the house.

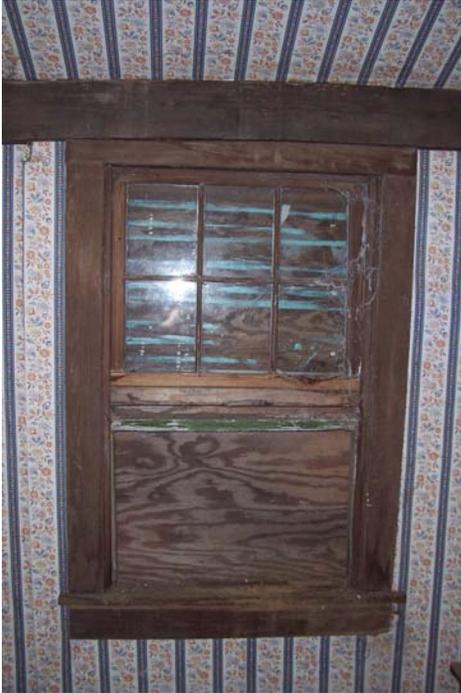
The most common window is the one pictured in figure 10.1. This style is in the eight windows located in the dogtrot's main rooms and the six windows in the rear addition. There are two window holes in the north wall of the dogtrots original walls that are now being used as shelving, and do not have any glass within. The majority of this style of window is intact, but there are two that are broken as shown in figure 10.2.

Figure 10.2 shows this window in the east side rear addition is the same style as the one located in the original dogtrot (fig 10.1), but this one's glass is broken. Another window in the west side rear addition is also broken.

The windows need to be plumb and the ones replaced with shelving fixed when the rear addition is removed. They should be the same style windows, and the windows in the addition that is being removed has the same type. They can be used to replace the missing windows in the original structure, as long as the glass is replaced.

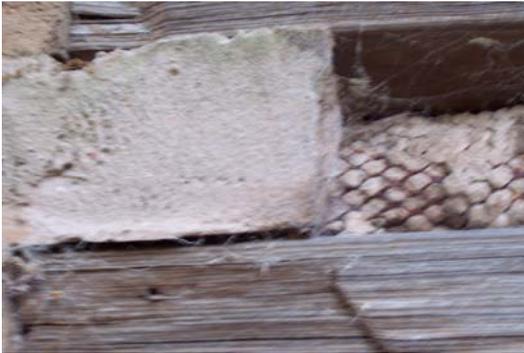
Figure 11.1 shows the concrete daubing used and the wire mesh chinking. This daubing is broken and as seen in figure 11.2 are typical. Many locations are void of daubing material and allow the light to enter the building. Daubing and Chinking require routine maintenance.

The chinking and daubing needs to be replaced and maintained twice a year. Daubing will crack and break, no matter the material used, as the building settles or the ground shifts slightly. Due to the fragility of daubing, it should not be replaced or repaired until after the building has been shored up and any replacement logs have seasoned. Daubing was typically made from clay and the chinking was any available materials, from wood to rocks and stones. However, *Preservation Brief 26* lists modern mixes that will retain an historic feel but be sturdy and long lasting.

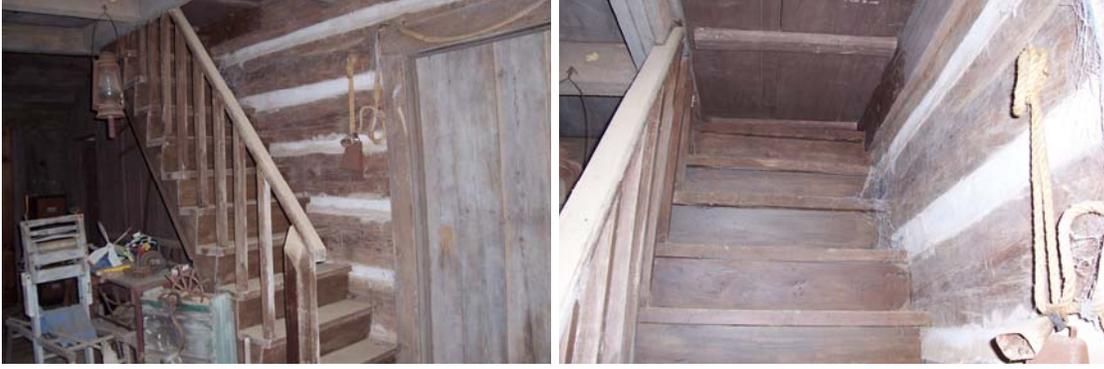
There are only two sets of stairs in the structure. One set of stairs is located in the space way between the two sections of the dogtrot and appears to be in an original location (Fig. 12.1-2). The stairs are in poor condition and relatively unstable. While they will bear weight, they do not feel very secure or safe because there is shifting as weight is applied. Secondly, they no longer actually lead into the second story. There is a covering above the stair case that was securely closed, and could not be opened.

Figures 12.1 and 12.2 show the stair case that is located in the space way. You can see that the stairs are sealed off and no longer used, but they appear to be in the original location.

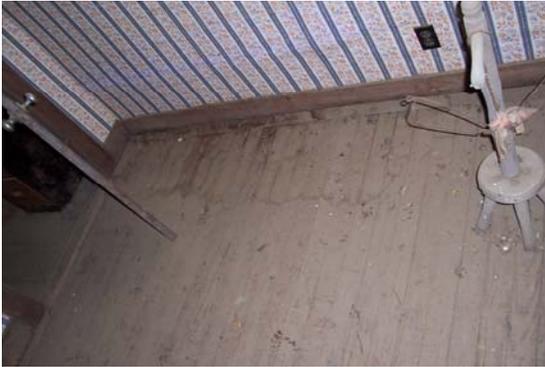
The floor in the east side rear addition is in bad shape. The floor has major water damage along the north wall and along the threshold leading into the space way (Fig 13.1). The floor in this room is also not tightly fitted, as there are gaps between the boards. The floor also has a slight unsteady feeling as you traverse, but it is relatively level with a slight slope from the front to the rear of the house.

Figure 13.1 shows the flooring in the east side rear addition. The water damage is clearly evident along the north wall flooring and the threshold.

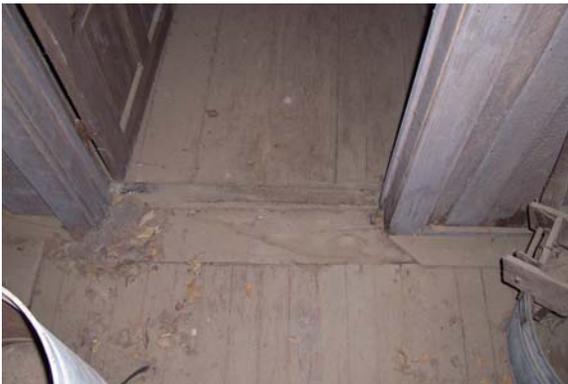
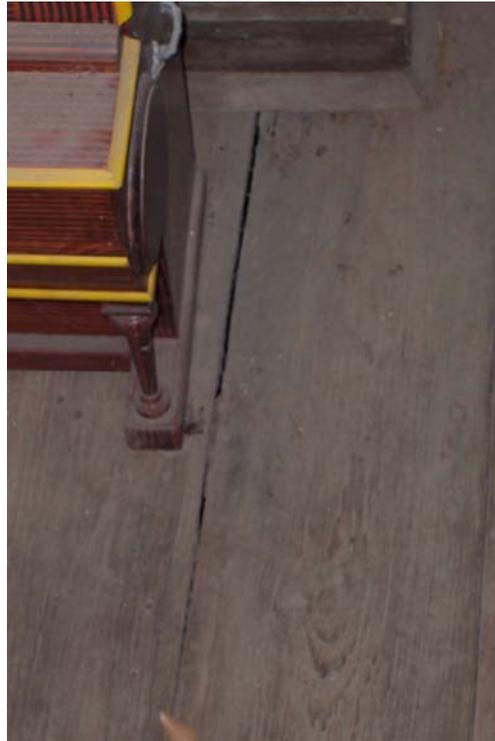
The floor in the west side rear addition is in terrible shape (Fig 13.2-3). The floor feels unsafe to walk upon, as it has a squishy feeling from extensive water damage. The planks of flooring do not fit together well any longer and major gaps occur where you can see the ground beneath the house. The floor is also warped badly due to the water damage, and one does not need a level to see the different directions of slope that occur within this room. There is major water damage along the base boards of the exterior walls and the threshold that leads into the space way.

Figures 13.2 and 3 show the flooring in the west side, and one can see the gaps and cracks in the flooring. Looking closely at Figure 13.2 the threshold has a cracked section. This section is not secured and if you were to put weigh ton it you would fall through the floor.
