**STEPHEN F. AUSTIN STATE UNIVERSITY
Request for Qualifications #AE-BLDG PROJECTS-2018**

ADDENDUM NO. 1

Stephen F. Austin State University L. E. Griffith Jr. Fine Arts Building

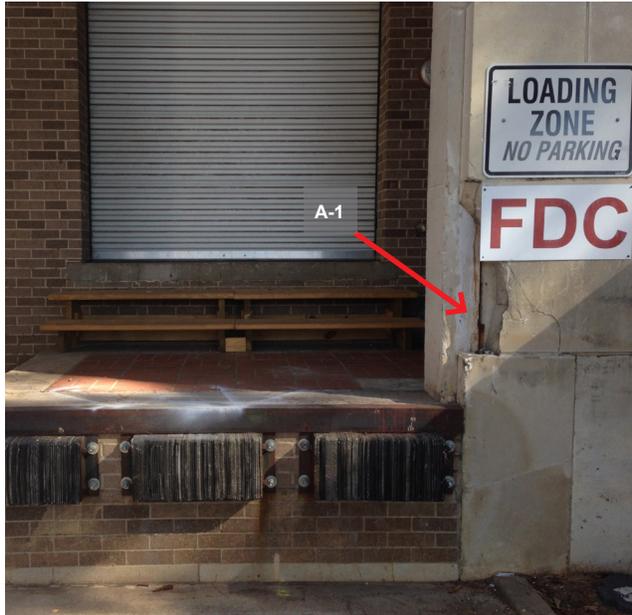
Item No. A-1

Description Exterior brick and stone work

| KEY | ITEM | CONDITION | DESCRIPTION |
|---|---|---|--|
| A-1 | Exterior brick and stone work | Poor | Repoint and reattach all damaged exterior brick and stone work |

As noted by Haynes Whaley's assessment, there are several areas of the brick façade that require repair. Some areas (refer to item S-11) pose safety issues due to the decorative stone's height above the ground. Others are more cosmetic. Areas of cracked brick and loose stonework should be repointed and/or reattached (A-1).

Action Repoint and reattach all damaged exterior brick and stone work.

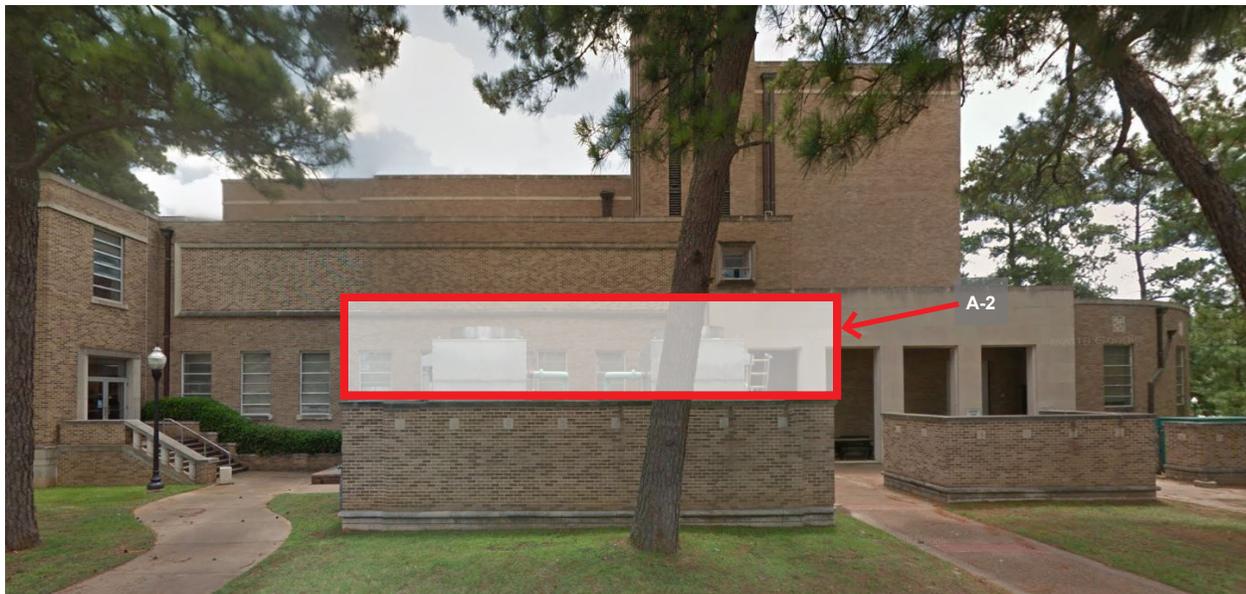
Item No. A-2

Description Brick wall surrounding air conditioning unit on west side of building

The screen to surround and hide the top of the air conditioning unit on the West side of Griffith was never installed. Installation of the remaining screen to hide this equipment is recommended (A-2).

Action Install missing screen around air conditioning unit to conceal equipment

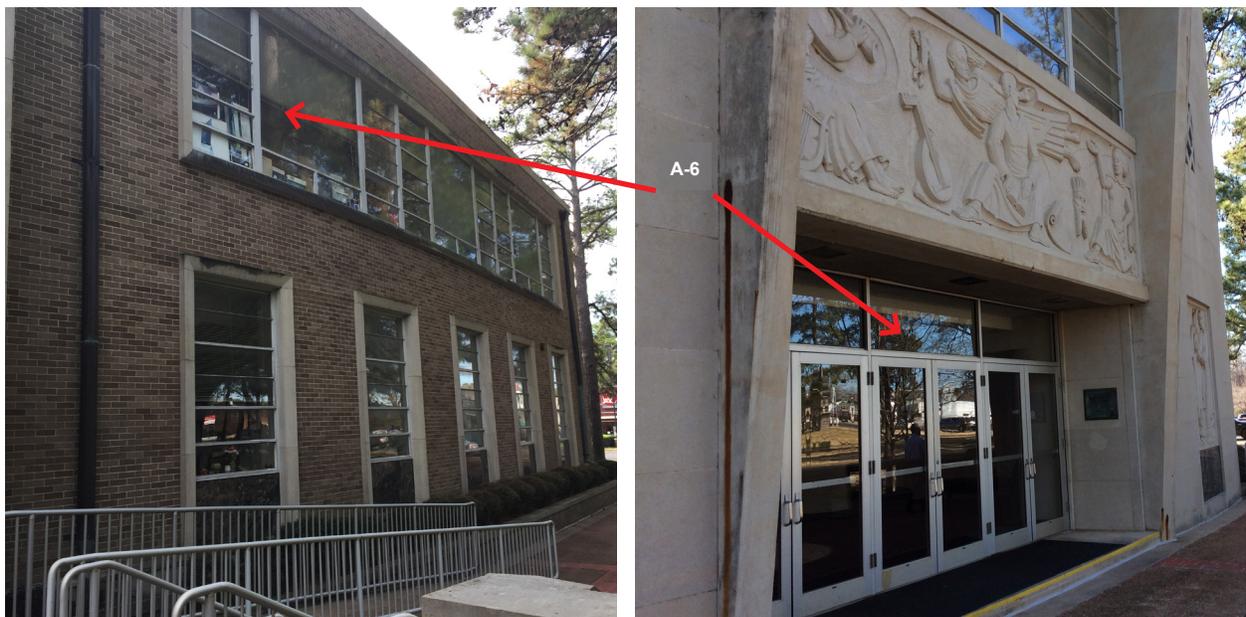
Item No. A-6

Description Exterior doors and windows

| KEY | ITEM | CONDITION | DESCRIPTION |
|---|---|---|--|
| A-6 | Exterior doors and windows | Fair | Replace with aluminum storefront system |

A replacement of all exterior doors and windows with an aluminum frame storefront system is recommended (A-6). If new construction is an option, the use of new curtainwall may serve areas like a new lobby more effectively.

Action Replace with aluminum storefront system

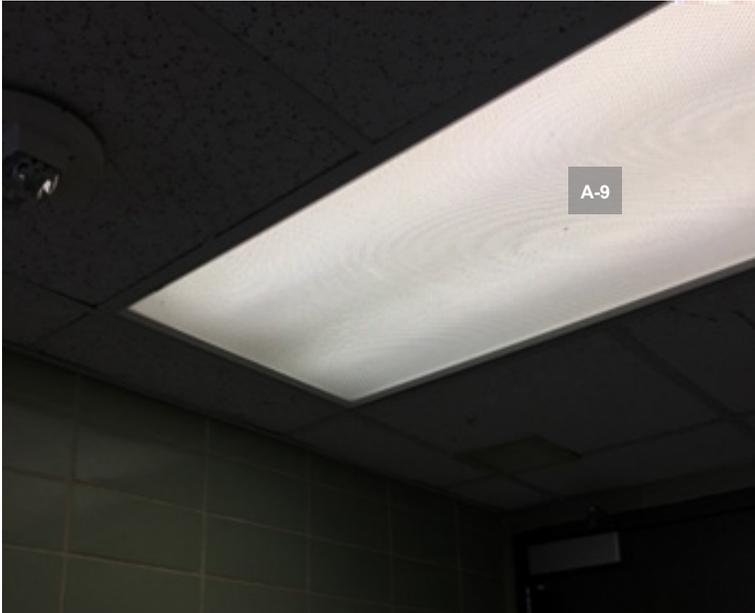
Item No. A-9

Description Fluorescent lighting

Action Replace all fluorescent lighting with LED

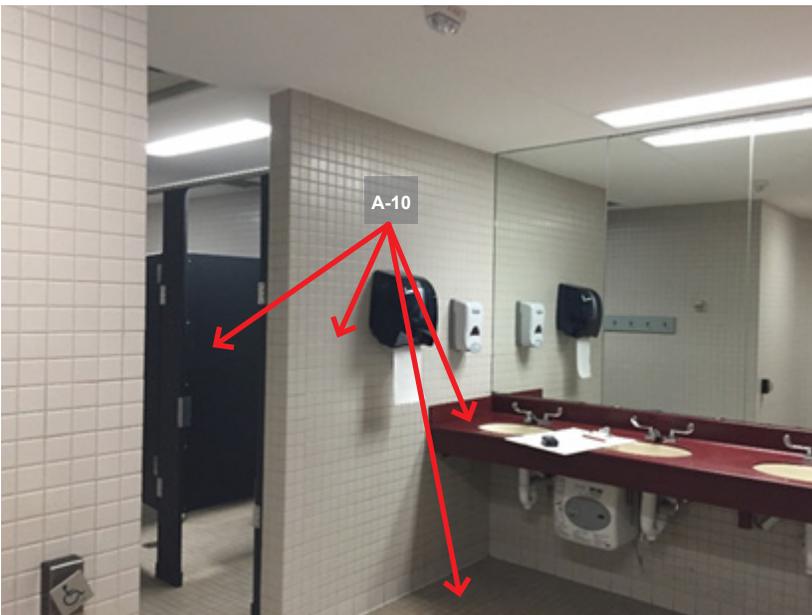
Item No. A-10

Description Restrooms

| KEY | ITEM | CONDITION | DESCRIPTION |
|---|---|---|--|
| A-10 | Restrooms | Poor | Replacement of floor and wall tile, countertops and toilet partitions |

Action Replacement of floor and wall tile, countertops and toilet partitions

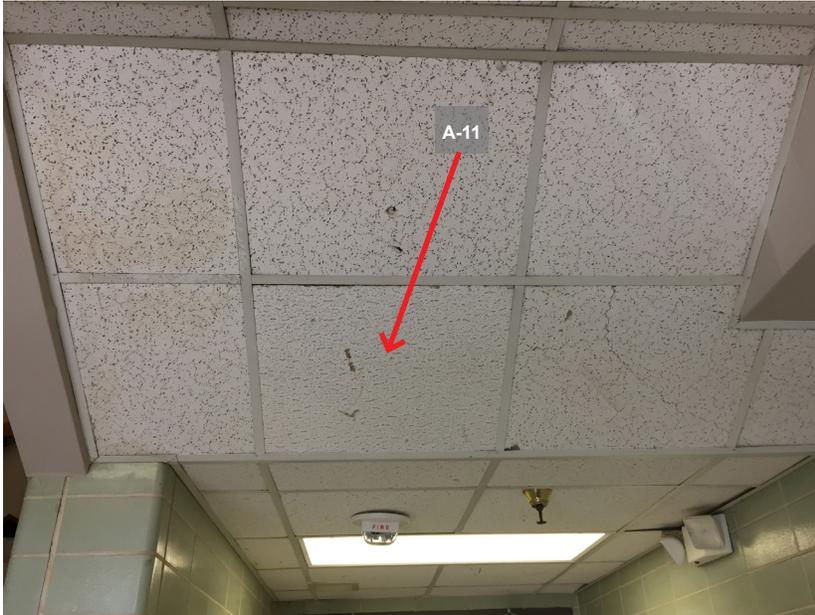
Item No. A-11

Description Lay-in ceiling

| KEY | ITEM | CONDITION | DESCRIPTION |
|---|---|---|--|
| A-11 | Lay-in Ceiling | Poor | Replace all lay-in ceilings |

Action Replace all lay-in ceilings

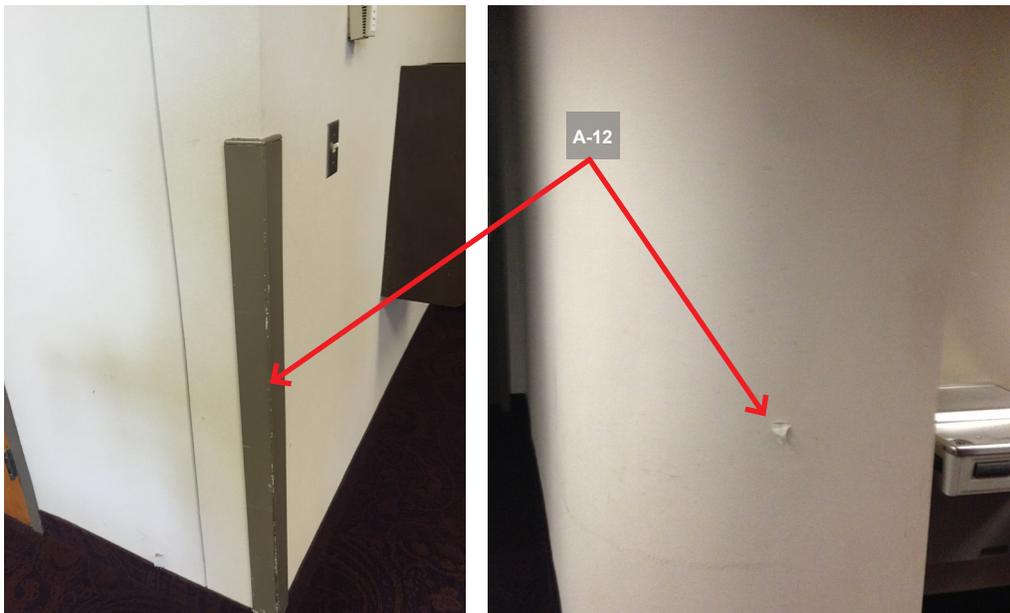
Item No. A-12

Description Painted walls and wall coverings

| KEY | ITEM | CONDITION | DESCRIPTION |
|---|---|---|--|
| A-12 | Painted walls and wall coverings | Fair | Repaint walls and replace wall coverings and corner guards |

Action Repaint walls and replace wall coverings and corner guards

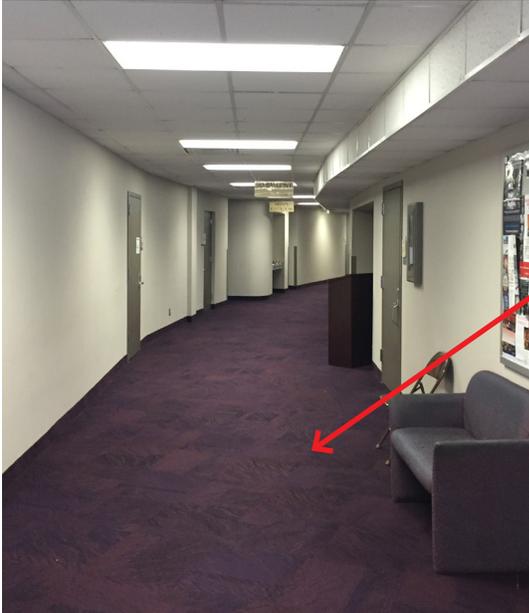
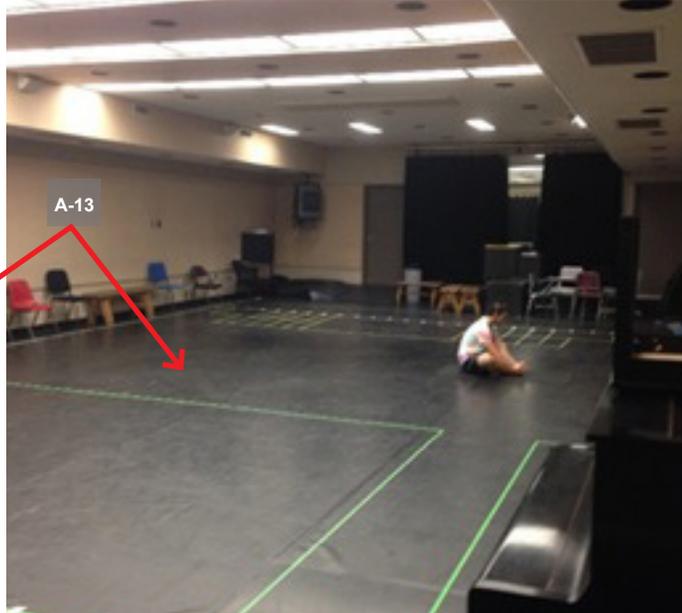
Item No. A-13

Description Floor finishes

| KEY | ITEM | CONDITION | DESCRIPTION |
|---|---|---|--|
| A-13 | Floors | Poor | Replace all floor finishes |

Action Replace all floor finishes

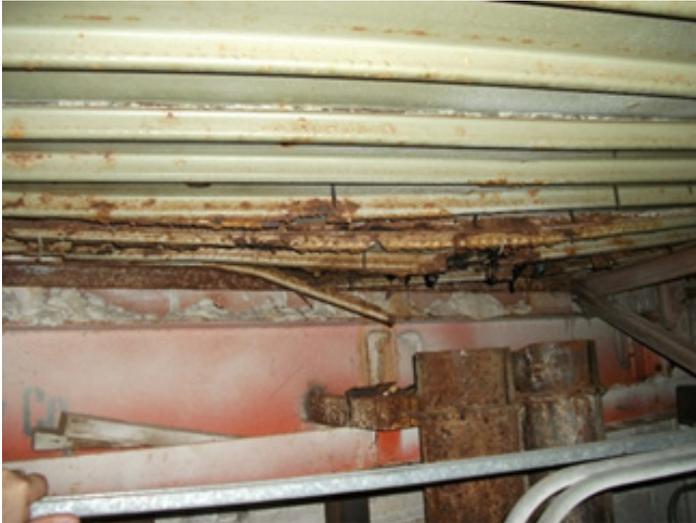
Item No. S-1

Considering the age of the Griffith Fine Arts Building and the large amount of use the facility is experiencing, the structure is in good condition. The largest structural concern observed is detailed in observation S1. The metal roof deck over the stage area has corroded through at several locations around the perimeter due to previous leaks. This has compromised the capacity of the deck in this area and may create an unsafe condition for maintenance work on the roof in these areas. In addition, construction materials have been placed on top of the roof in this area adding load to this already compromised area. Three other high priority observations are noted in the report. Observations S5 and S10 relate to the safety of fixed ladders on the roof of the structure used by maintenance workers. Observation S11 refers to a decorative stone that appears to have disbonded from the adjacent stones near the roof line at the North West corner of the north entrance element. Because of its height above the ground it is important to verify that this stone is secured.

Description Underside of roof above stage South West and North Wall. Existing roof deck has corroded through in a few areas along the wall due to roof leaks in the past. This has compromised the structural capacity of the deck in these areas.

Action Remove and replace existing metal deck in this area. (High Priority)

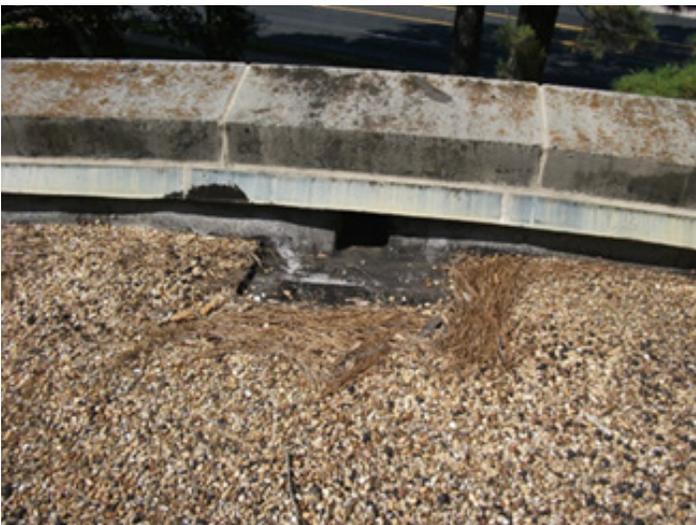
Item No. S-2

The roof appears to have ponding although it does not appear to be overly excessive throughout the entire roof. As noted by several consultants, including DBR (refer to item P-4) and Haynes Whaley (refer to item S-2), the existing scuppers are few and far apart. Number and size of scuppers and roof drains should be evaluated and if necessary, redesigned or enlarged to better suit the building's drainage requirements (A-4).

Description Roof of building (general). The scuppers on the roof of the building are small, widely spaced and in general do not have overflow drains or scuppers. This can lead to standing water on the roof that can cause roof leaks and higher roof loads in areas where the drain is blocked.

Action Review current roof drainage and consider adding additional drainage. (Medium Priority)

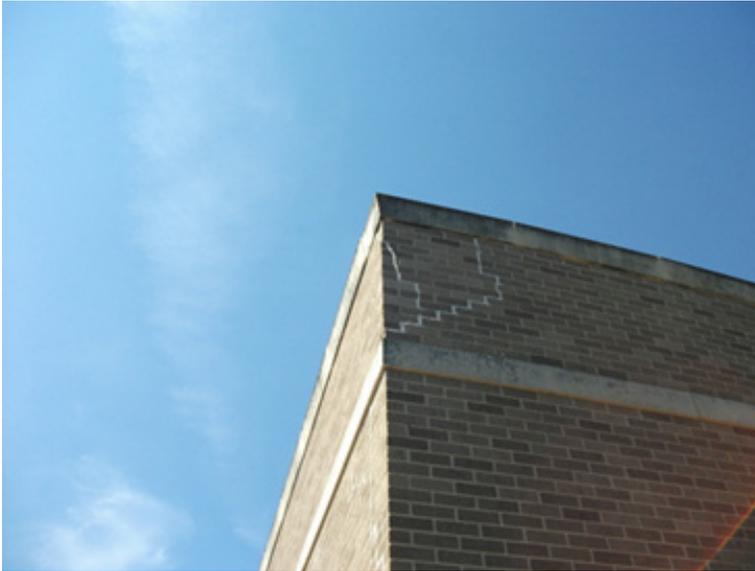
Item No. S-3

Description North East corner of upper parapet at back of auditorium. Corner has cracked and appears to have been caulked instead of mortared back in place.

Action Have a mason repoint this corner to restore structural integrity. (Medium Priority)

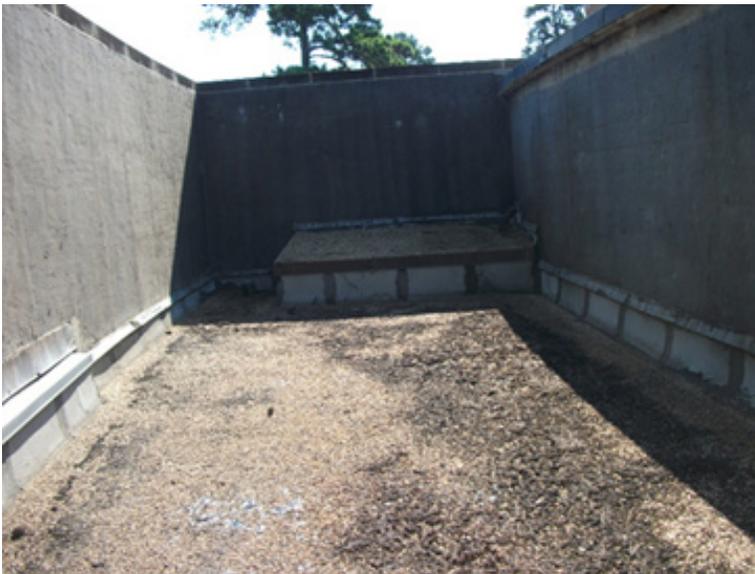
Item No. S-4

Description Roof over North entrance. Roof has inadequate drainage, signs of long term standing water and debris. This can lead to roof leaks and excessive roof loading in this area.

Action Review current roof drainage and provide adequate slope/drainage. (Medium Priority)

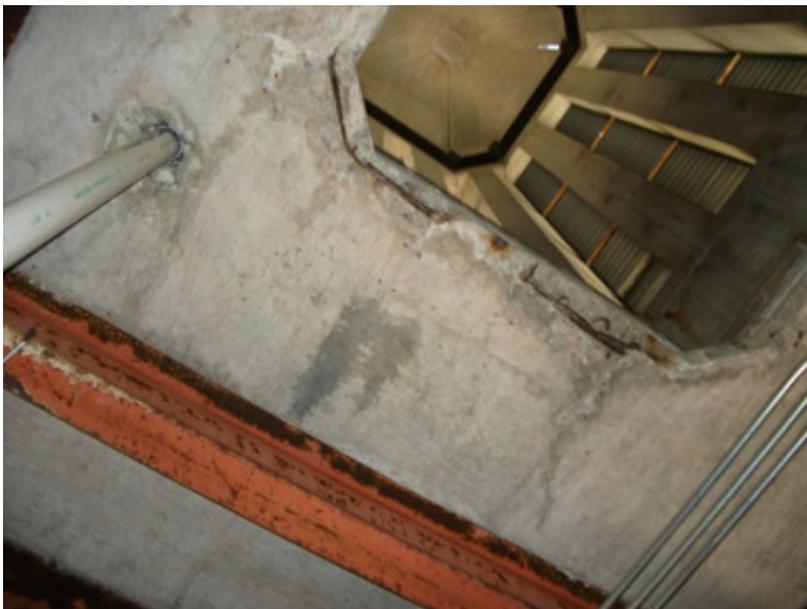
Item No. S-6

Description Inside bell tower. Spalled concrete and corroded reinforcement at slab edge.

Action Clean reinforcement and repair with polymer modified Portland cement mortar. (Medium Priority)

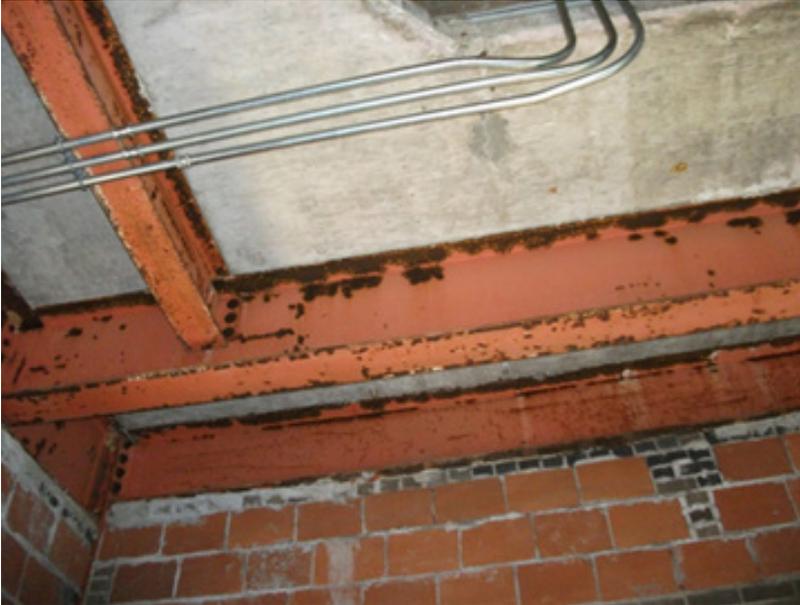
Item No. S-7

Description Bell tower. Top flange of wide flange beams supporting bell tower are corroding.

Action Clean and paint existing structural steel with good quality paint. (Medium Priority)

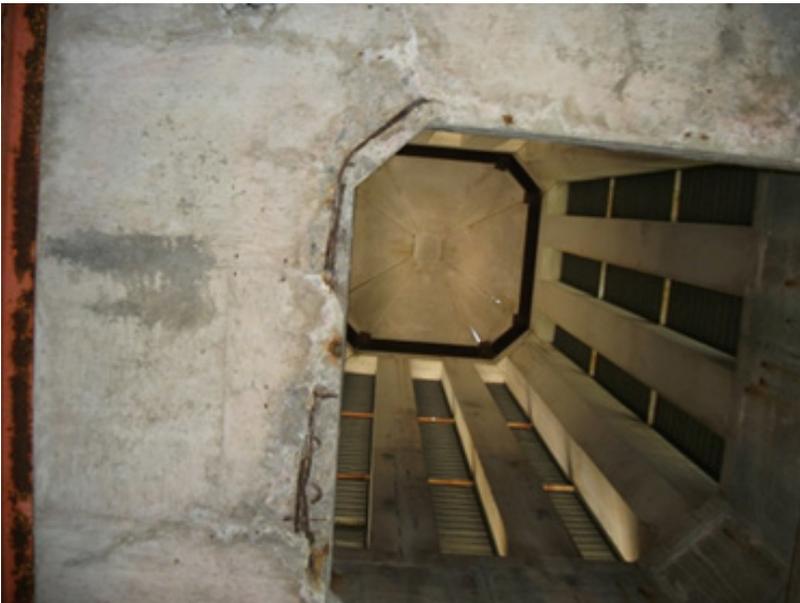
Item No. S-8

Description Bell tower. Daylight visible through seam at top of tower, roof of tower leaks.

Action Seal roof of tower to prevent future water intrusion. (Medium Priority)

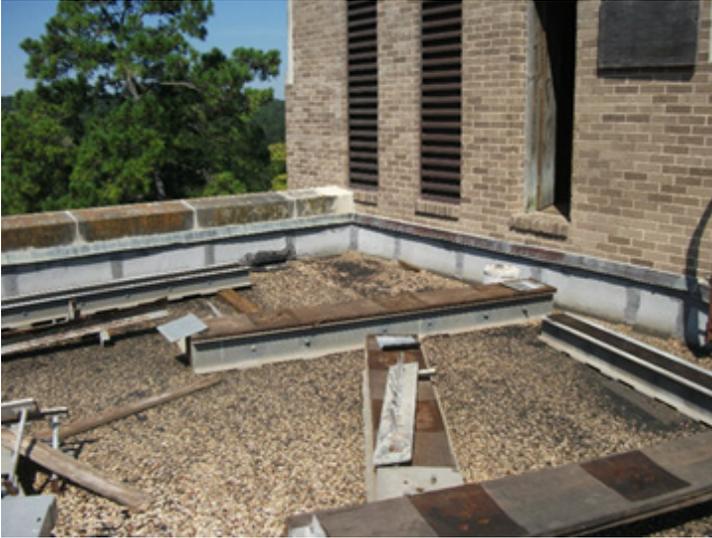
Item No. S-9

Description Roof over stage near bell tower. Construction materials stored on roof over stage in area where the deck is compromised due to corrosion.

Action Although the weight of these materials would normally be within what the roof could safely support with the corrosion damage observed on the roof deck below, this material needs to be removed. (High Priority)

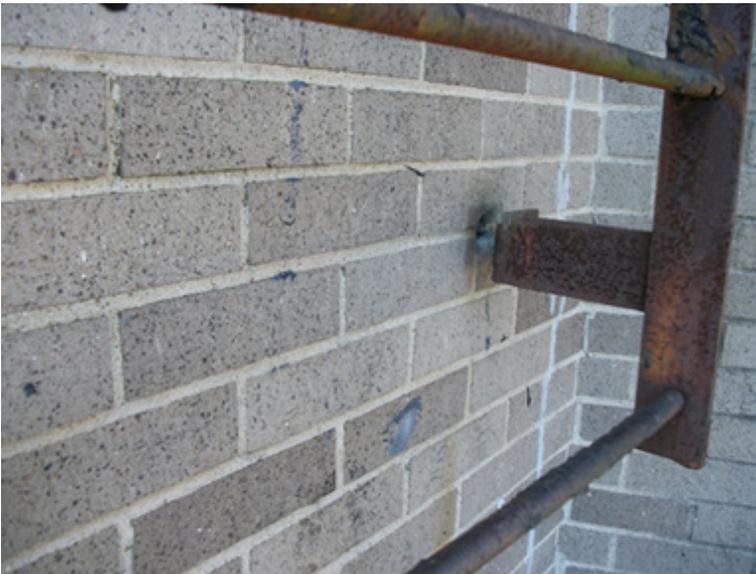
Item No. S-10

Description Roof Ladder from roof over stage to roof over auditorium. Several of the embeds anchoring this ladder are either missing or disengaged.

Action Reattach ladder to the existing wall. (High Priority)

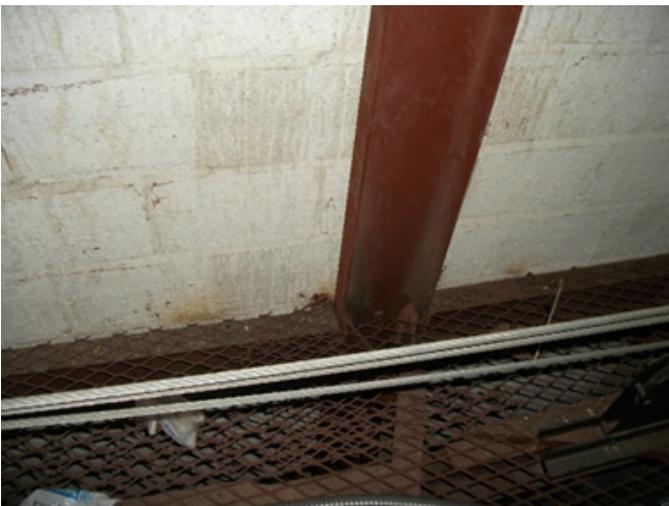
Item No. S-12

Description The "Grid" area over the main auditorium stage. The access up to the grid area does not appear to comply with current safety practices and the mesh on the grid area itself has several openings in it that larger than 6 inches x 6 inches.

Action We recommend that a theater and/or access consultant review this area to verify that the safety measures in place in these areas comply with current industry norms. (Medium Priority)

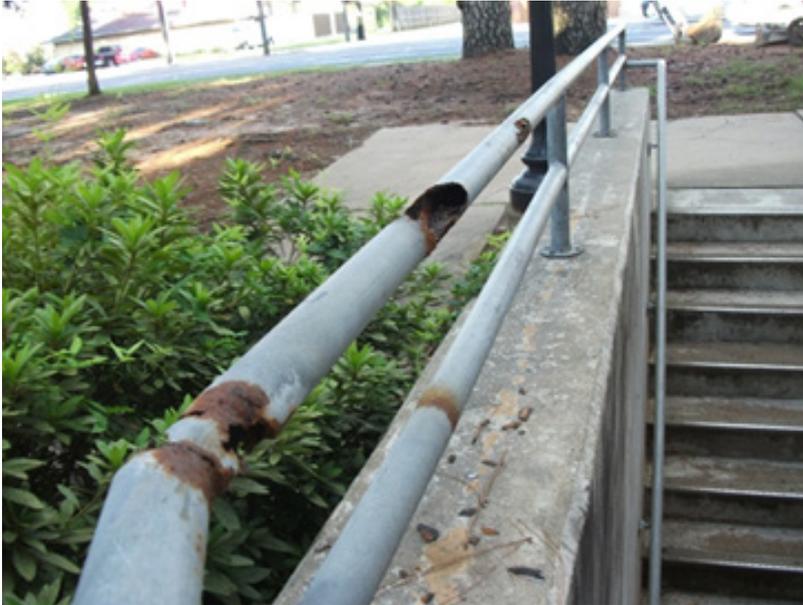
Item No. S-13

Description West side of building at stair down to mechanical area. Guardrail has corroded through.

Action Replace guard rail. (Medium Priority)

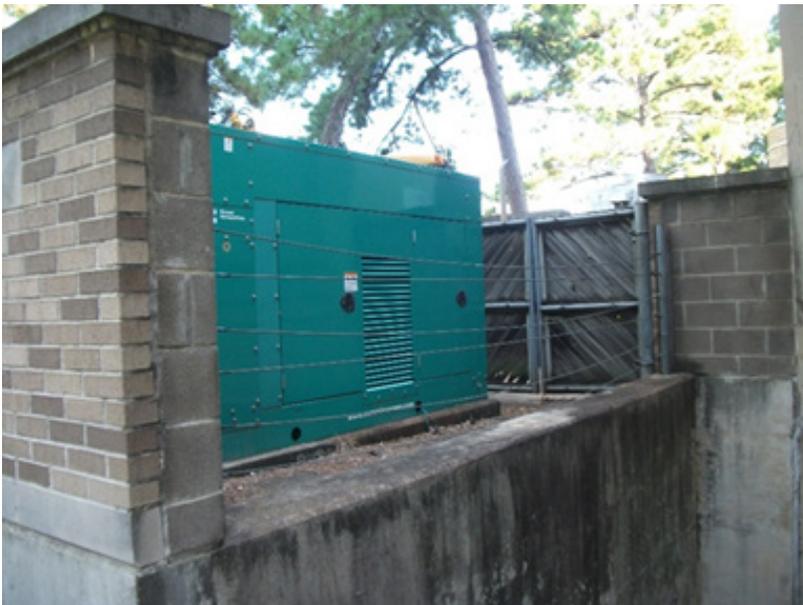
Item No. S-14

Description West side of building at stair down to mechanical area. Slack cables in safety barrier.

Action Tighten cables. (Medium Priority)

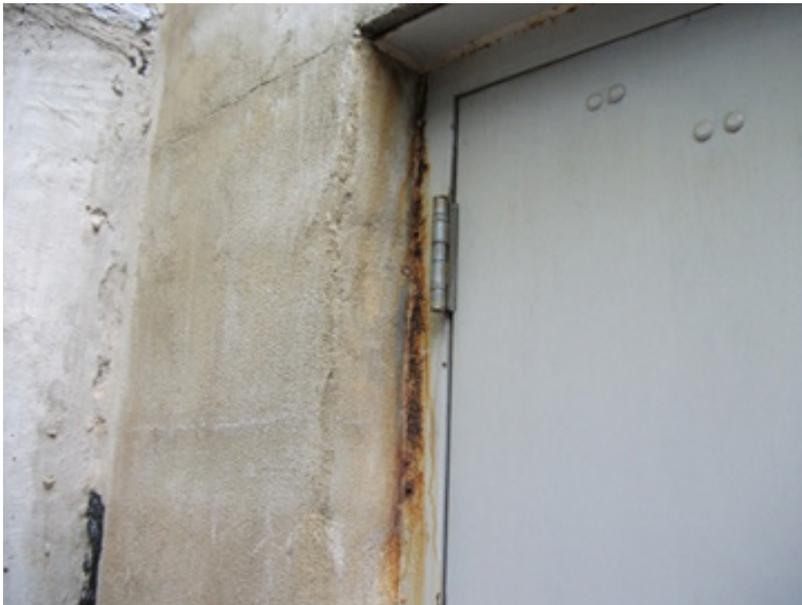
Item No. S-16

Description West side of building at stair down to mechanical area. Corroded door frame.

Action (Non-structural)

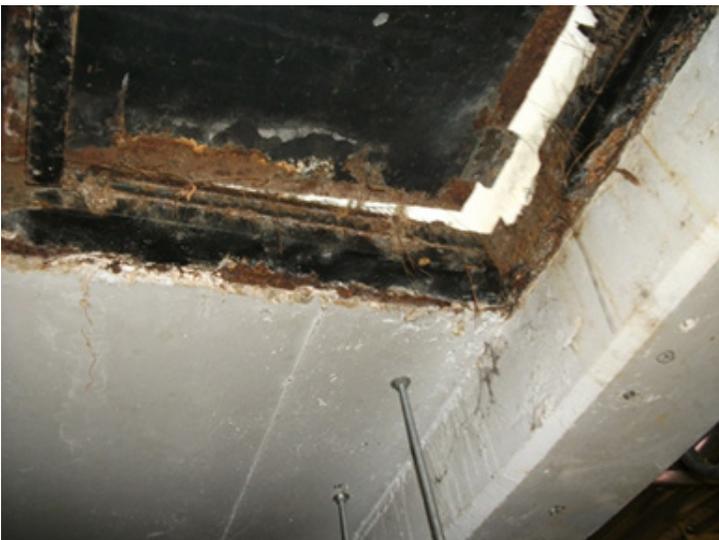
Item No. S-18

Description Horizontal hatch door into mechanical area on West side of building. Hatch has significant corrosion around the perimeter due to water intrusion.

Action Consider replacing hatch and detailing new hatch to prevent water intrusion (Medium Priority) Re: Photo M-1 in MEP Systems Assessment.

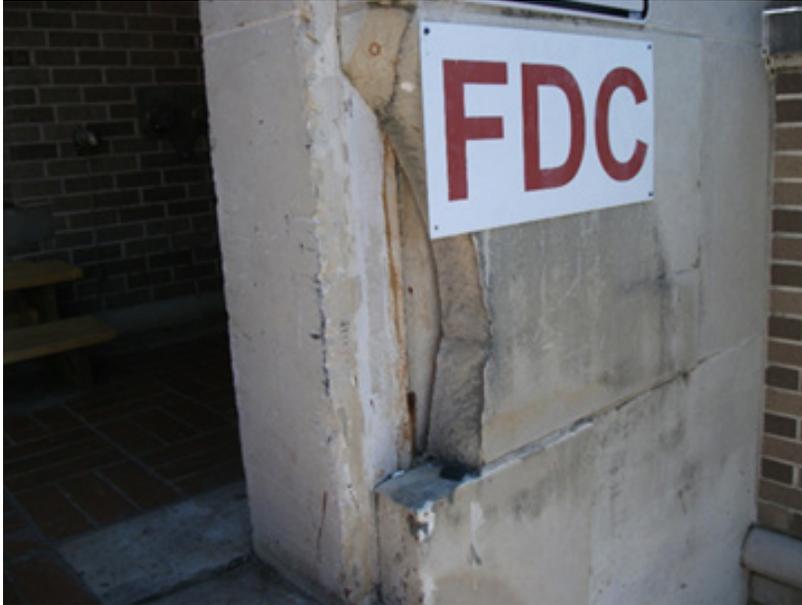
Item No. S-19

Description West side of building at dock. Broken stonework.

Action Replace broken stonework. (Non-structural)

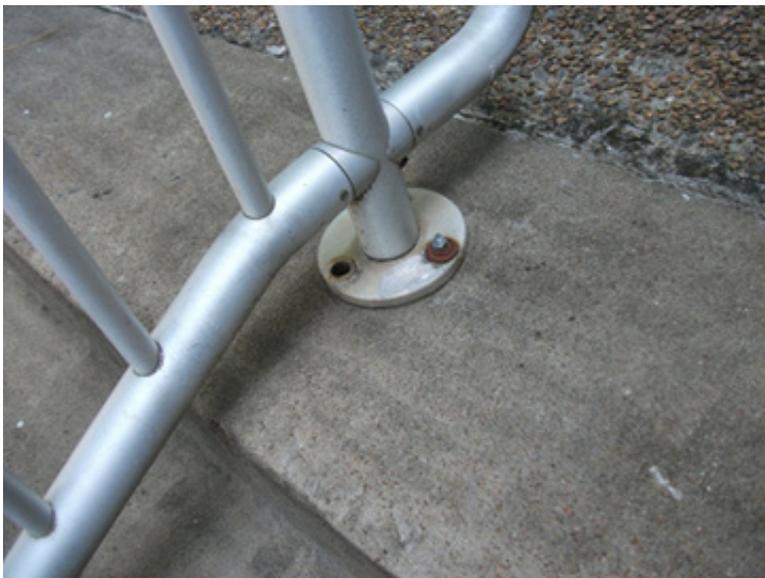
Item No. S-20

Description Handrails on North side of building. Carbon steel bolts have been used to secure aluminum handrails. Several of these bolts are heavily corroded and some bolts are missing.

Action Replace missing and/or corroded bolts with new post installed stainless steel anchors. (Medium Priority)

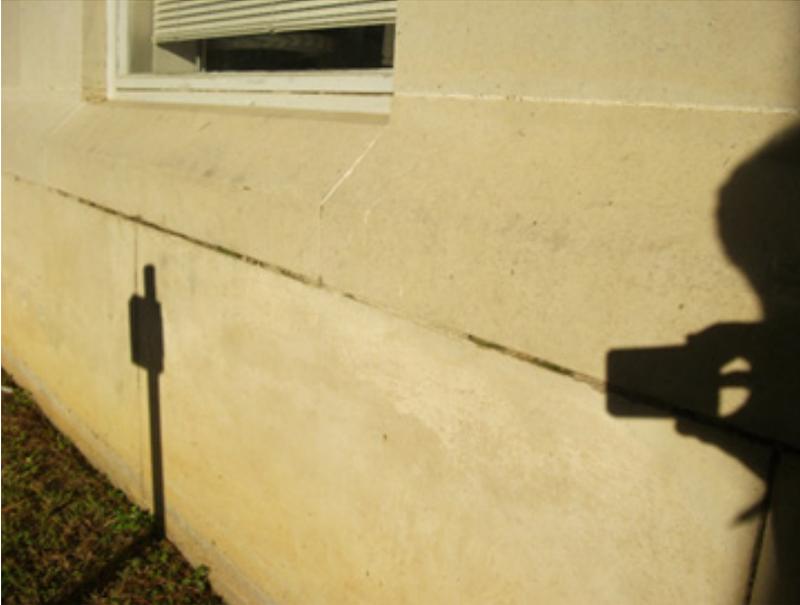
Item No. S-21

Description East side of building near elevator lobby. Deteriorated mortar in joint in stonework.

Action Repoint joint. (Non-structural)

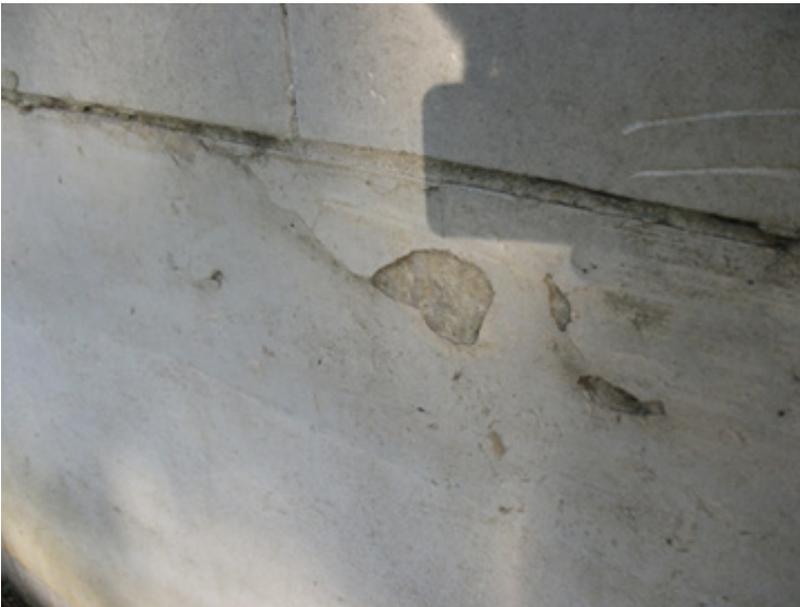
Item No. S-22

Description East side of building near elevator lobby. Spalling of patch on decorative stonework.

Action Remove spalled material and patch to match adjacent (Non-structural)

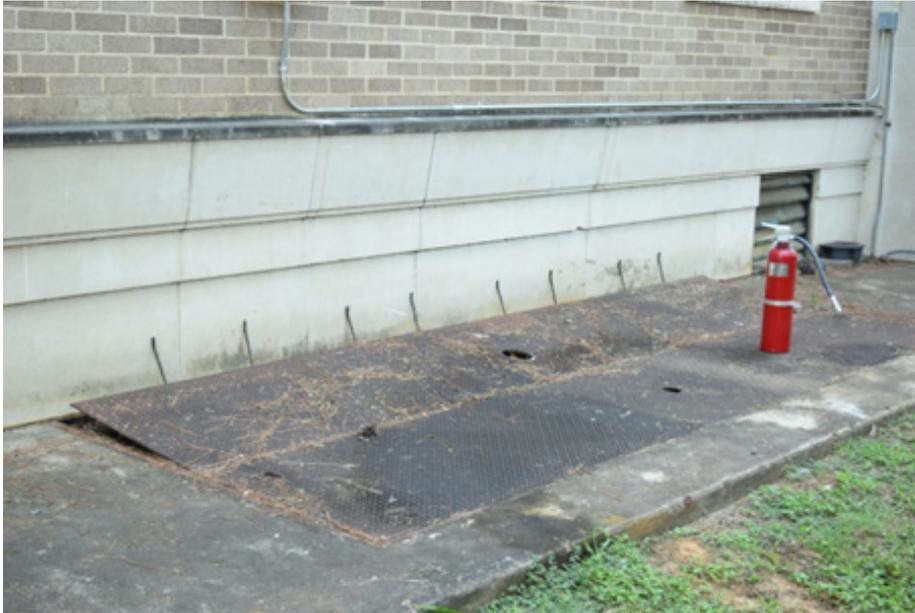
Item No. M-1

Description 6' x 15' steel access door to level 1 basement, mechanical room

Action Access door needs to be replaced

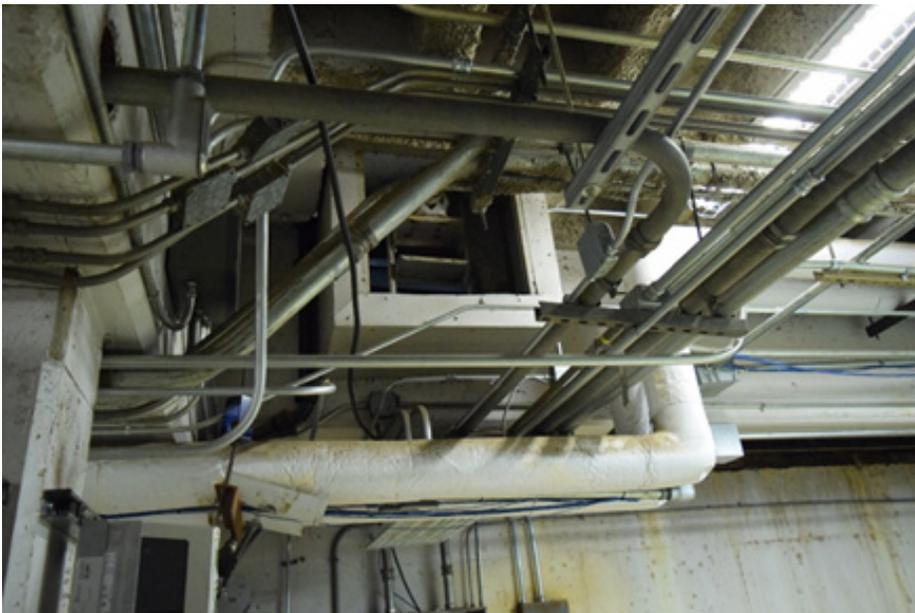
Item No. M-2

Description Prop and scenery storage

Action Install concrete slab on grade to all spaces with dirt floors

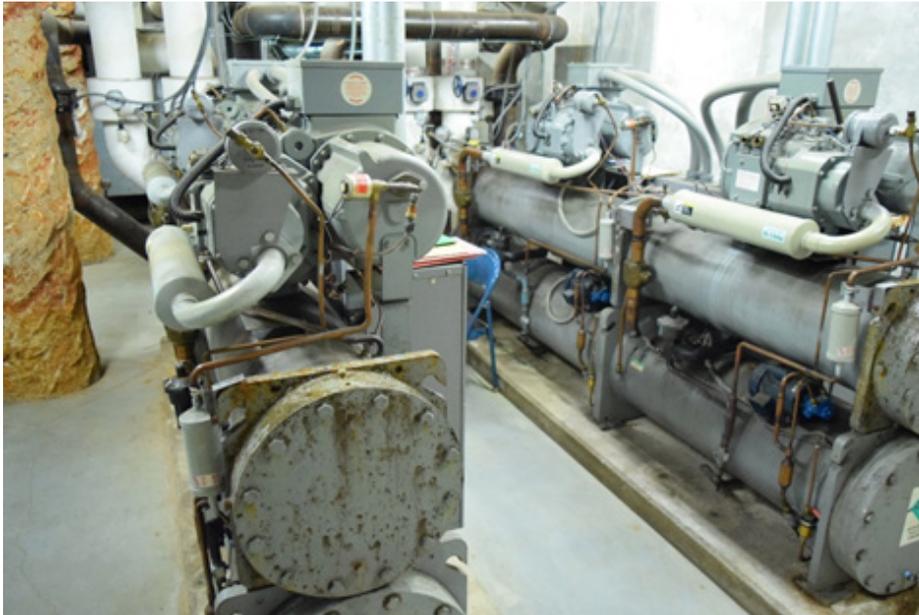
Item No. M-3

Description Existing chillers

Action Replace chillers (2)

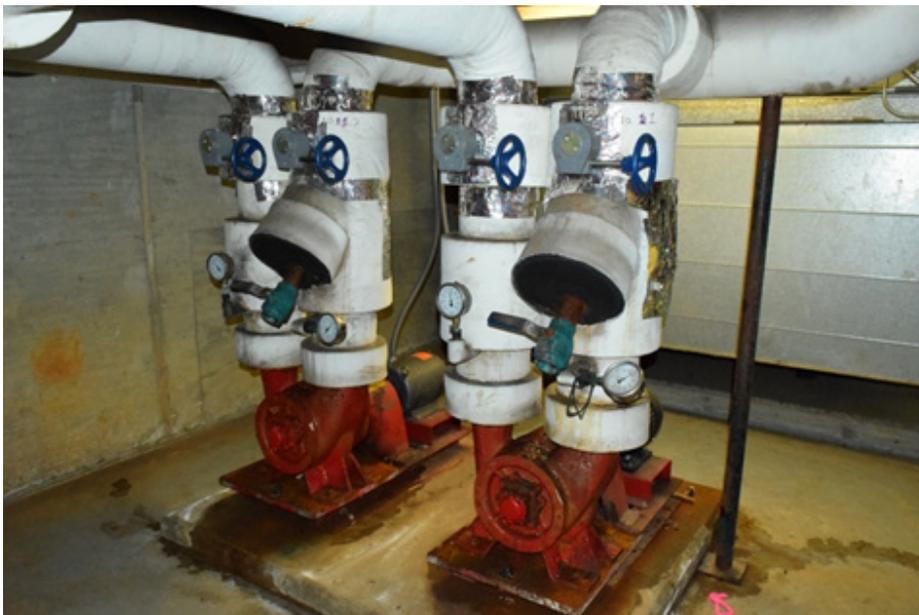
Item No. M-4

Description Chilled water pumps

Action Replace chilled water pumps (2)

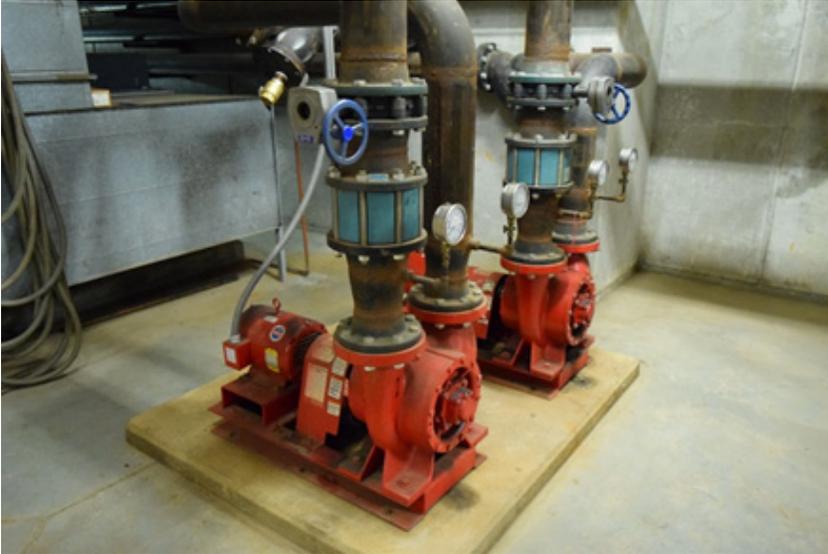
Item No. M-5

Description Condenser water pumps

Action Replace condenser water pumps (2)

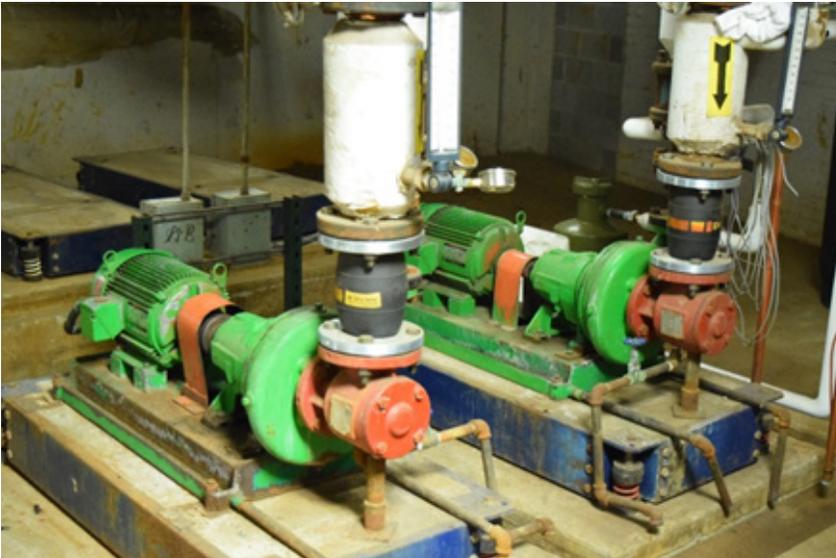
Item No. M-7

Description Hot water system pumps

Action Replace hot water pumps (2)

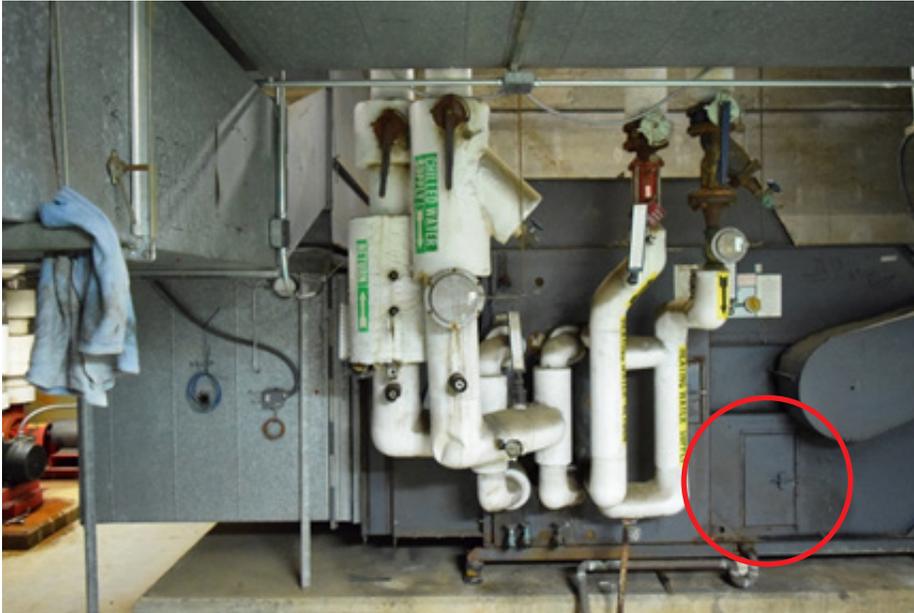
Item No. M-9

Description Very small access panels that don't facilitate maintenance and cleaning

Action Replace air handlers

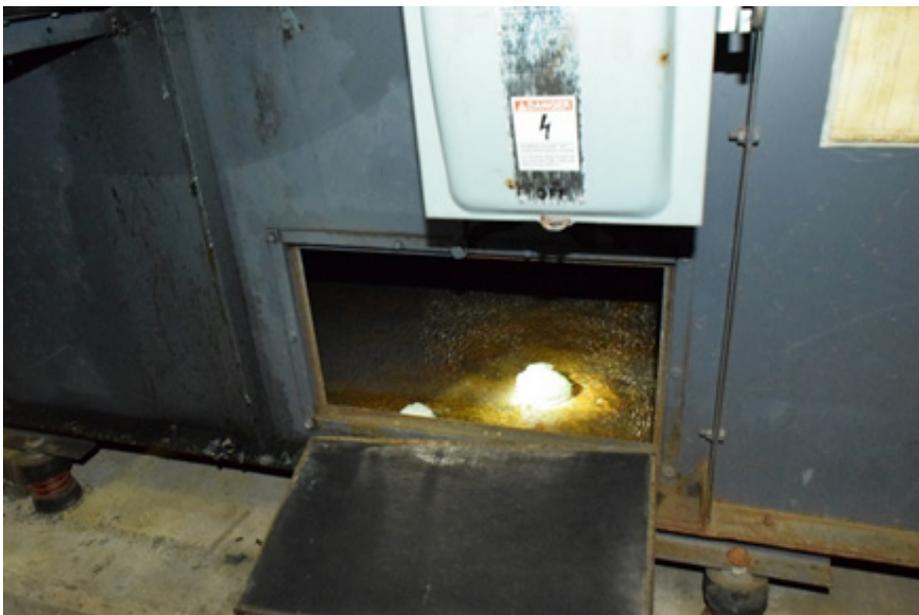
Item No. M-10

Description Apparent microbial growth

Action Refurbish air handlers

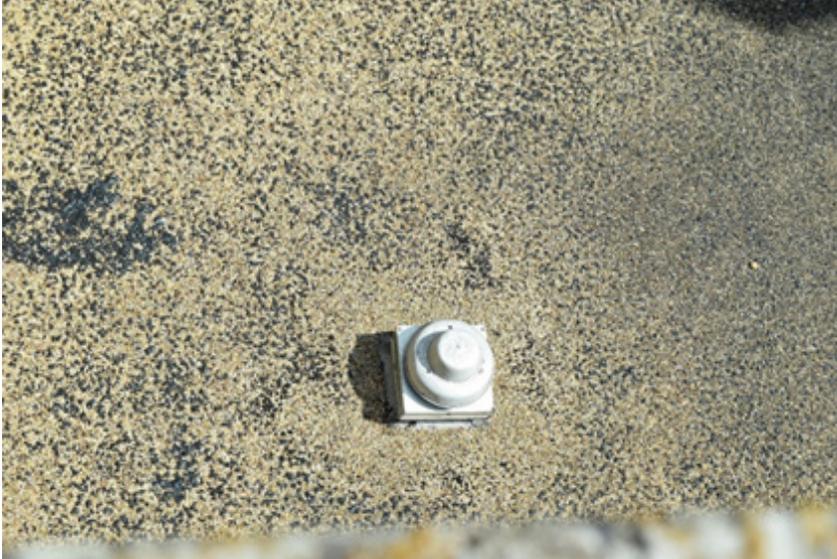
Item No. M-15

Description Roof mounted exhaust fan

Action Replace roof mounted exhaust fans

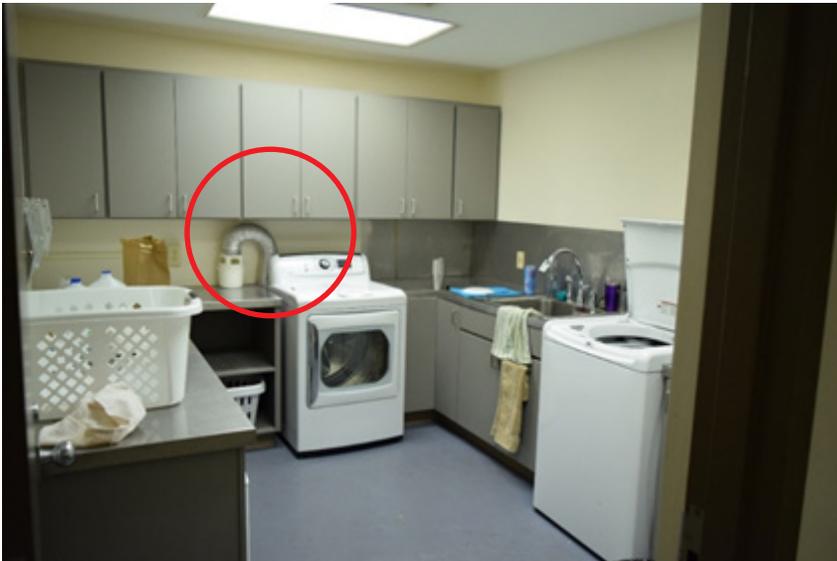
Item No. M-16

Description Dryer lint trap

Action Provide boost fan and exhaust duct for clothes dryers

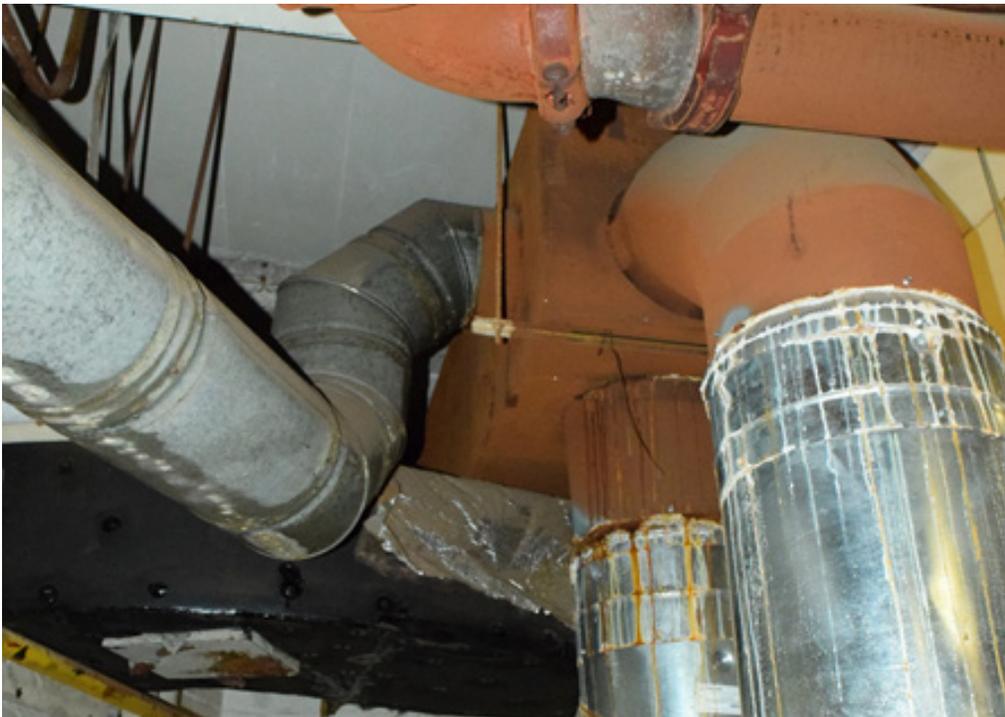
Item No. M-23

Description Boiler venting

Action Replace boiler vent stacks (3)

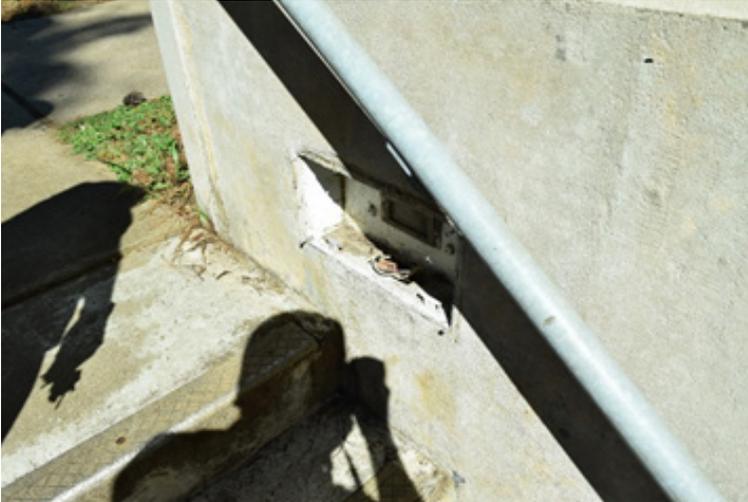
Item No. E-10

Description Stair lighting in poor condition

Action Replace stairlighting on exterior stairs

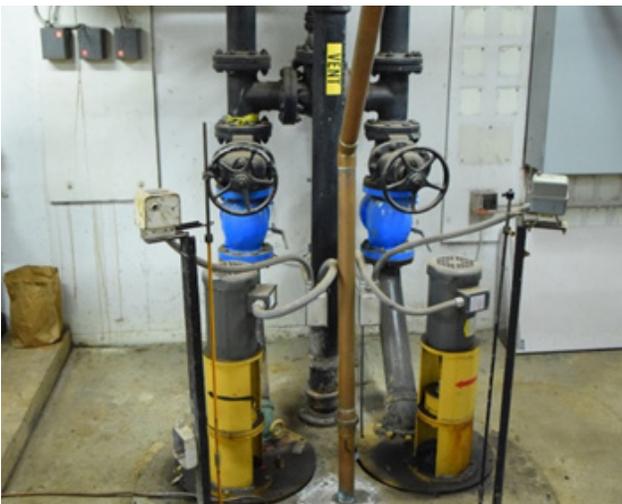
Item No. P-3

Description Sanitary lift station

Action Replace lift station components

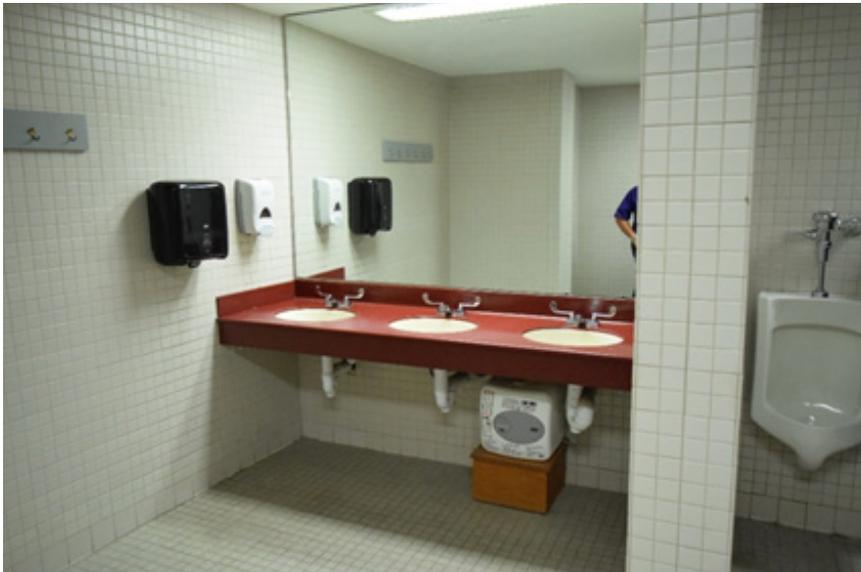
Item No. P-6

Description Under counter water heater

Action Replace water heaters

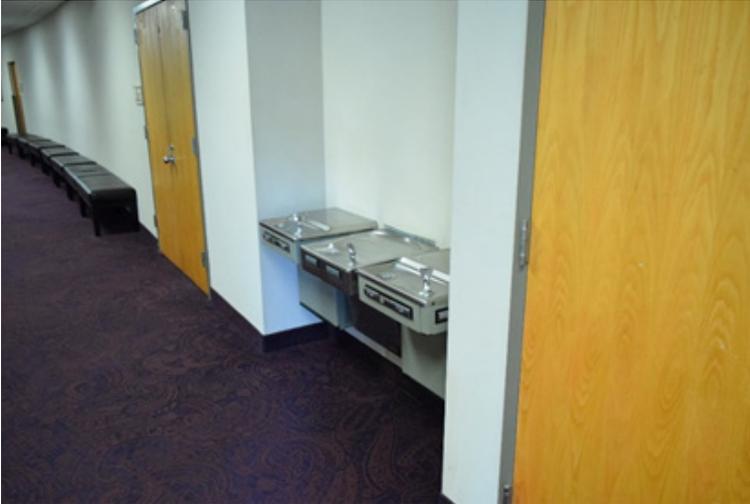
Item No. P-7

Description Electric drinking fountains

Action Replace drinking fountains
