**STEPHEN F. AUSTIN STATE UNIVERSITY
Request for Qualifications #AE-BLDG PROJECTS-2018**

ADDENDUM NO. 1

Stephen F. Austin State University L. E. Griffith Jr. Fine Arts Building

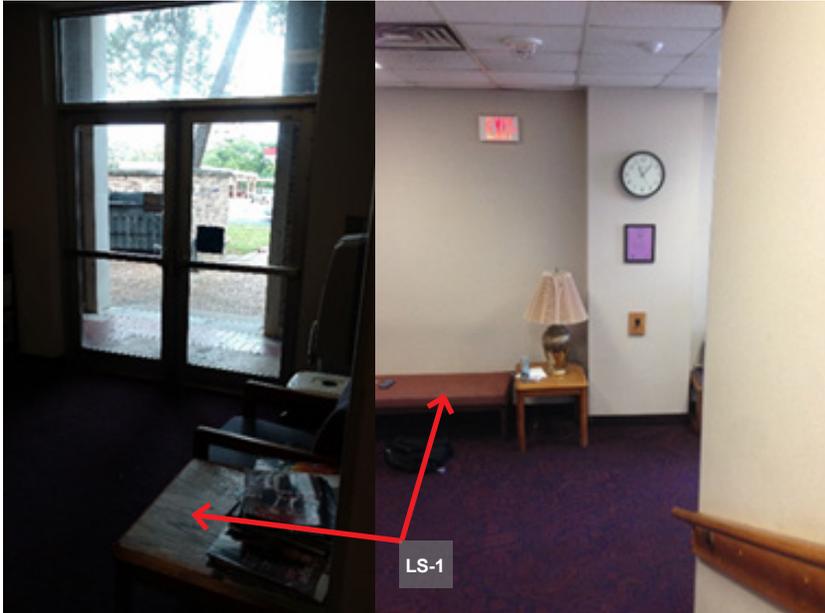
Item No. LS-1

Description Combustible furniture in exit passageway

Action Remove furniture

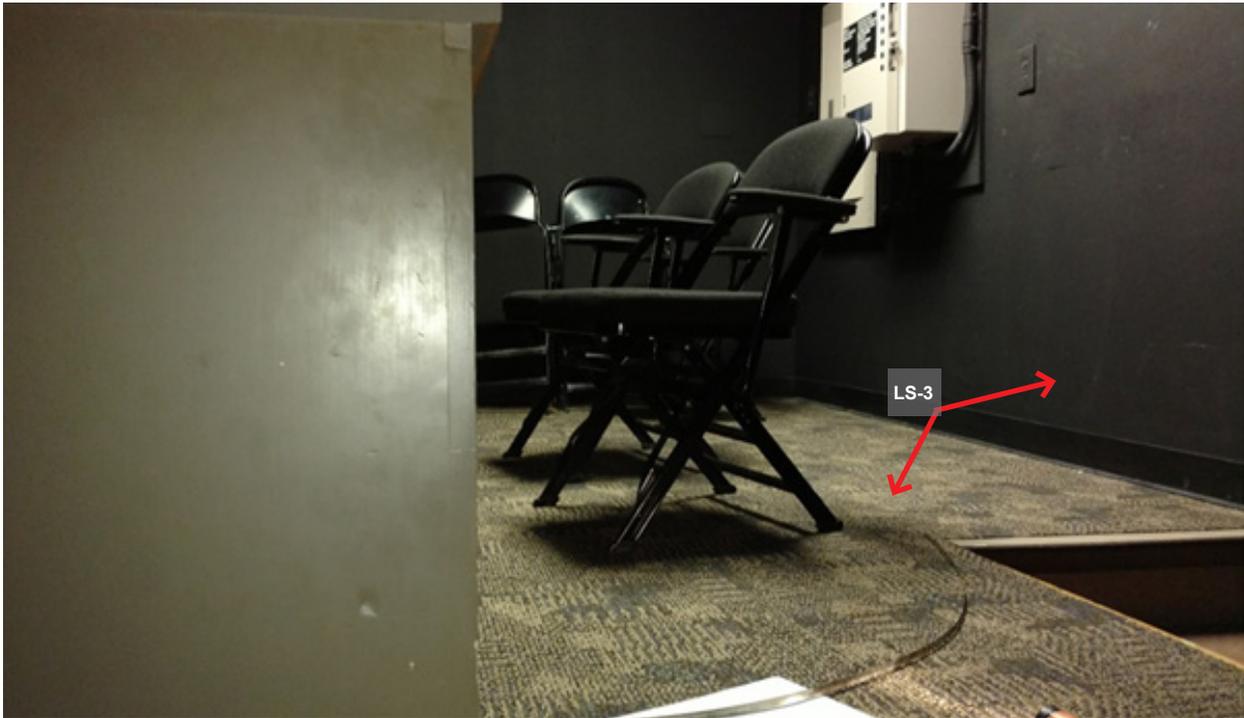
Item No. LS-3

Description Combustible platform in Room 300 Sound Booth

Action Replace with noncombustible construction or provide automatic sprinkler protection

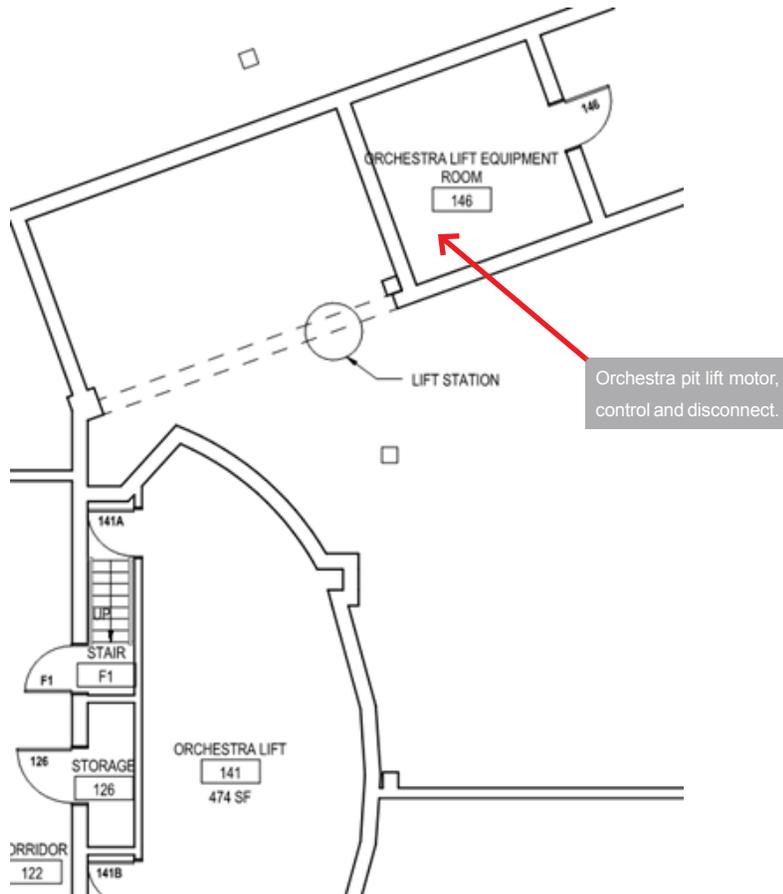
Item No. T-1, T-2, T-3, T-4

Description Orchestra Lift 141 and Equipment Room 146

Action Abandon the existing orchestra pit lift motors, controls, and disconnect. Install new orchestra pit lift platform, motors, controls, disconnects, and interlocks

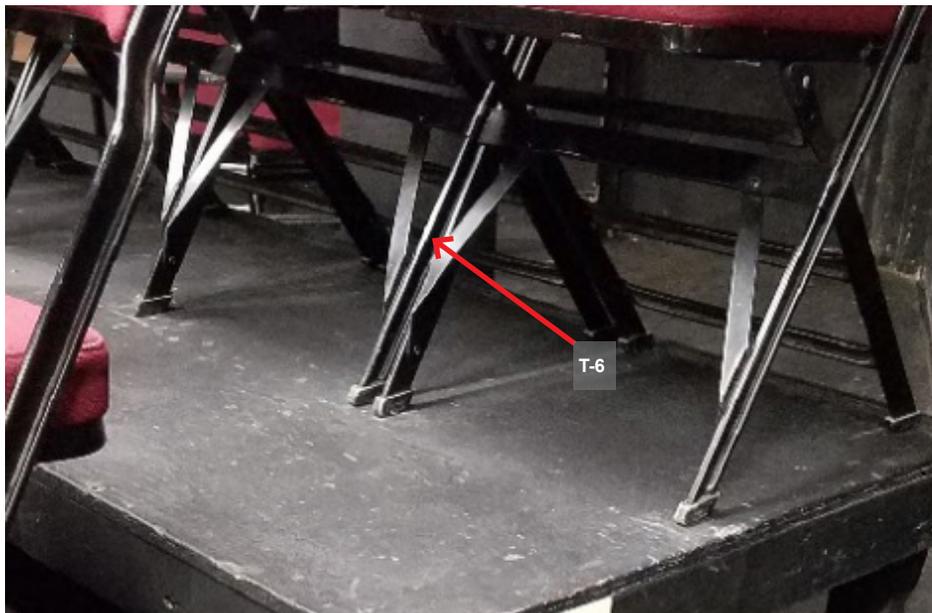
Item No. T-6

Description Black Box Theater 132

Action Loose audience chairs are not gangable. Replace with new audience chairs that are gangable and have arm rests

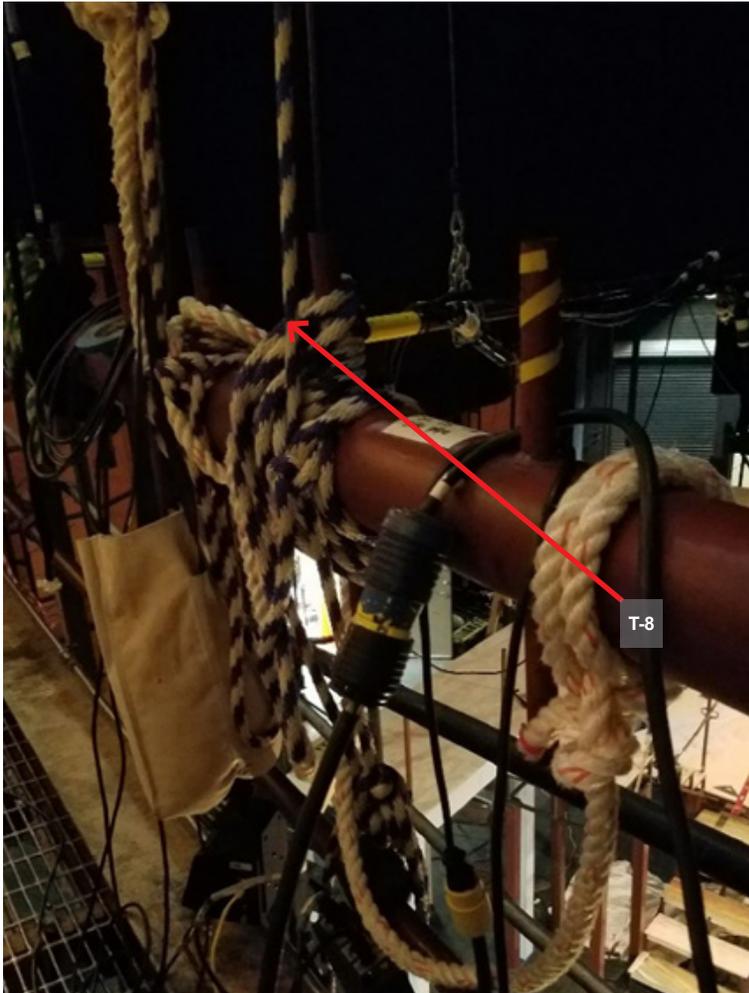
Item No. T-8

Description Stage 250, Locking Gallery

Action Replace hardware rope with rated fiber rope

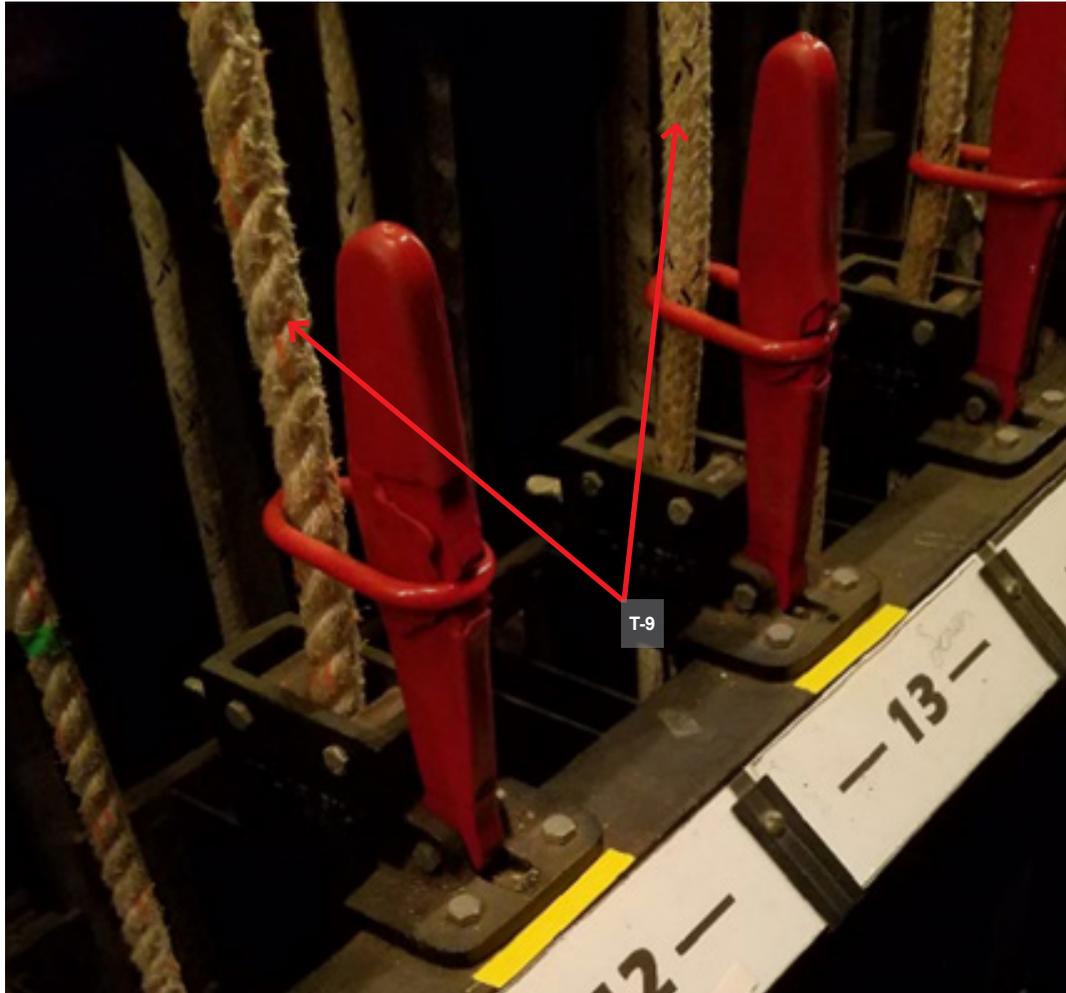
Item No. T-8

Description Stage 250, Locking Gallery

Action Replace all purchase lines

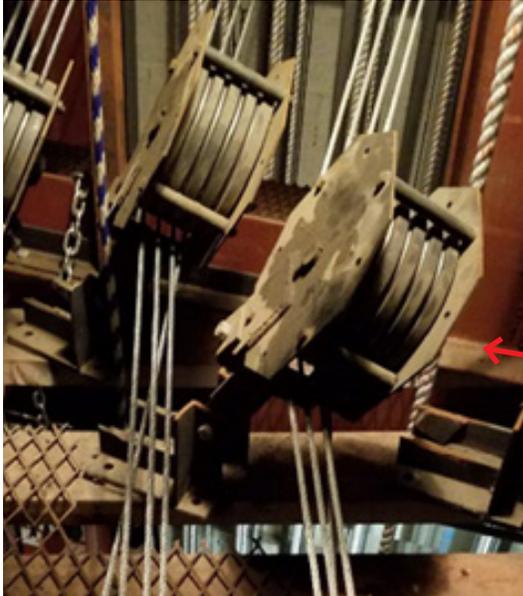
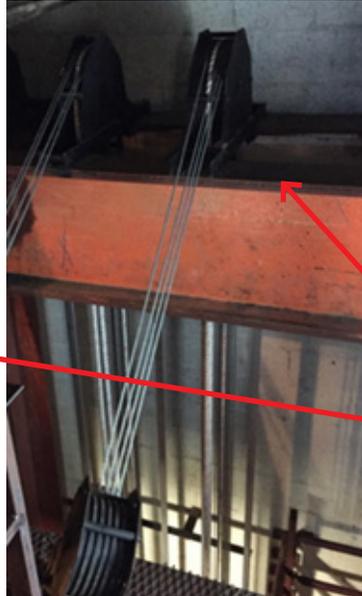
Item No. T-10

Description Stage 250, Gridiron

Action Replace head blocks, loft blocks, and multi-line mule blocks

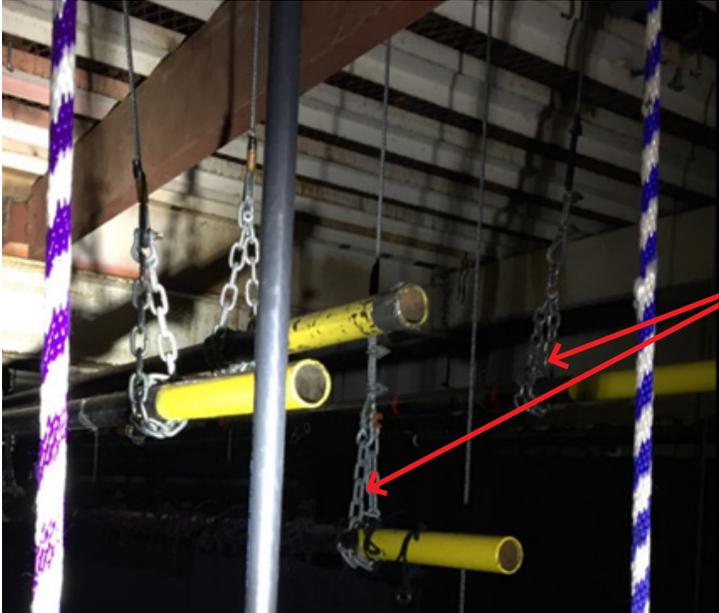
Item No. T-13

Description Stage 250, Gridiron

Action Replace all utility wire rope and terminations

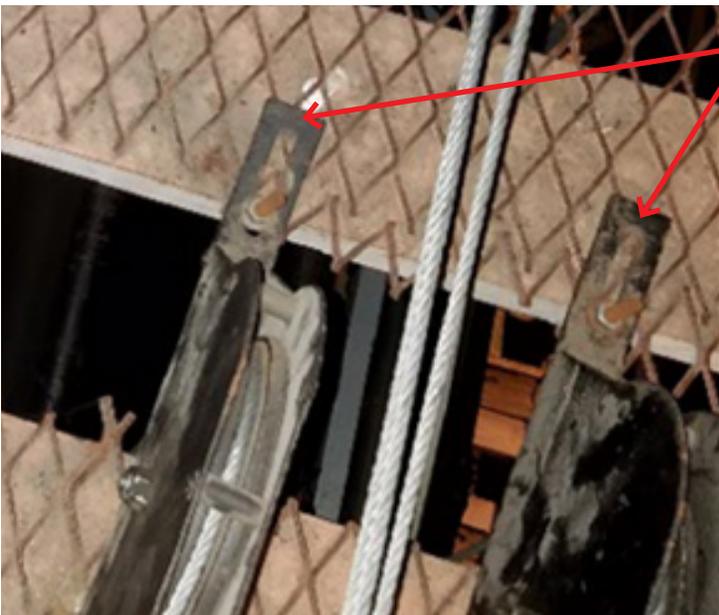
Item No. T-14

Description Stage 250, Gridiron

Action Replace all rigging hardware that shows signs of corrosion

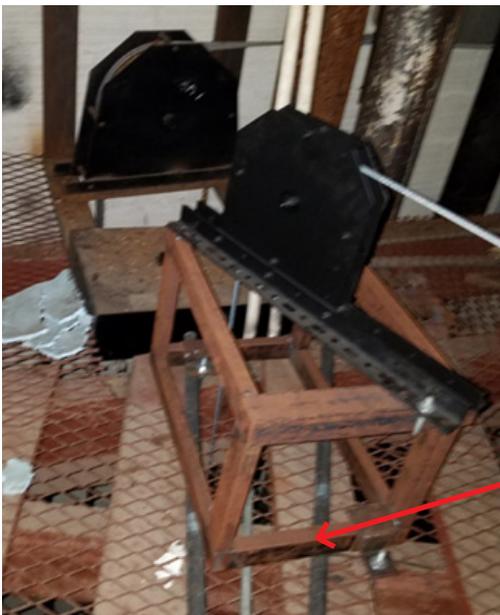
Item No. T-16

Description Stage 250, Gridiron
