Sitton Dogtrot at Millard's Crossing

Historic Structures Report

By Paul Maleski
Stephen F. Austin State University

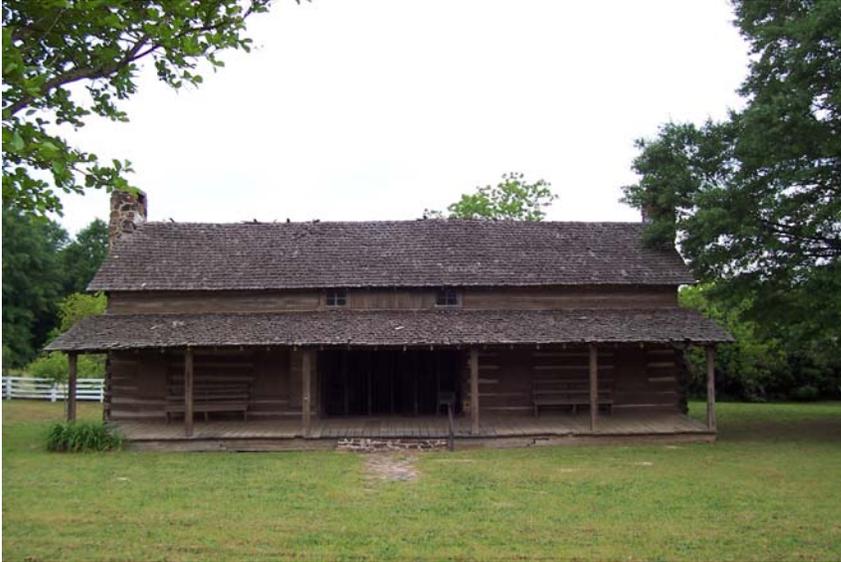
The building's general architecture is a typical dogtrot log home (Fig. 1.1). It has two sections divided by a space way covered with a wooden shingled roof; however, the building has three major additions that change the look and design of the original structure. The original structure was built in 1842 and the three additions were built later on. The addition of a porch changes the front facade and characteristics of the original log structure. The addition of a second story does not change the feel of the building when viewed from the front, but when viewed from the side (Fig. 1.2) the second story siding does not match the original structures construction materials. The second story addition is also not fitted snugly and the siding materials are slightly protruding where they meet the original structure. This creates a shoddy appearance to the general construction of the original structure.

Figure 1.1 shows the Sitton Dogtrot built in 1842. Note the two sides separated by the middle passageway.

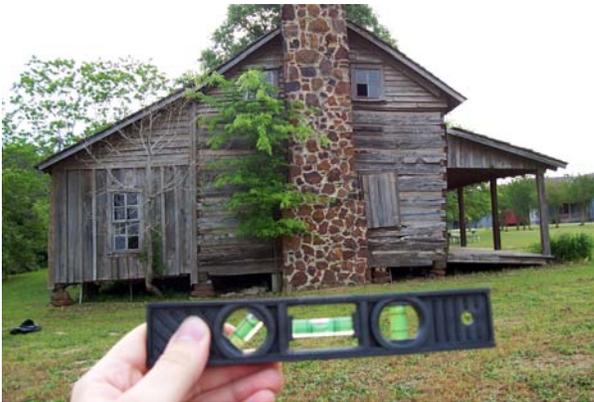
The site the building is located on has an adequate grade to allow drainage and prevent water from collecting under the house (Fig 2.1). The grade slopes down

Figure 2.1 shows the grade of the land sloping from the front to the back of the building.

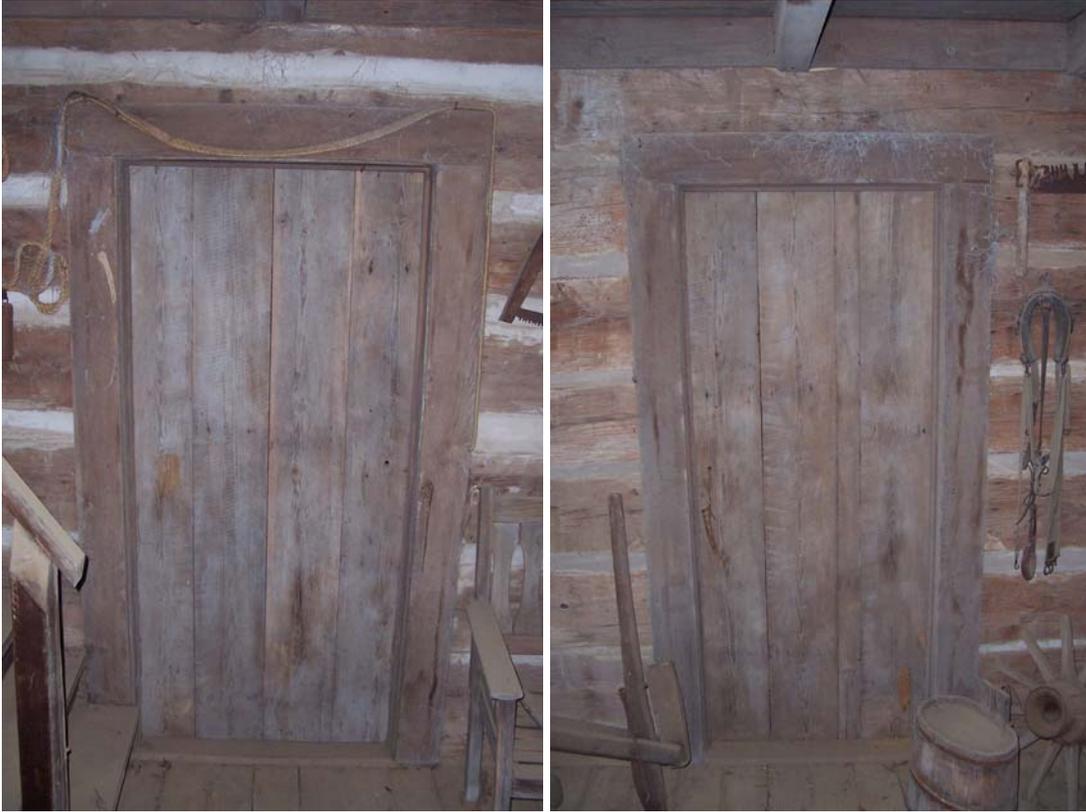
The two doors located on the original structure within the central walkway appear to be in the original locations of dog trot. These doors are in good condition and do not have a modern appearance (fig 9.1-2). They both are in working condition and retain the historic feel of the dogtrot.

Figure 9.1 shows the east side entrance and figure 9.2 shows the west side entrance. Both doors are in good condition and fit the historic feel of the house

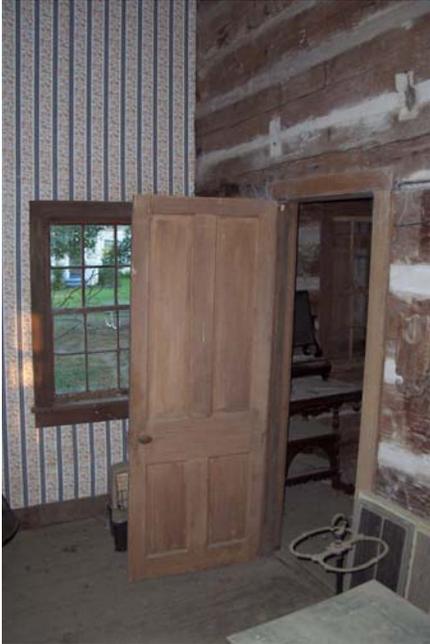
side walls within both sides of the addition. Three openings have been cut out of the original walls to allow access into the main structure from the addition. Two openings have doors that lead into the main houses rooms, and one has a door, which opens to a set of stairs leading up to the second story addition. The three doors are like the other doors of the structure and appear to be of the same age as the rear addition (fig. 9.4).

Figure 9.4 shows that the interior doors leading to the dogtrot's main rooms are of the same style as the doors that lead into the addition. All three doors look like the one shown.

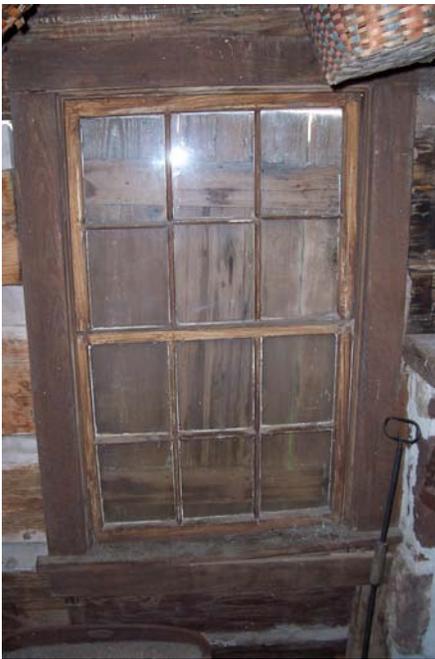
The most common window is the one pictured in figure 10.1. This style is in the eight windows located in the dogtrot's main rooms and the six windows in the rear addition. There are two window holes in the north wall of the dogtrots original walls that are now being used as shelving, and do not have any glass within. The majority of this style of window is intact, but there are two that are broken as shown in figure 10.2.

Figure 10.1 shows the style of window on the first floor. All 14 windows on the first floor are exactly like this one.
