**STEPHEN F. AUSTIN STATE UNIVERSITY
Request for Qualifications #AE-BLDG PROJECTS-2018**

ADDENDUM NO. 1

Stephen F. Austin State University L. E. Griffith Jr. Fine Arts Building

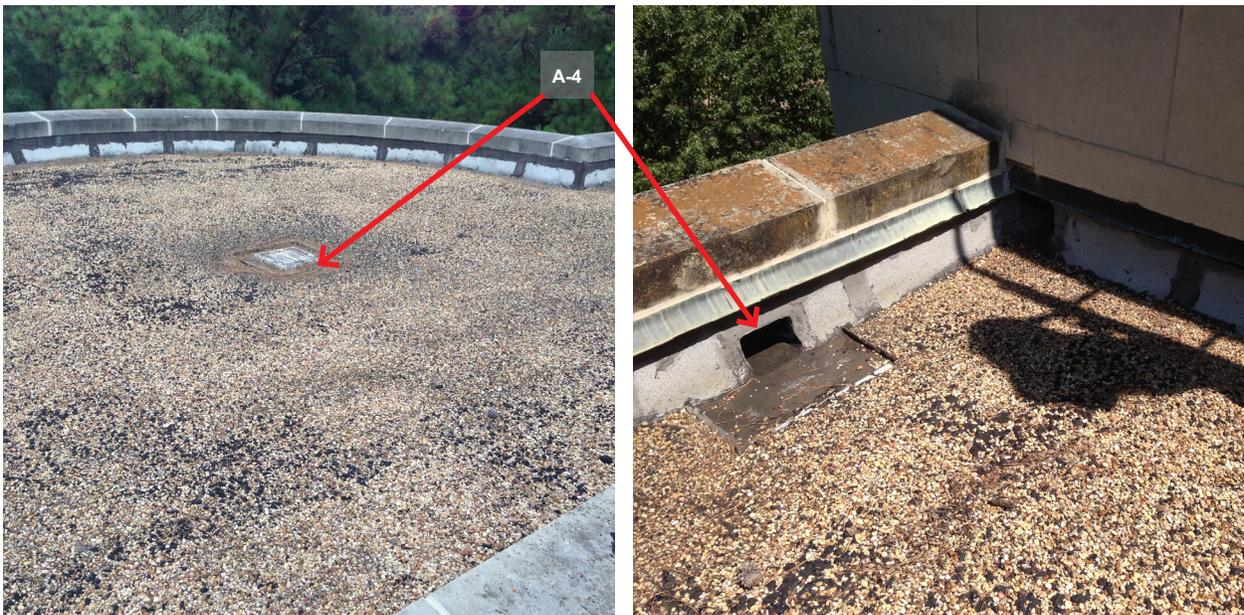
Item No. A-4

The roof appears to have ponding although it does not appear to be overly excessive throughout the entire roof. As noted by several consultants, including DBR (refer to item P-4) and Haynes Whaley (refer to item S-2), the existing scuppers are few and far apart. Number and size of scuppers and roof drains should be evaluated and if necessary, redesigned or enlarged to better suit the building's drainage requirements (A-4).

Description Close-up of roof scupper and drain

Action Evaluate roof drainage requirements and consider additional and/or larger scuppers and/or roof drains

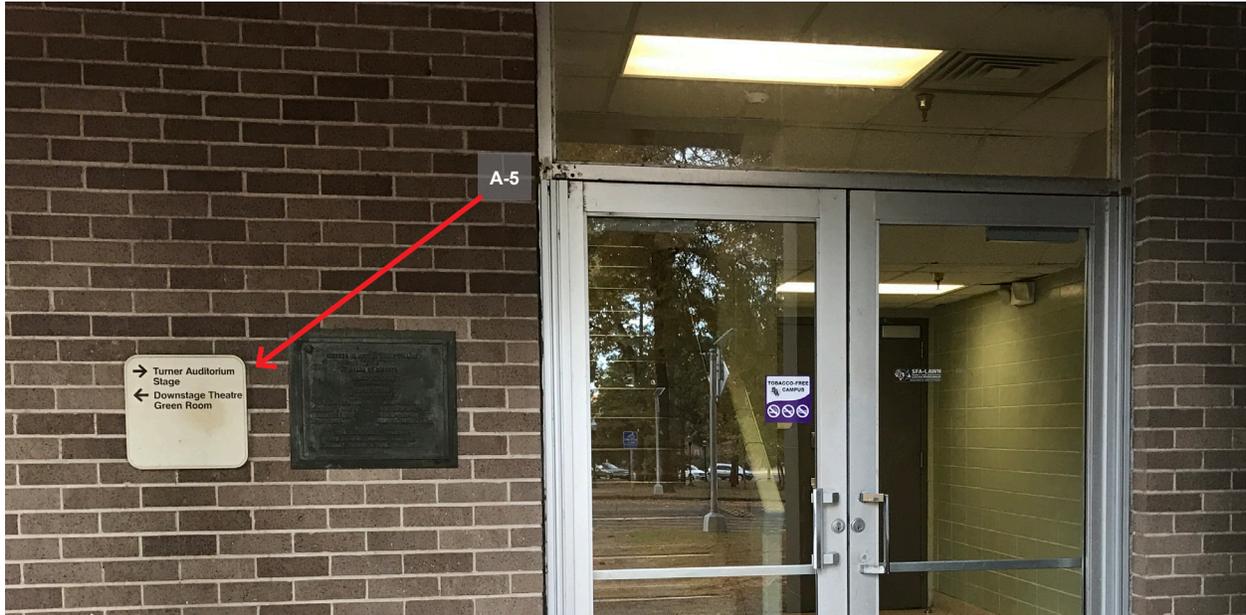
Item No. A-5

In general, the sequence of wayfinding for a theater-going patron attending a performance at Griffith needs improvement. The sequence from arrival to the box office to the theater should be clarified through wayfinding techniques such as improved signage or more prominent street frontage. A sign change for the box office is recommended (A-5). If new construction is an option, relocating the box office to a prominent location should be considered.

Description Signage

Action Improve wayfinding for theater patrons

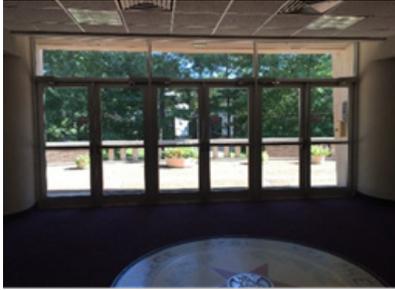
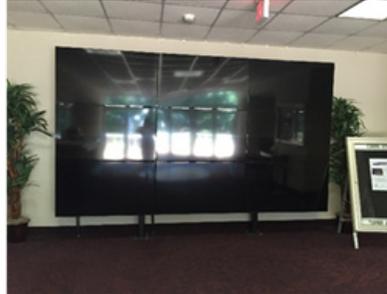
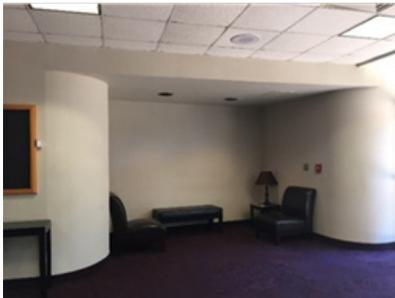
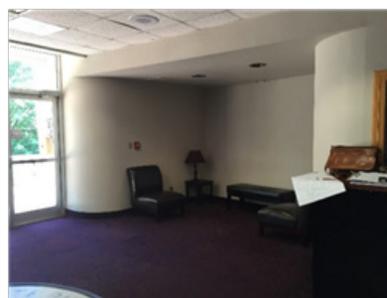
Item No. A-7

The entrance to Griffith Auditorium lacks the grandeur ideal for the lobby to such a large performance space. A general enhancement of the building entrance/lobby is recommended (A-7). If new construction is an option, enlarging the floor area as well as the volume of the lobby should be considered.

Description Lobby

Action Renovation and general enhancement of the lobby

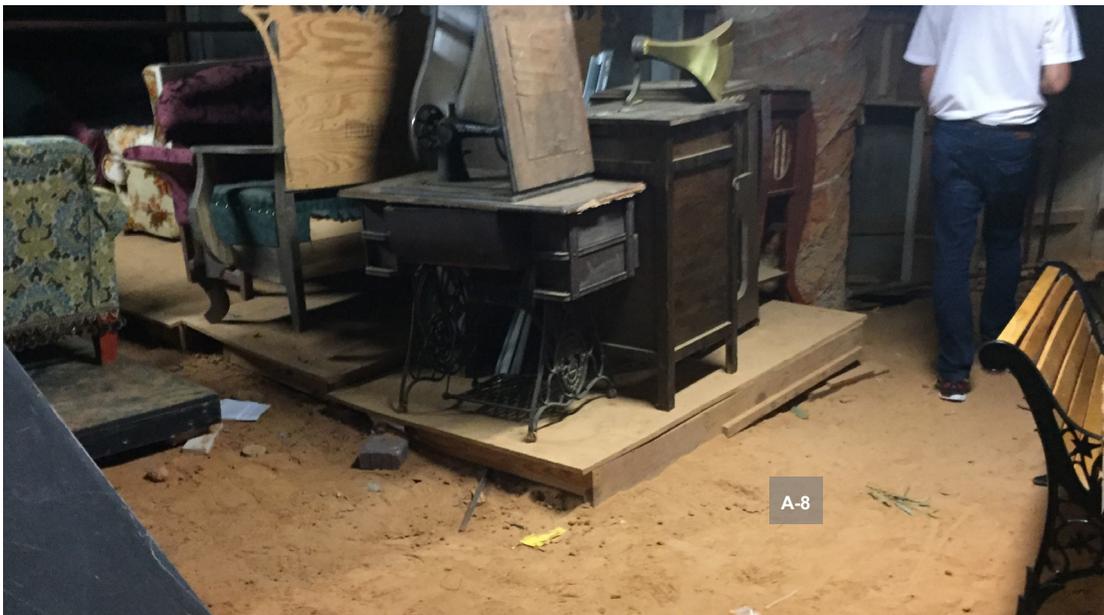
Item No. A-8

Description Prop and scenery storage

Action Install concrete slab on grade to all spaces with dirt floors

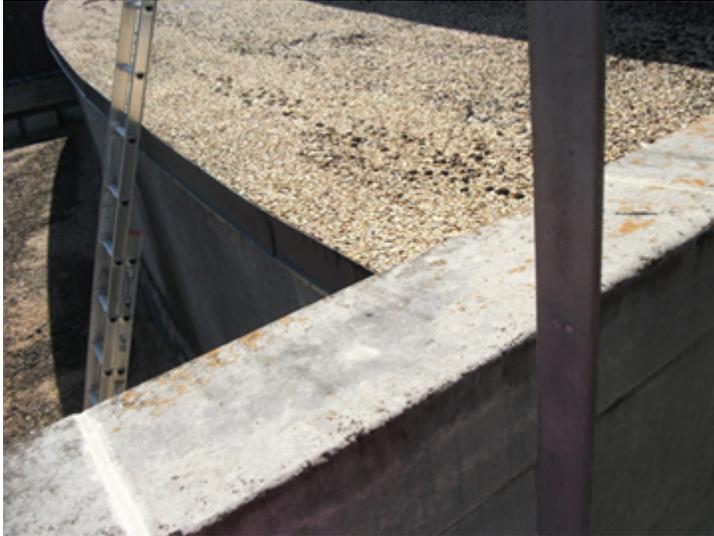
Item No. S-5

Description North West side of main entrance on roof. Fixed ladder on wall exits over depressed area instead of adjacent roof. This does not appear to meet current safety guidelines. Also no permanent ladder to lower roof.

Action Verify position of ladder meets current access/safety guidelines and relocate if necessary. (High Priority)
Consider providing ladder to lower roof area (Non-structural)

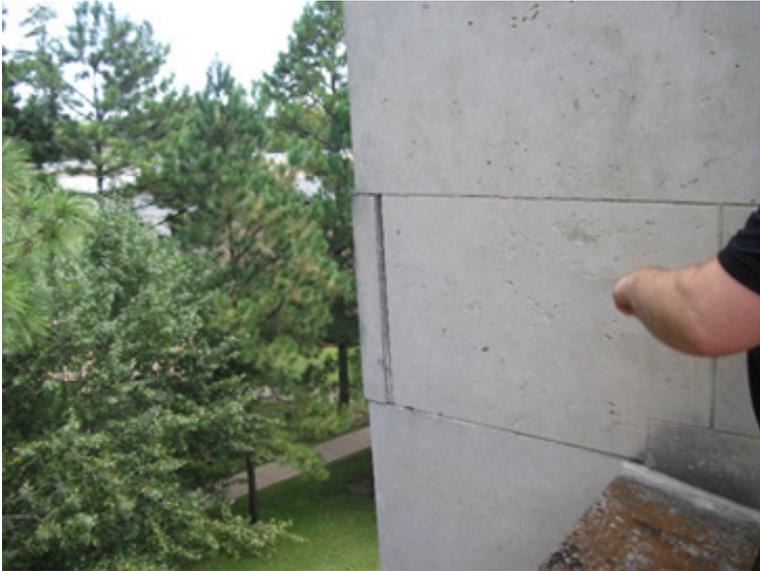
Item No. S-11

As noted by Haynes Whaley's assessment, there are several areas of the brick façade that require repair. Some areas (refer to item S-11) pose safety issues due to the decorative stone's height above the ground. Others are more cosmetic. Areas of cracked brick and loose stonework should be repointed and/or reattached (A-1).

Description North West corner of north entrance near roof level. Piece of stone veneer appears to have shifted outward.

Action Repoint/reattach stone veneer at this location. (High Priority)

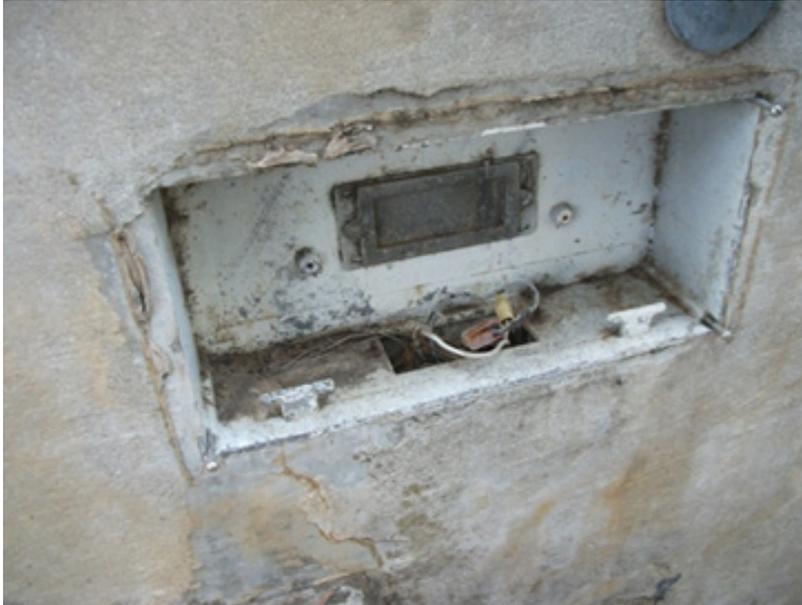
Item No. S-15

Description West side of building at stair down to mechanical area. Open light fixture with exposed wires.

Action (Non-structural)

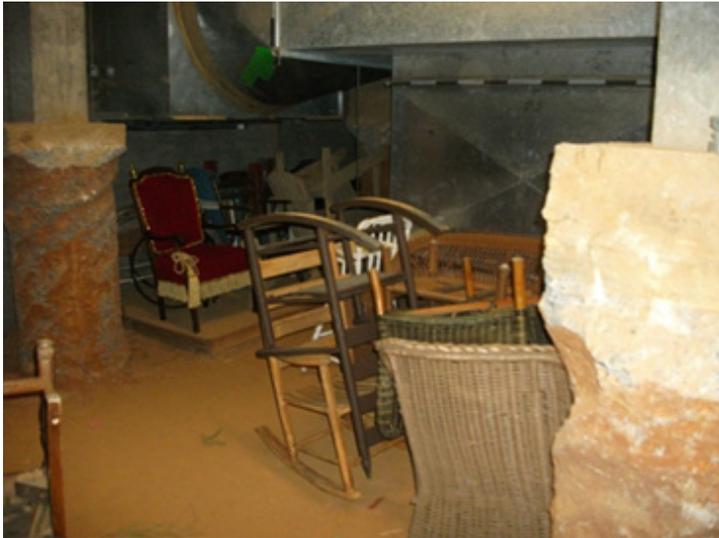
Item No. S-17

Description Basement in prop storage area. Several rooms in the basement that are being used for prop storage have dirt floors.

Action Consider adding a concrete slab on grade in these rooms to improve operations and access.
(Non-structural)

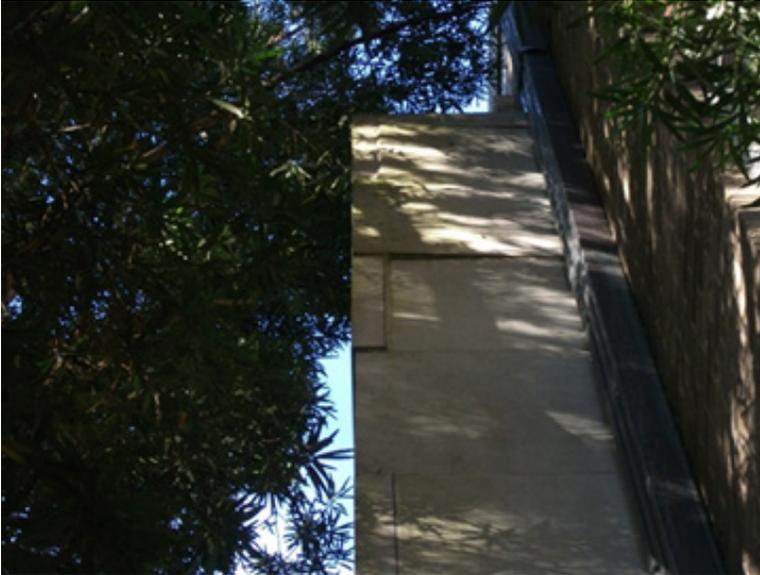
Item No. S-23

Description East side of building near covered entrance. Decorative stone seems to have shifted and be out of alignment.

Action Mason to verify that stones are secure. (Medium Priority)

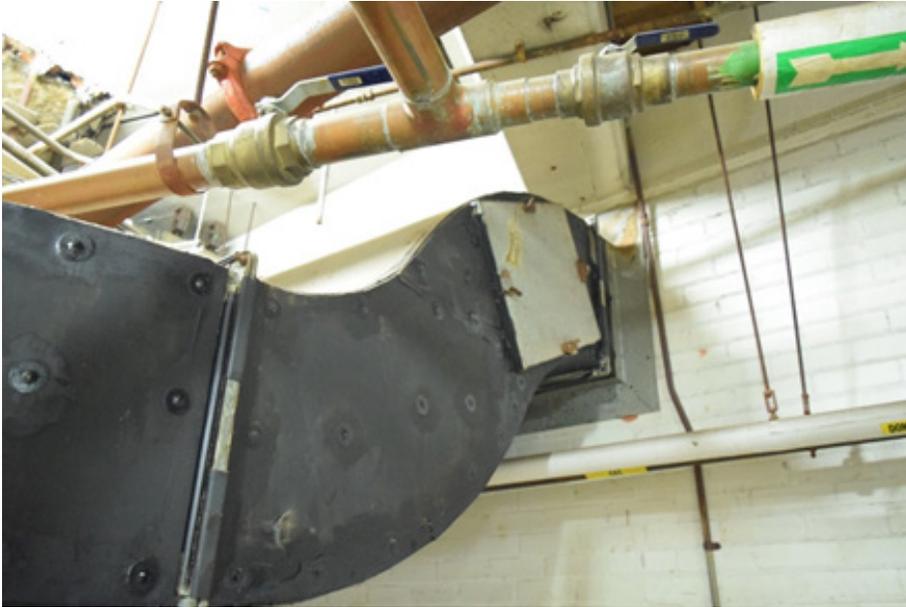
Item No. M-12

Description Lead lined vinyl coating on duct.

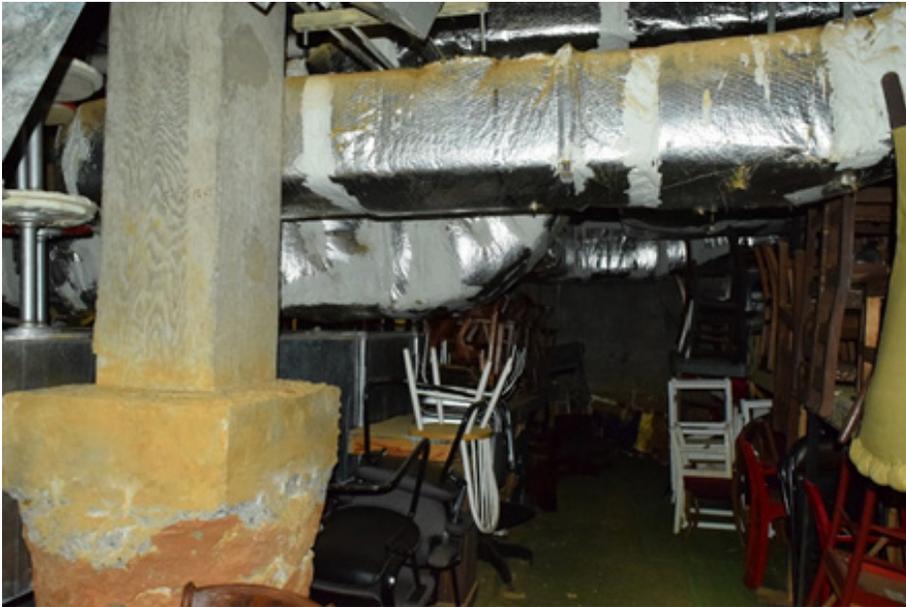
Item No. M-13

Description External duct insulation.

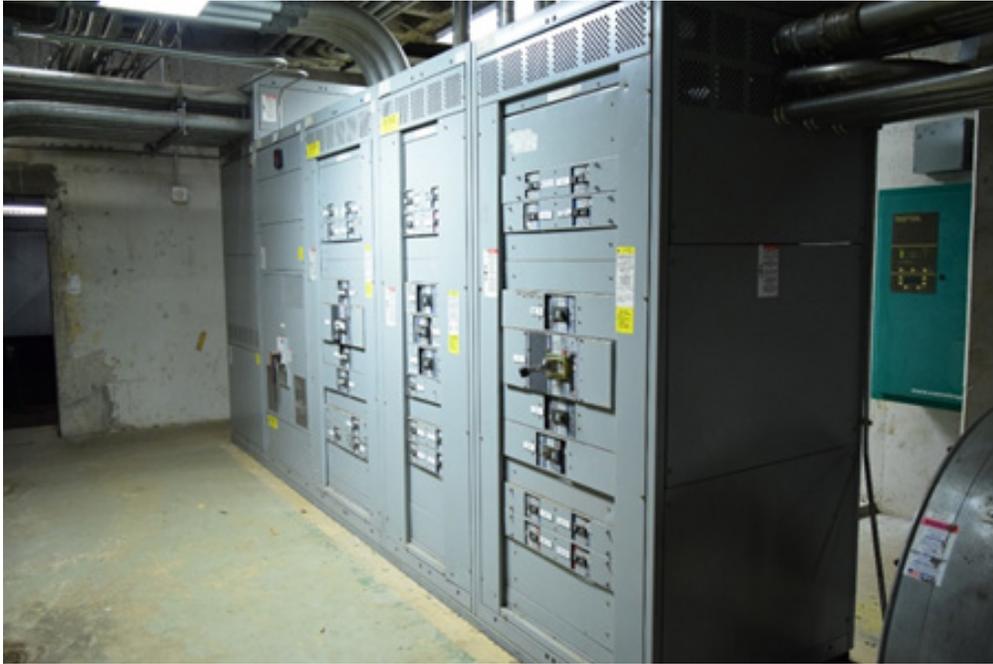
Item No. E-1

The electrical system consists of replaced main switch gear that is in good condition, and original distribution equipment that is at the end of its projected service life. The distribution system should be considered for replacement. The grounding system for the building is the conduit system which is code compliant but not the best practice. Installing grounding conductors should be considered for safety and power quality. Lighting has been upgraded in the spaces around the auditorium to energy efficient fluorescent but upgrading to LED should be considered for maintenance reduction and energy usage reduction. Lighting in the auditorium should be considered for upgrade to dimmable LED also. The stand-by generator was recently installed and is in good condition but the feeder circuit to the building should be upgraded.

Description Switchboard

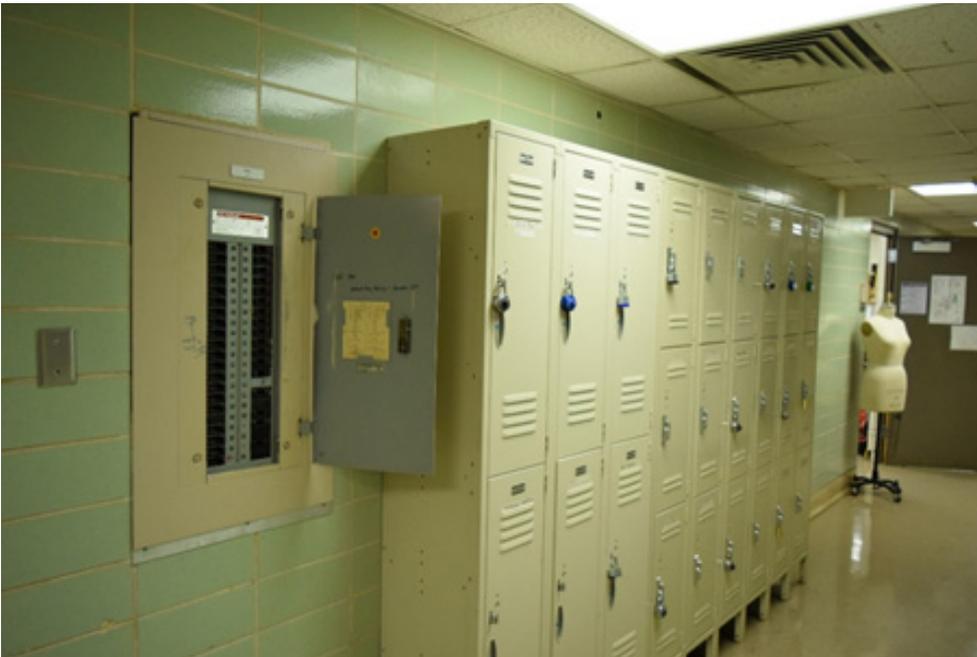
Item No. E-2

Description Panel located in corridor

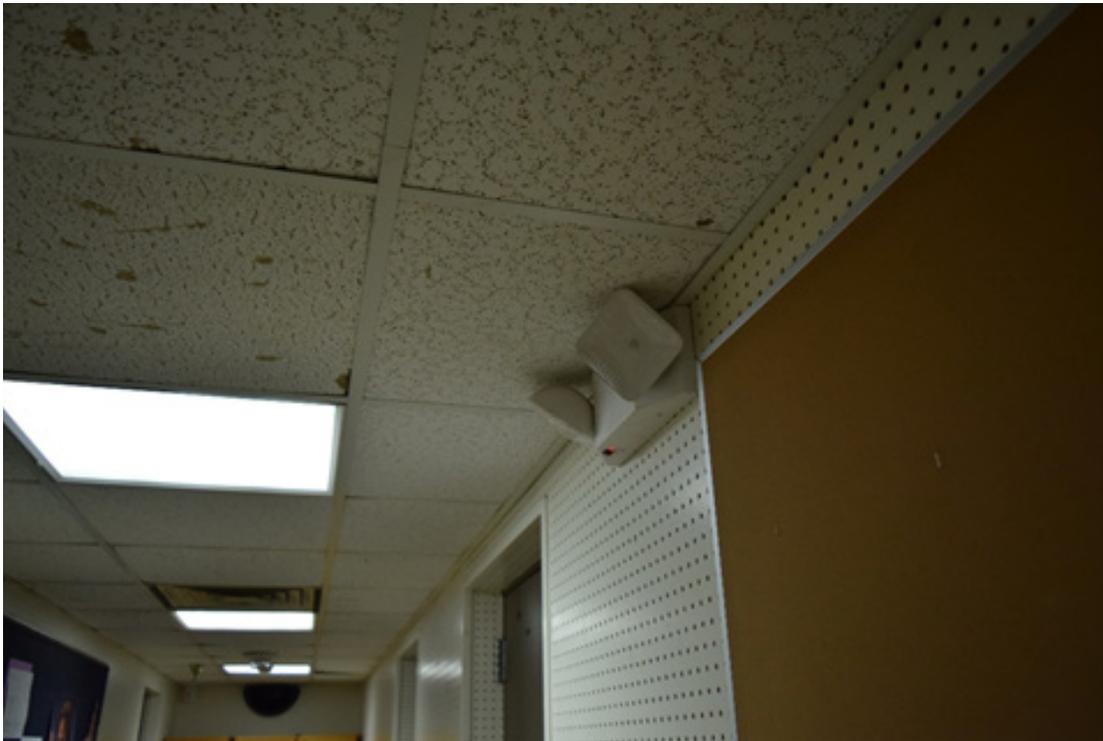
Item No. E-7

Description Battery powered egress lighting

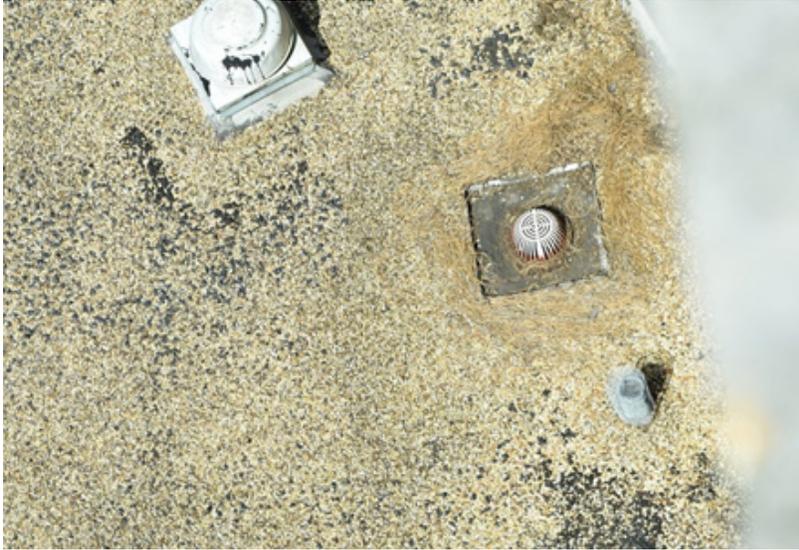
Item No. P-4

Description Roof drain

Action Inspect and clean roof drain piping

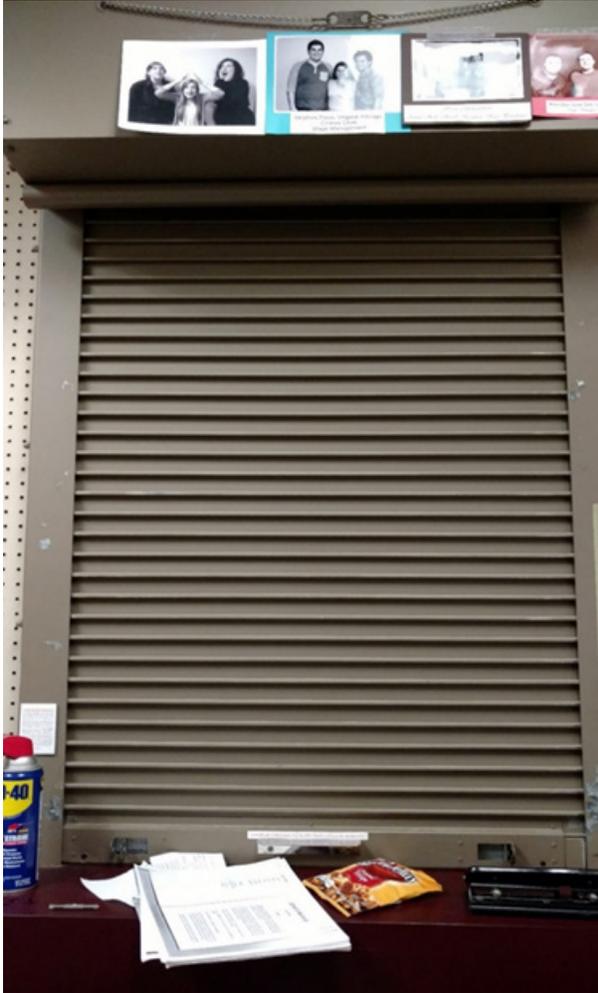
Item No. LS-2

Description Box office window in corridor

Action Remove window, provide fire shutter or provide automatic sprinkler protection

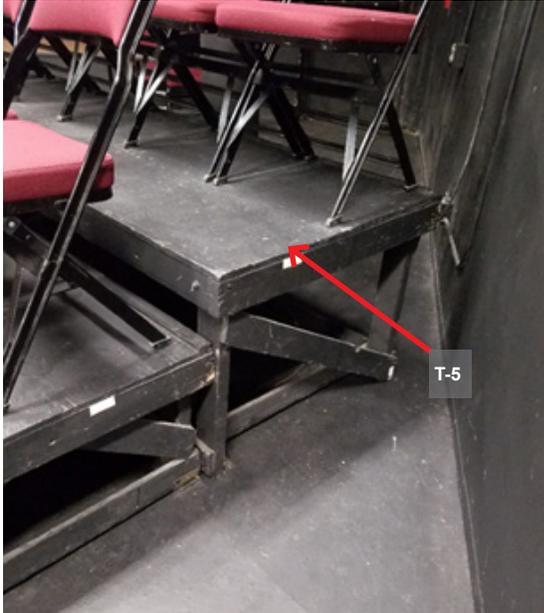
Item No. T-5

Description Black Box Theater 132

Action Demo existing audience seating risers and install new equipment with railings

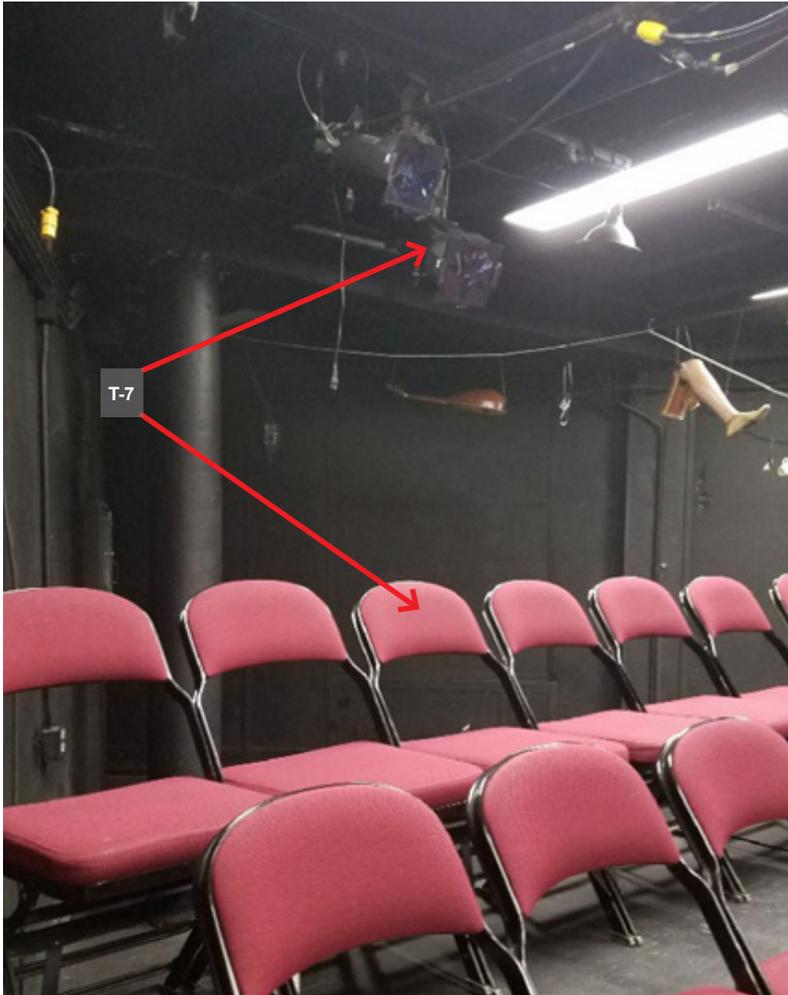
Item No. T-7

Description Black Box Theater 132

Action Demo existing incandescent performance lighting. Install new LED performance lighting system

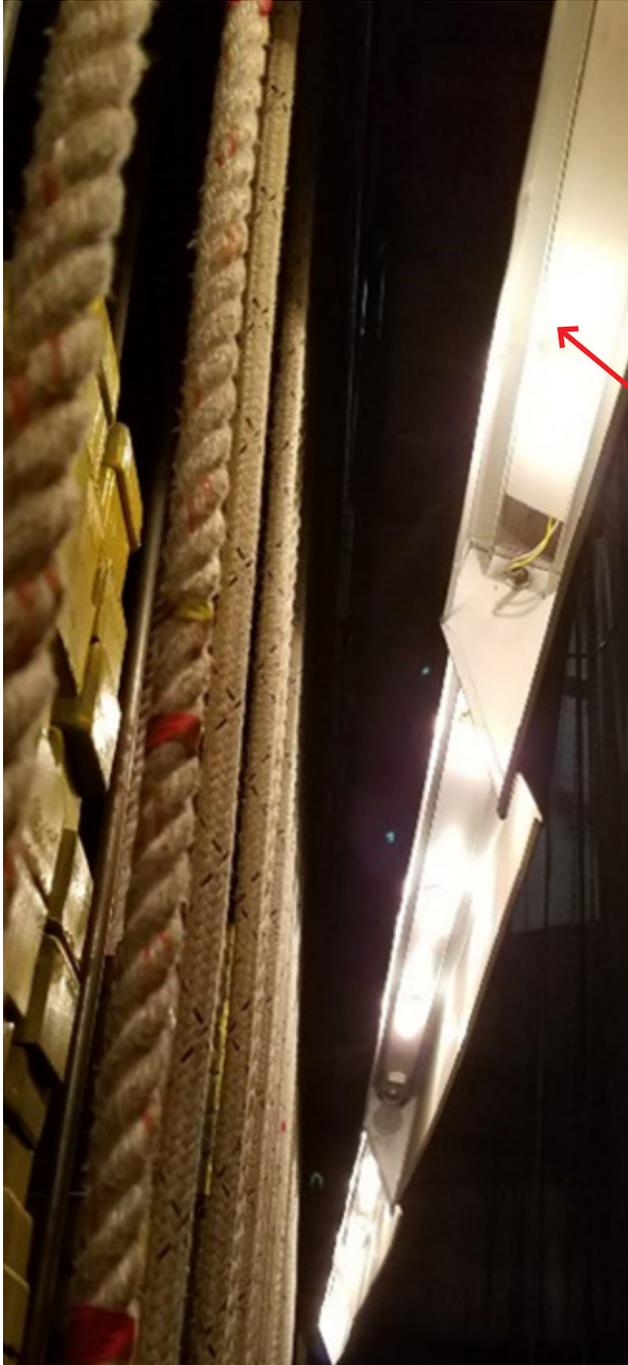
Item No. T-10

Description Stage 250, Locking Gallery

Action Demo existing lighting fixture. Install two color LED index strip light

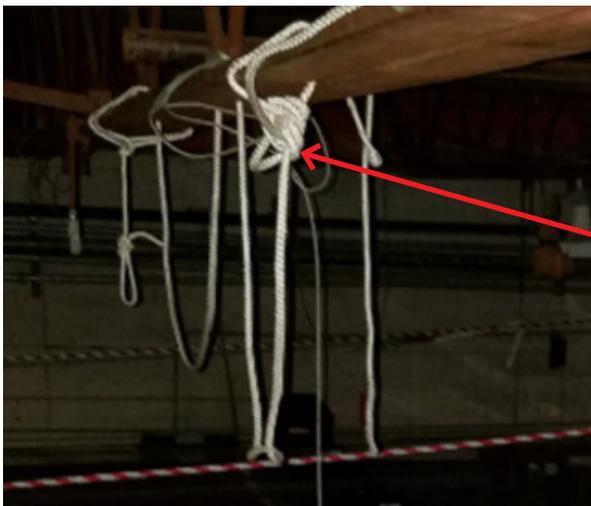
Item No. T-12

Description Stage 250, Gridiron

Action Add rigging rope loft blocks as necessary

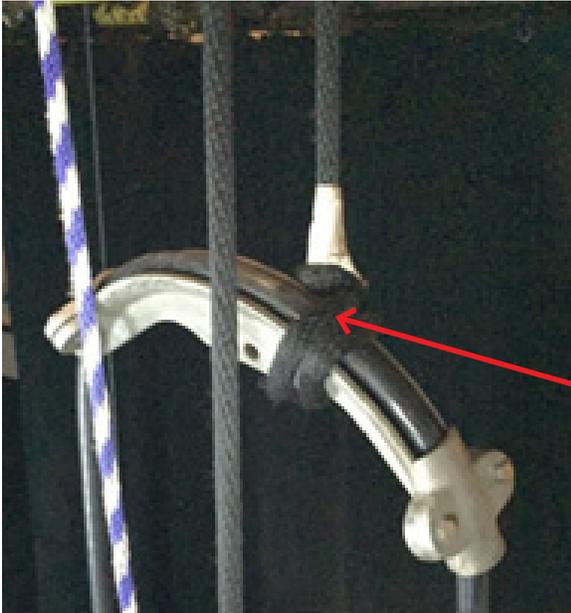
Item No. T-15

Description Stage 250, Gridiron

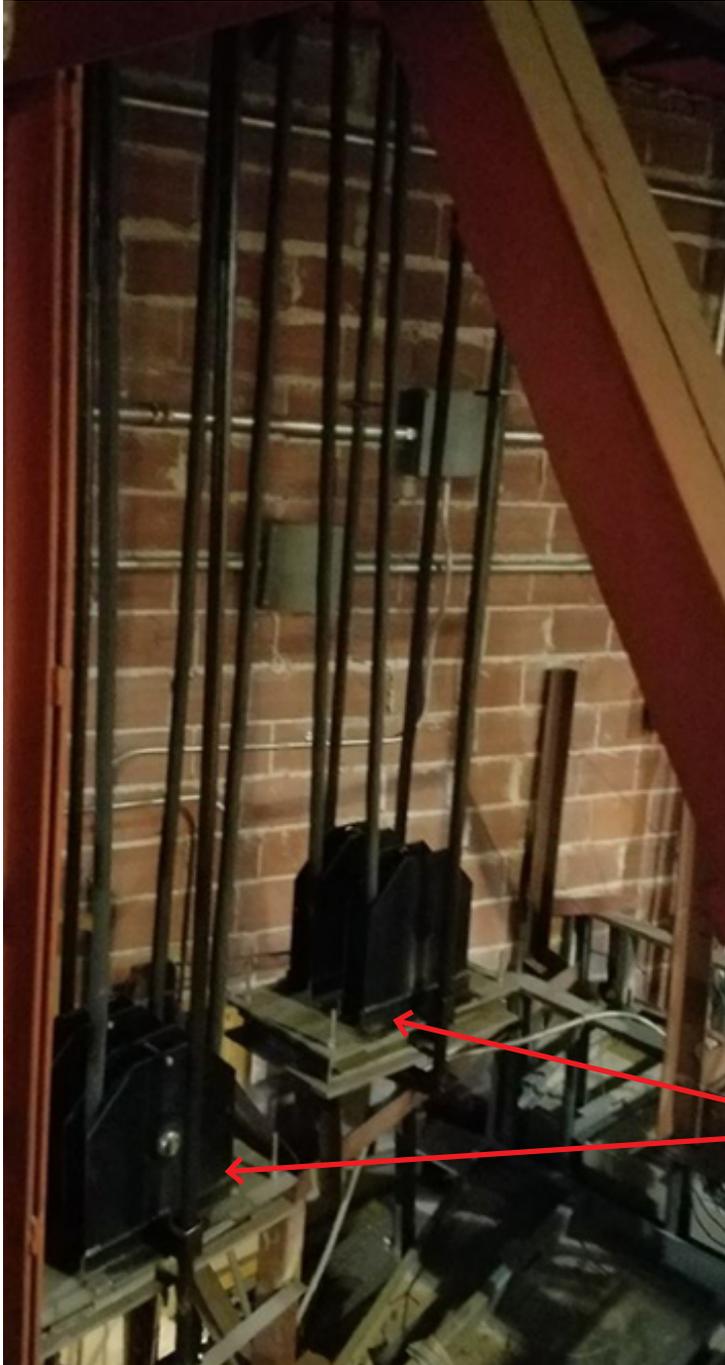
Item No. T-22

Description Catwalk Access 408

Action Demo existing cable management. Install cable reels

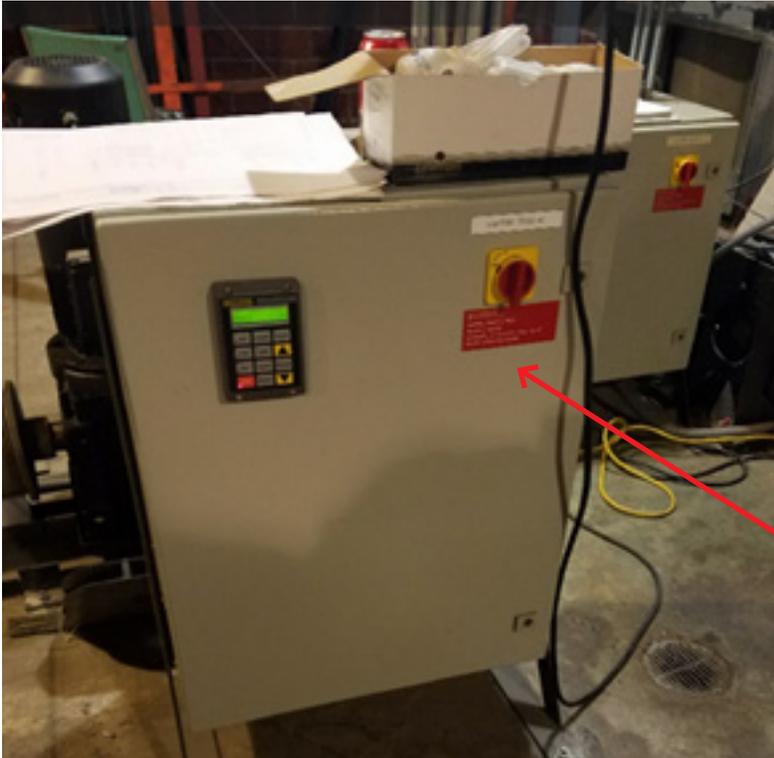
Item No. T-24

Description Catwalk Access 408

Action Demo existing Rigging motor controllers and add to new stage rigging system

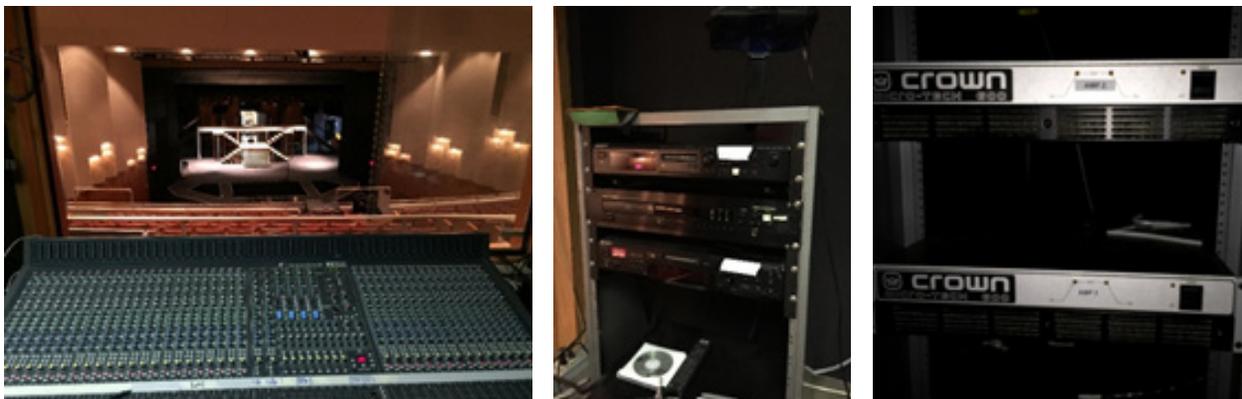
The Audio Control Booth: The existing audio control booth houses a 20-year old analog audio console, support equipment, playback speakers, and two equipment racks that house the sound systems audio amplifiers and support electronics. Considering the high level of amplifier fan noise present in the Audio Booth, it is almost impossible for the operator to hear issues like the onset of feedback before it occurs. Therefore, our first assessment recommendation is to remove the audio console and associated equipment from the Audio Booth and to convert this space into the Theater's AV Equipment Room. Given the current sound system infrastructure, this change would be cost effective and provide Turner Auditorium with a much need technology hub for Turner Auditorium.

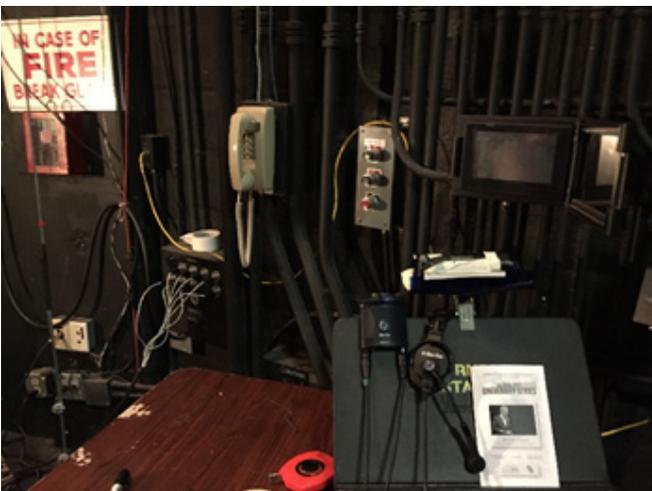
To assist with event and production and overall stage organization our assessment recommendation is to add a permanent Stage Manager's Position on stage right. Currently, there is an informal position on stage right but a permanent position would allow for centralized technology hub for video, lighting, audio, communications, and back-of-house. The image below shows the current position the stage Manager uses for show control.

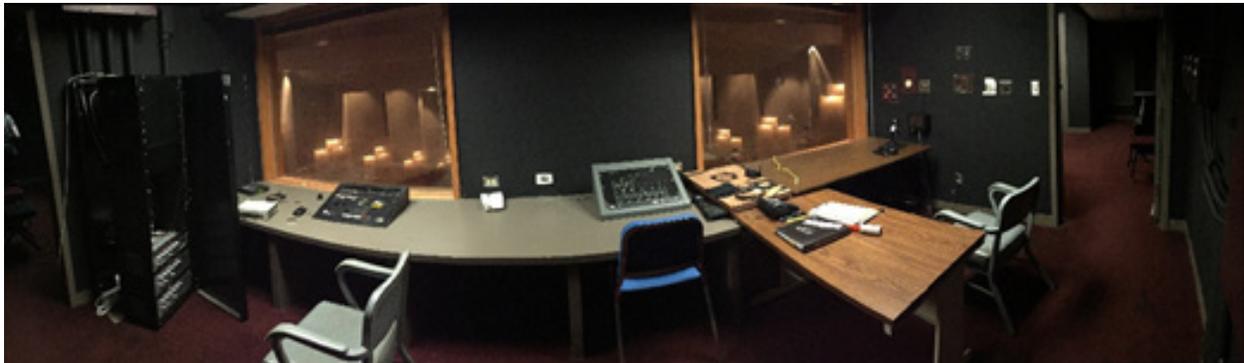
The Balcony Video & Lighting Control Room: The center section of the Balcony Control Booth is currently configured to support lighting and the event production staff. Our assessment recommendation would be to maintain the lighting and production staff and to add a video control position. The video position would control cameras, record and/or stream events, provide computer support for lectures, and generate graphics in support of events.

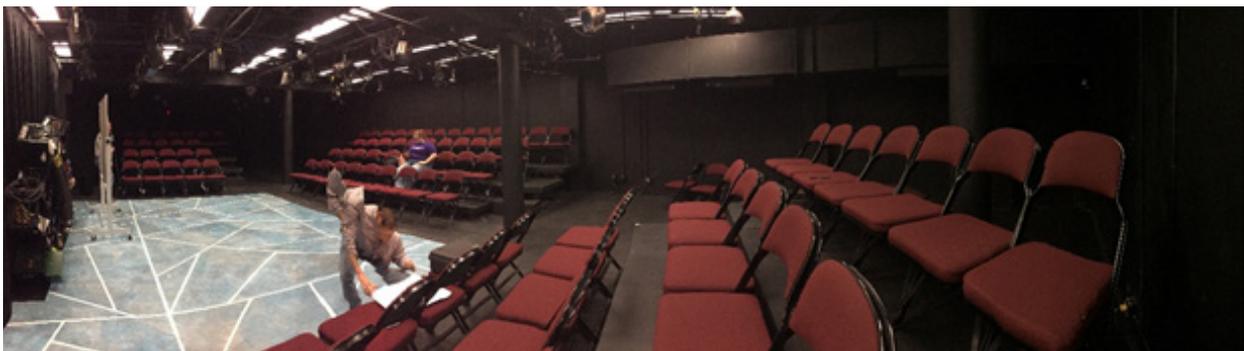
The Downstage Theater is an intimate 80 seat venue with a low rather low ceiling & grid. This space also has a complex set of acoustical issues. Although the Theater doesn't require a sound reinforcement system for speech and if the space is maintained in its current location, our assessment recommendation would be to install a reasonable quality sound system for special effects and production support.
