City of Nacogdoches Survey: Condition Guidelines

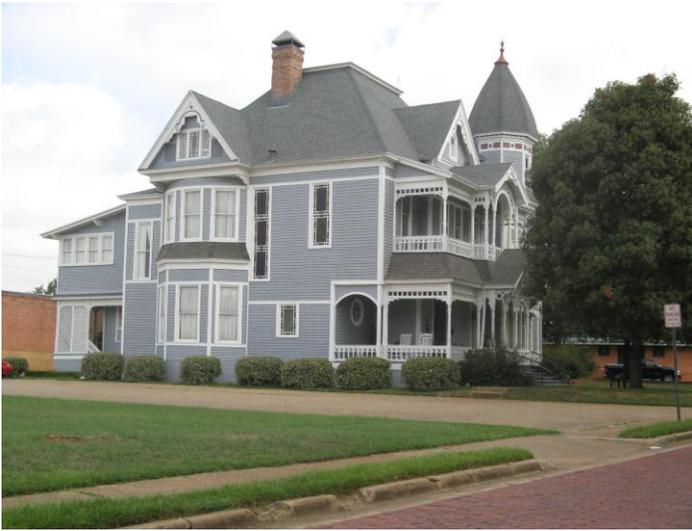
Excellent

Excellent: The resource is ... (100%-90% pristine)

- clearly well maintained/painted/cleaned with attention to small elements,
- the roof appears solid, is correct for the structure's style/date, and has no loose sections,
- all window and door frames appear solid and no weathering, glass appears original
- there are no cracks in the foundation, walls, or stairs,
- there are no apparent additions to the resource or missing elements, and
- there is no potential outside threat.

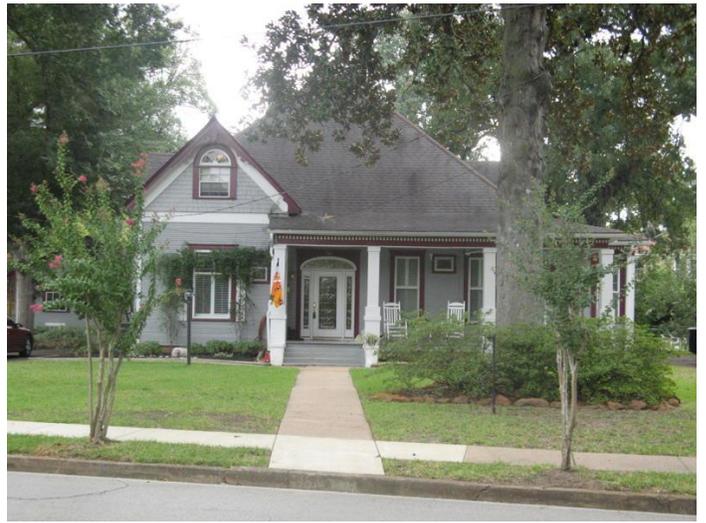
Good

Good: The resource is... (90%-75% pristine)

- has regular maintenance/painting/cleaning but smaller elements may not be individualized,
- the roof appears solid but may be incorrect for the structure's style/date, or may have slight loosening,
- the window and door frames appear to be original but may need minor repairs or finishing,
- there can be hairline cracks in the foundation, walls, or stairs but no shifting/settling,
- there may be some minor changes to the structure's historic fabric but they do not change its integrity, and
- there is a potential outside threat but not imminent.

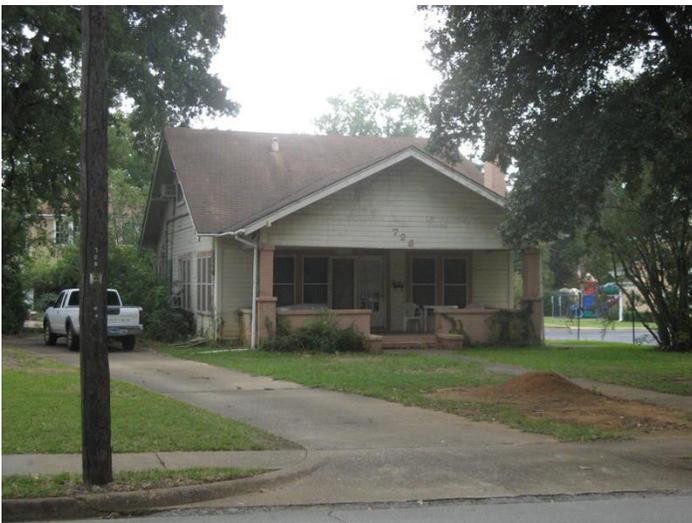
Fair

Fair: The resource is ... (75%-60% pristine)

- has occasional maintenance and basic repairs,
- the roof has clear wear but appears to be functional, the roof is most likely incorrect for the structure's style/date,
- the window and door frames have been replaced or modified, original materials show obvious wear,
- the foundation, walls, or stairs have some separation in a few locations and there is slight shifting/settling,
- there are some major changes to the structure's historic fabric which may affect its integrity, and
- there is a clear outside threat.

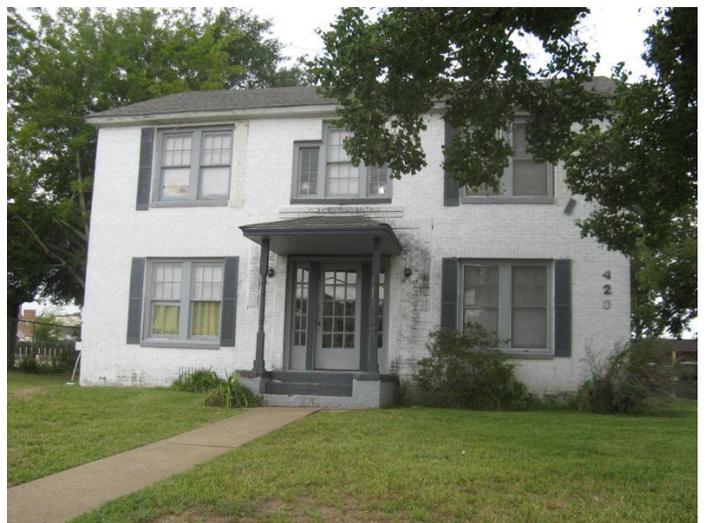
Poor

Poor: The resource is... (60%-45% pristine)

- has minimal maintenance and is lacking some basic repairs,
- the roof has extreme wear, it may have some leakage, and if original is most likely damaged beyond repair,
- the window and door frames, if original have extreme wear and/or breakage, or are very unsympathetic replacements, there may be a few broken panes of glass
- the foundation, walls, or stairs have clear holes, cracks, or damage and structure is unlevel in at least one area
- there are numerous changes to the structure's historic fabric which affect its integrity, and
- there is a clear, imminent threat.

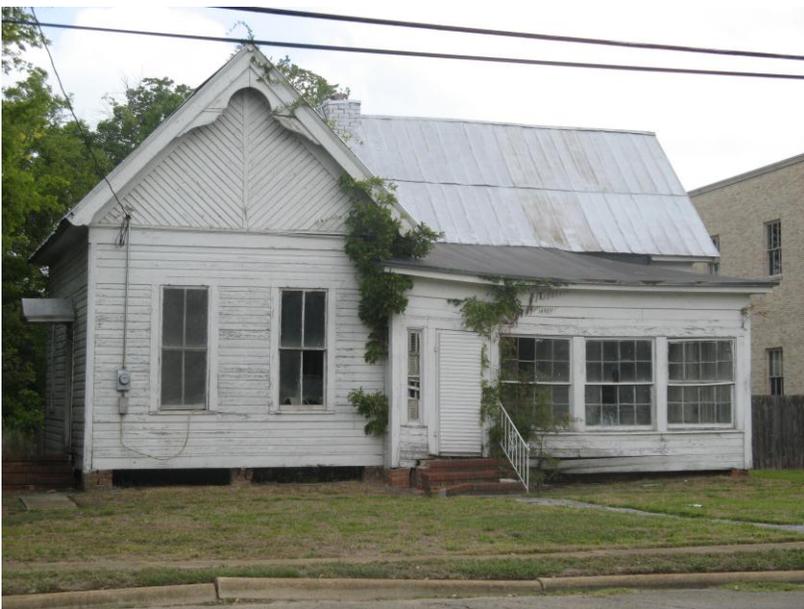
Bad

Bad: The resource is (45%-0% pristine)

- has clearly had no recent maintenance and needs major repairs,
- the roof has holes, leaks, is missing sections, or is completely unsympathetic to the structure,
- the window and door frames are not weather tight, there are several broken panes of glass or missing elements,
- the foundation, walls, or stairs are falling, buckling, or missing major sections, the structure is unlevel,
- there are so many changes to the structure's fabric that it is difficult to determine which parts if any are original, and
- it has already been threatened.
