# MILLARD-LEE HOUSE HISTORIC STRUCTURE REPORT

Written and Compiled by  
Christopher Elzen and Sara Baker

Department of History  
Stephen F. Austin State University

8 December 2008

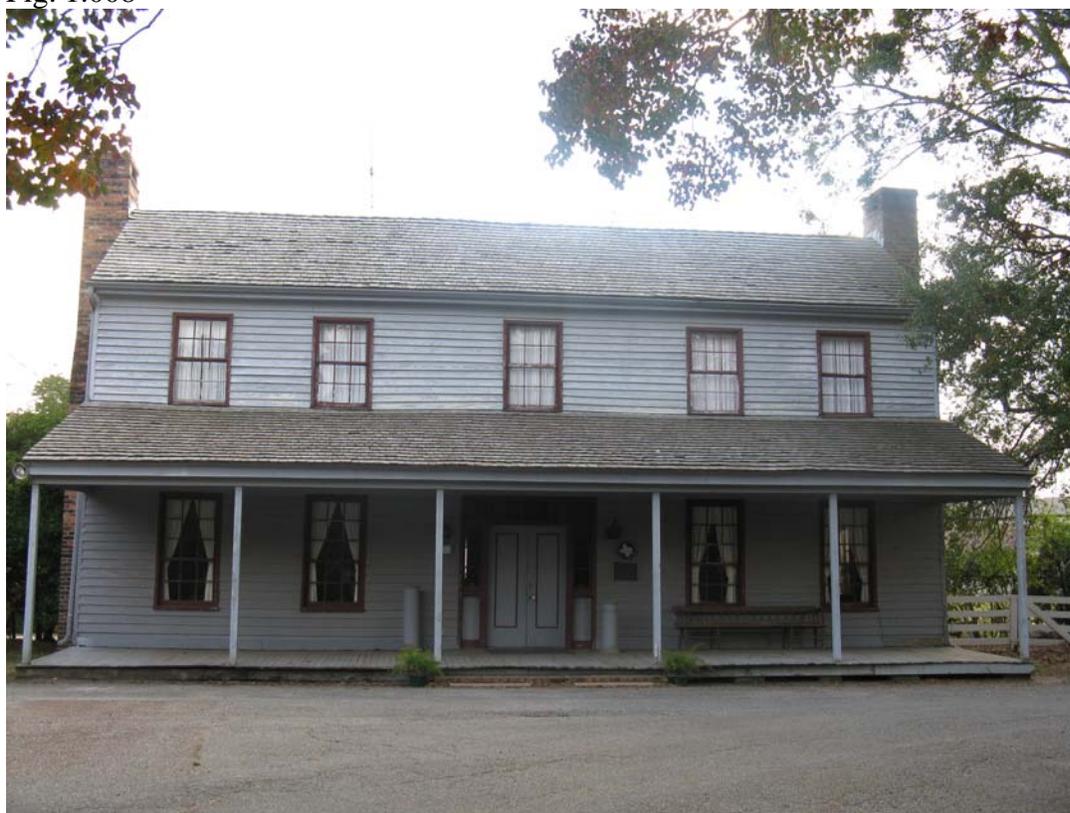
Fig. 2.001

<sup>31</sup> See Figure 2.001

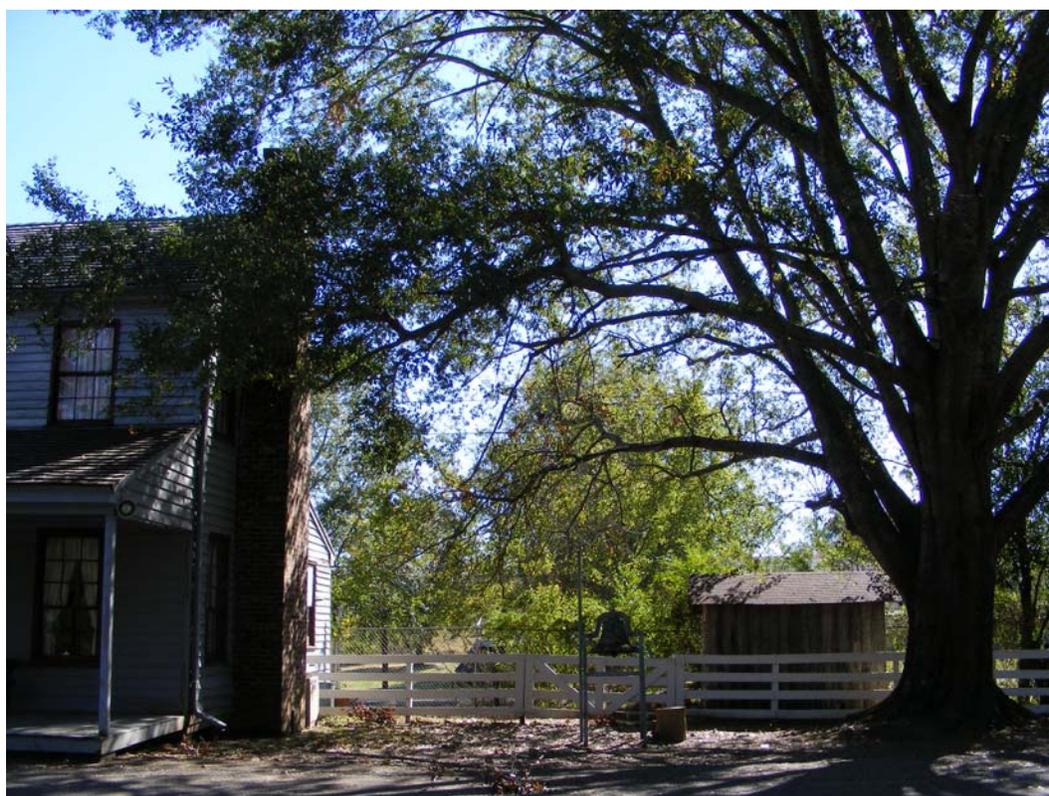
Fig. 2.002

<sup>32</sup> See Figure 2.002

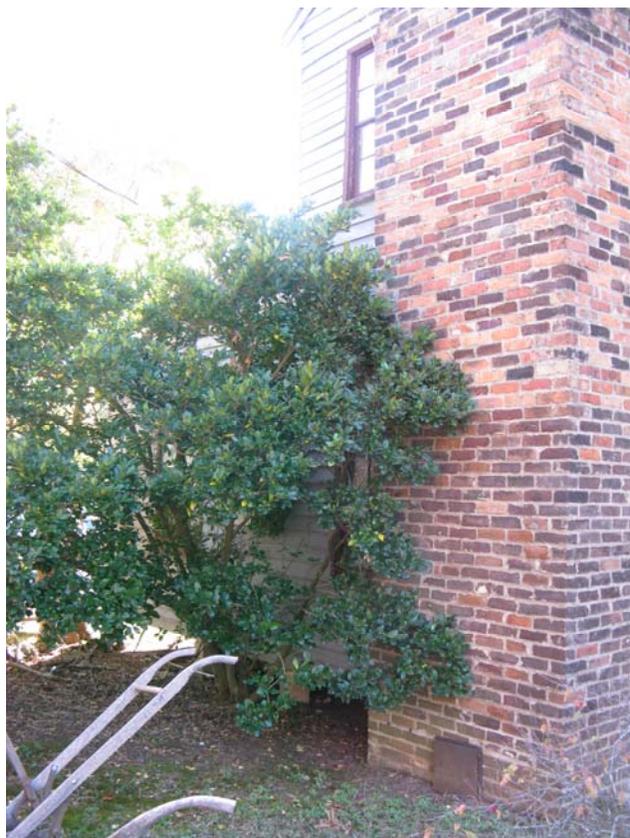
Fig. 2.003

2.03	Waxleaf Ligustrum on east side of house .....	12
2.04	Waxleaf Ligustrum threatening foundation and windows.....	12
2.05	Neighboring tree at southeast corner of house.....	13

<sup>33</sup> See Figure 2.003

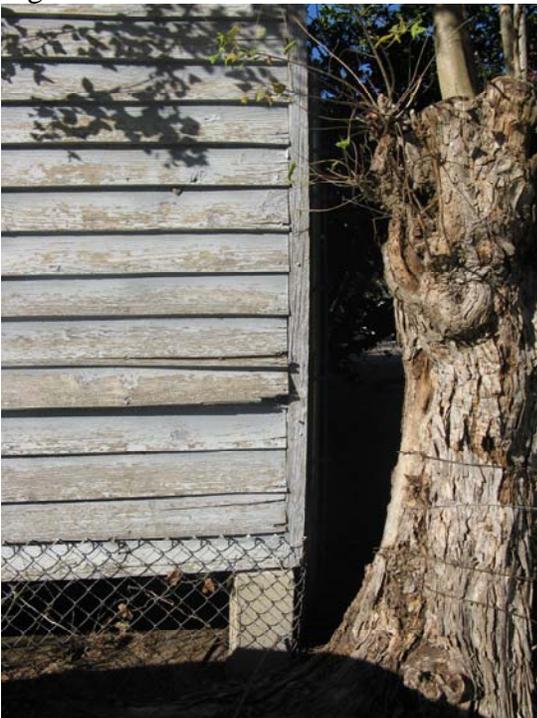
Fig. 2.006

2.06	Tree and southeast corner foundation support .....	13
2.07	Tree at southeast corner over roof .....	13
2.08	Fencing and plants caught along back of house.....	13

<sup>35</sup> See Figures 2.005-2.007

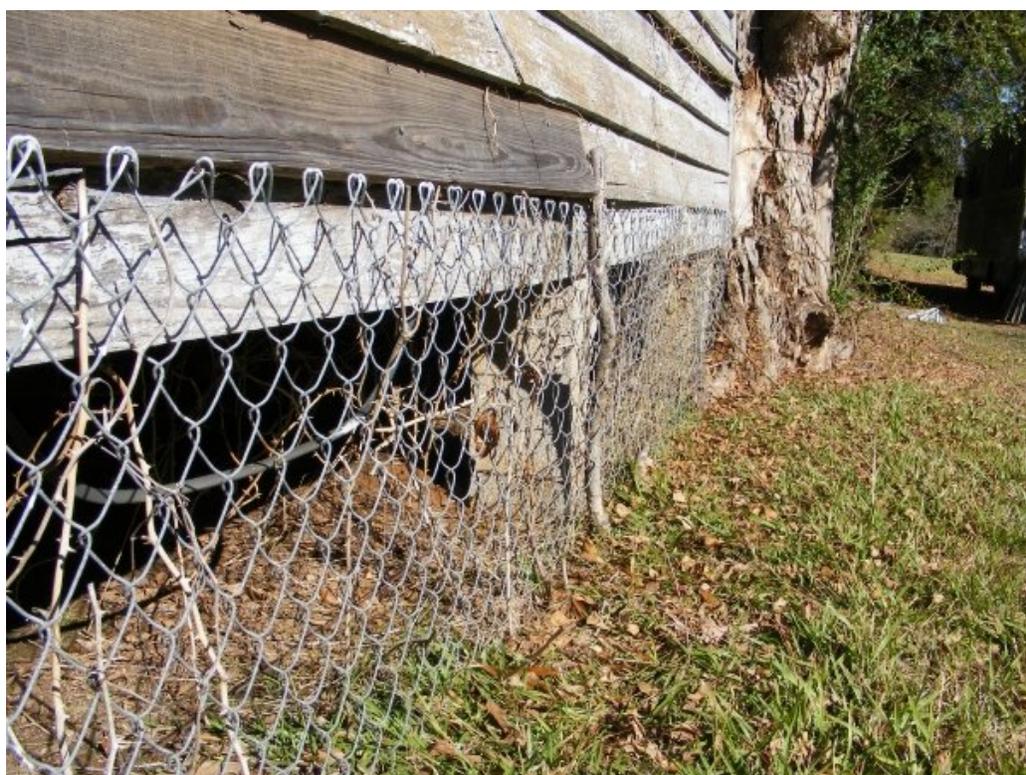
Fig. 2.008

<sup>36</sup> See Figure 2.008

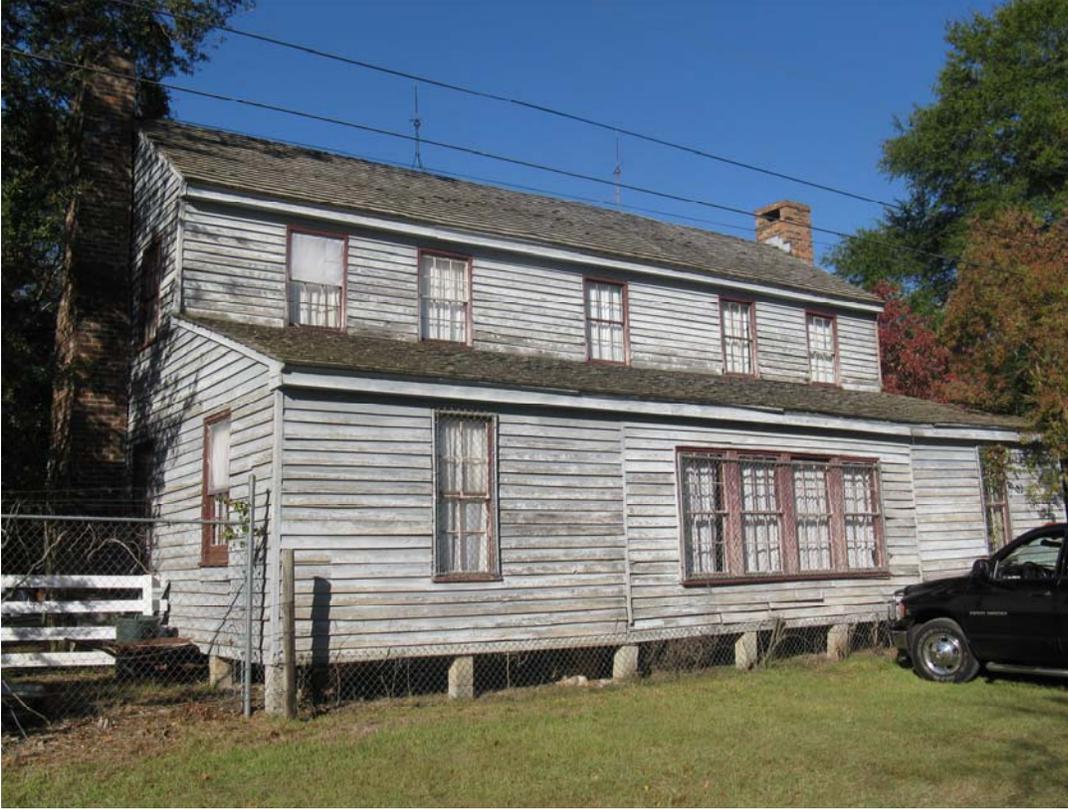
Fig. 2.009

<sup>37</sup> See Figure 2.009

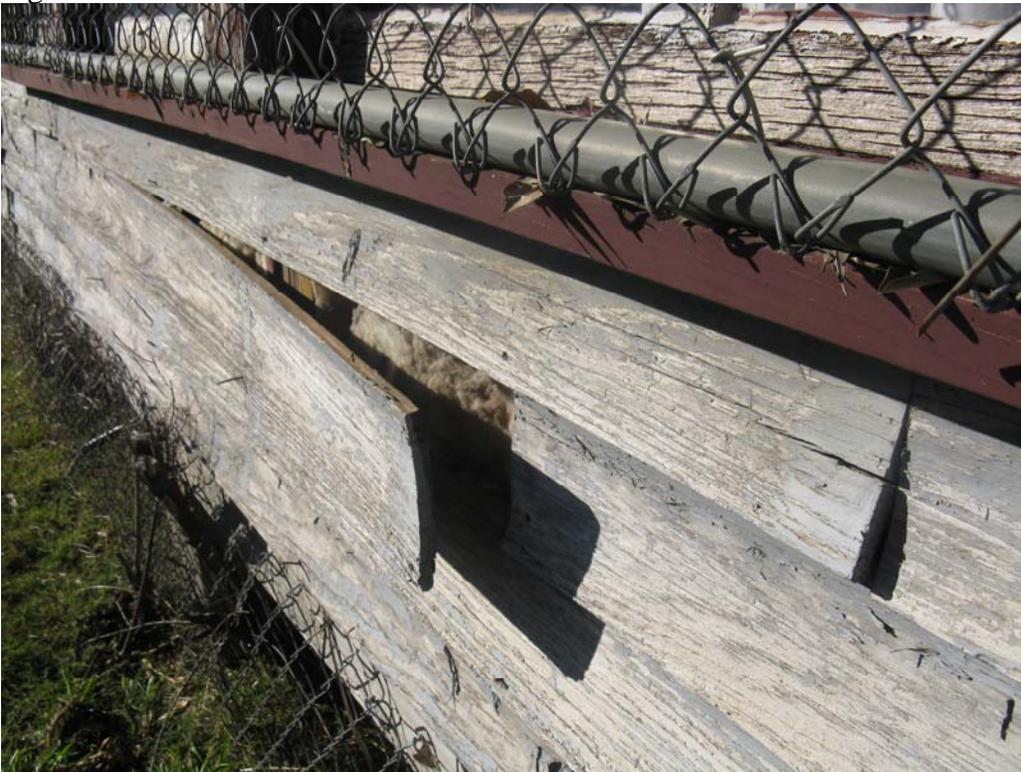
Fig. 2.010

2.09	Back of the house.....	13
2.10	Siding coming off of the back of the house .....	13
3.01	Foundation supports under the house leaning.....	14
3.02	Foundation supports.....	14

<sup>38</sup> See Figure 2.010

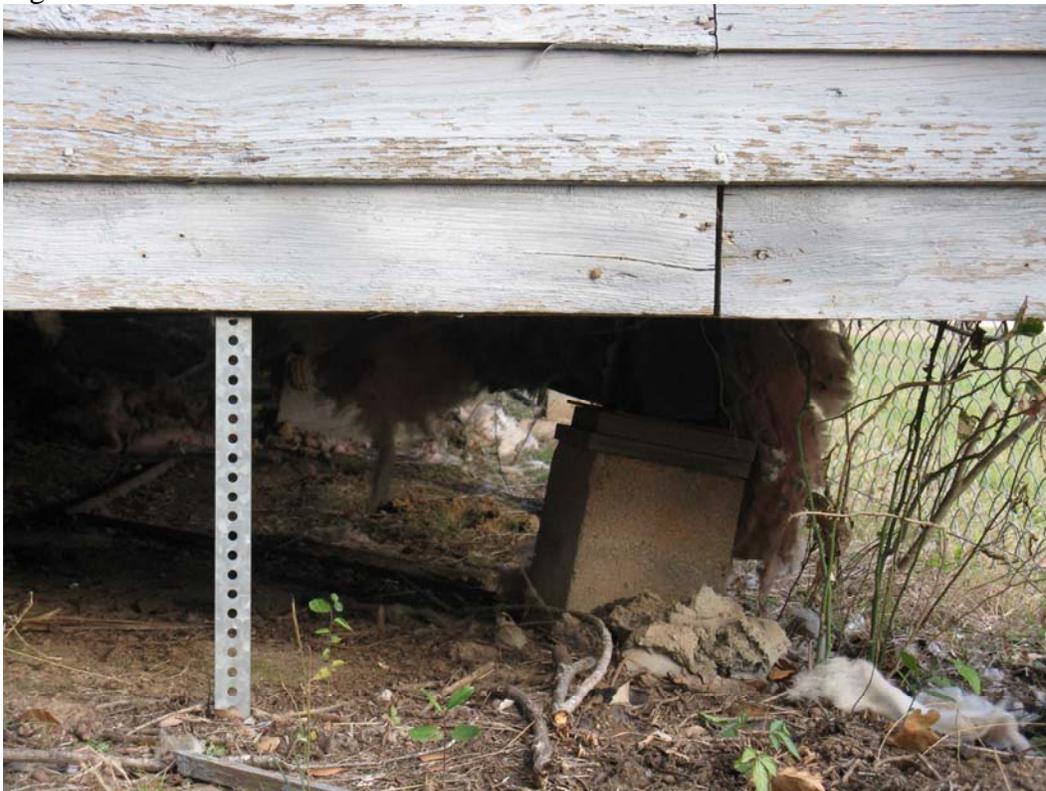
Fig. 3.002

<sup>39</sup> See Figure 3.001-3.003

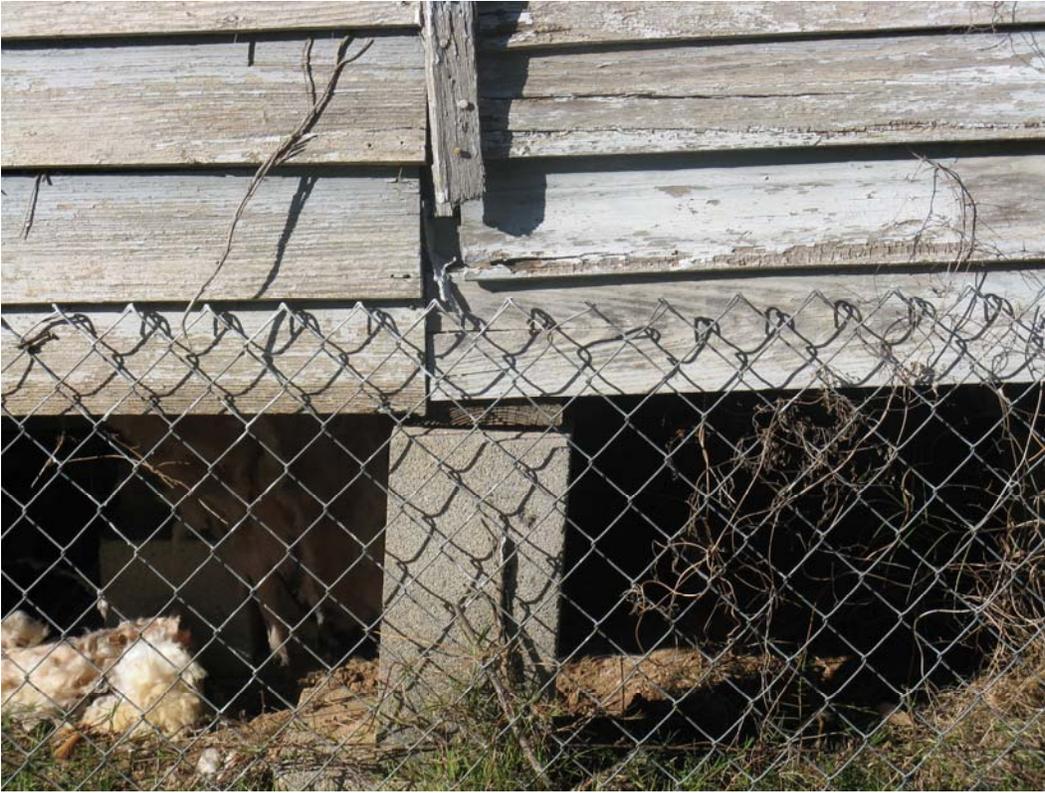
Fig. 3.003

3.03	Foundation support leaning.....	14
3.04	Back of the house and back porch enclosure .....	14

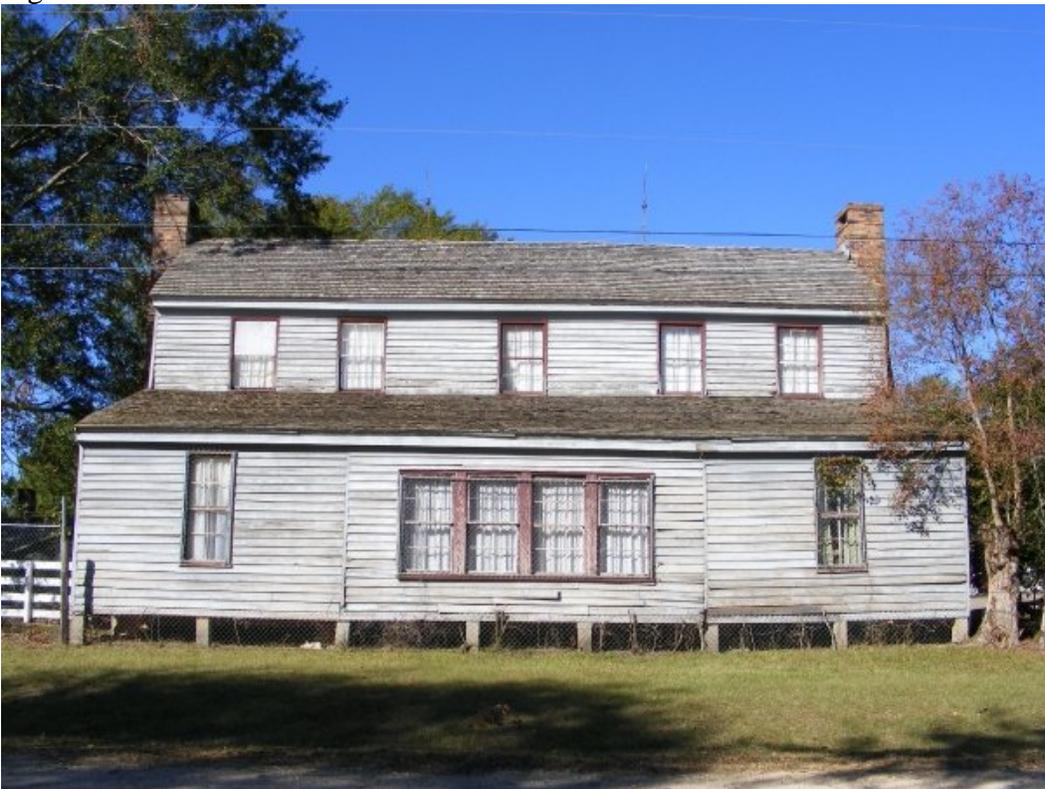
Fig. 3.004

<sup>40</sup> See Figure 3.004

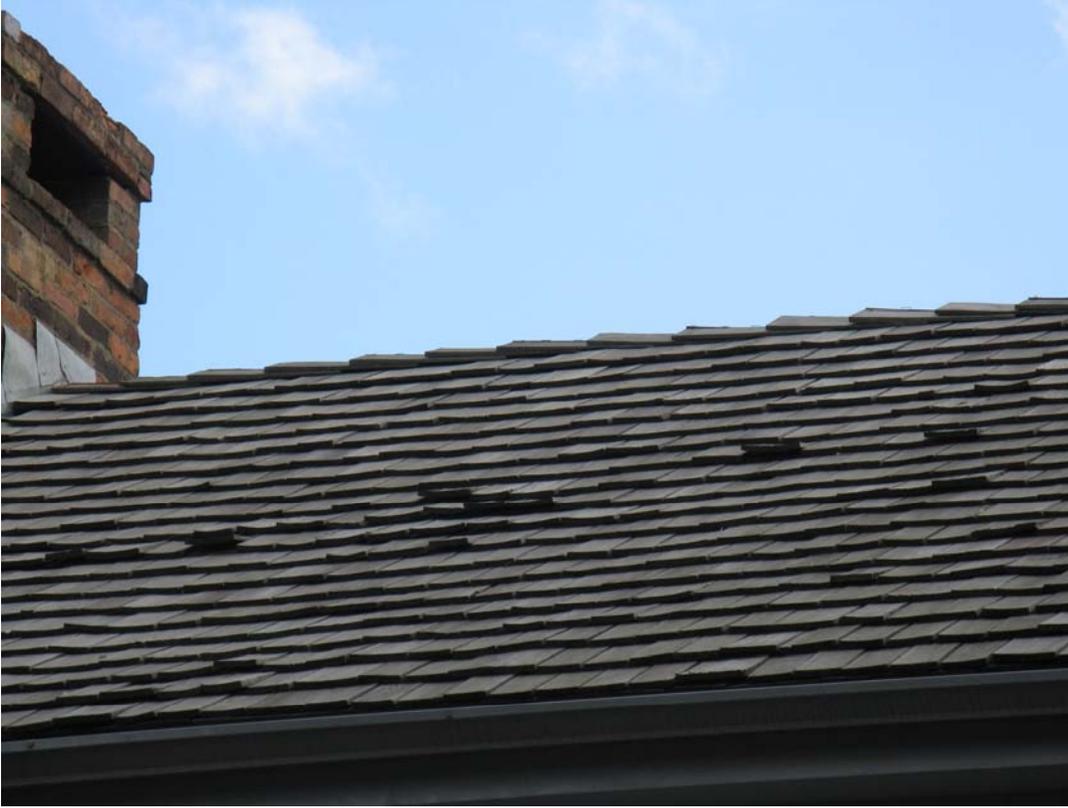
Fig. 3.005

<sup>41</sup> See Figure 3.005-3.008

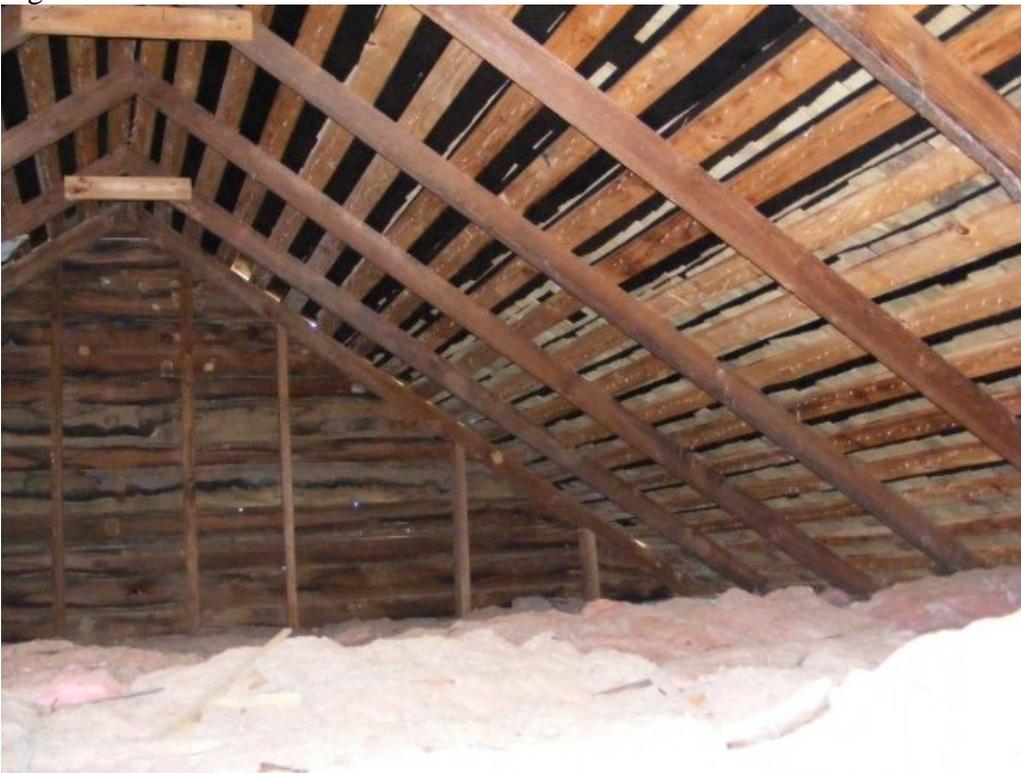
Fig. 3.012

<sup>43</sup> See Figure 3.012

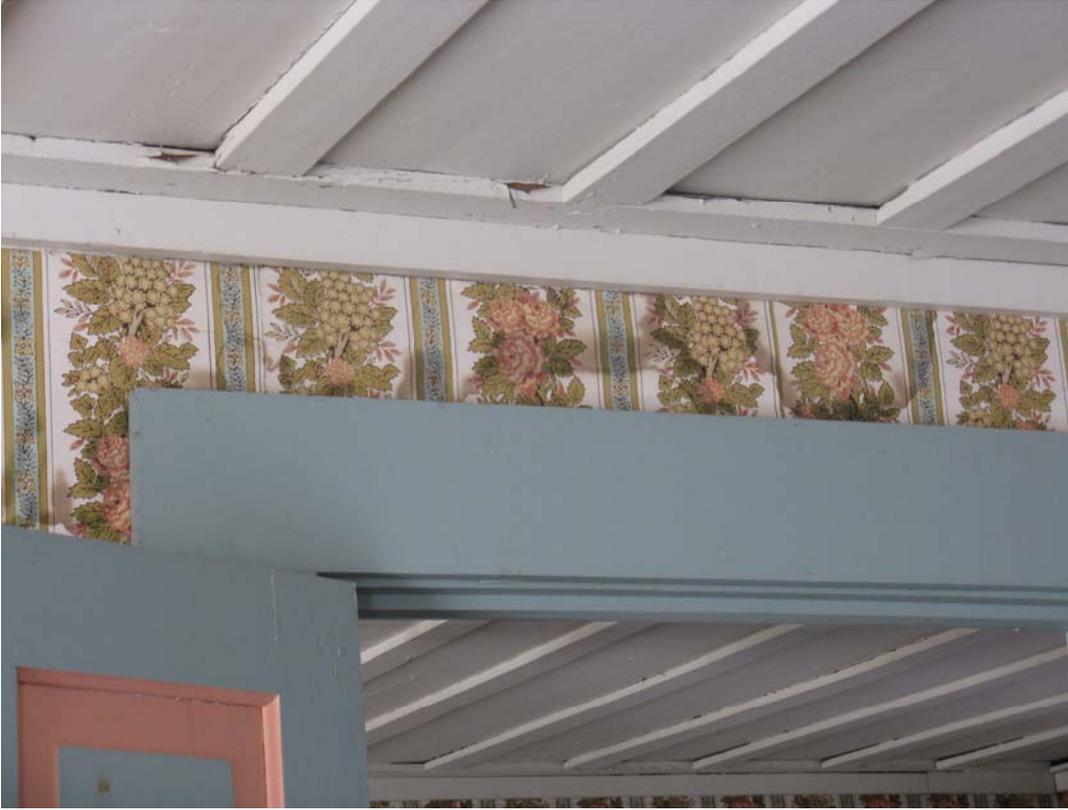
Fig. 3.013

<sup>44</sup> See Figure 3.013-3.014

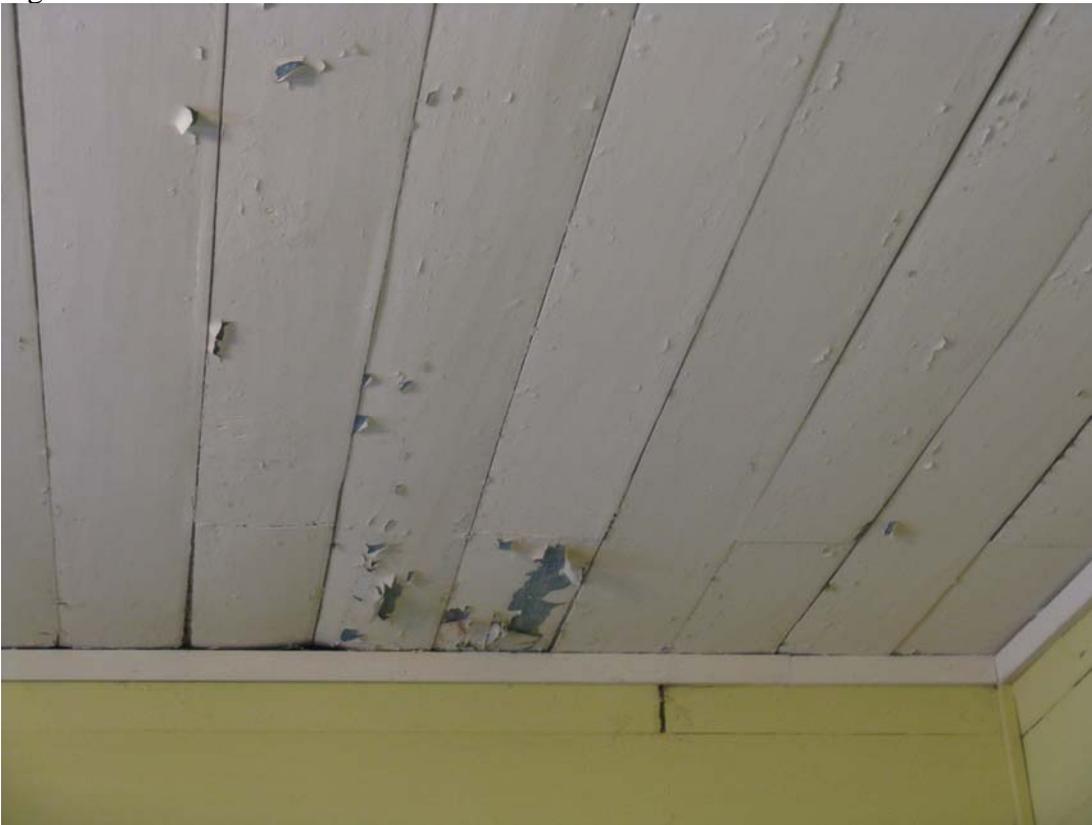
Fig. 3.014

<sup>71</sup> See Figure 3.014

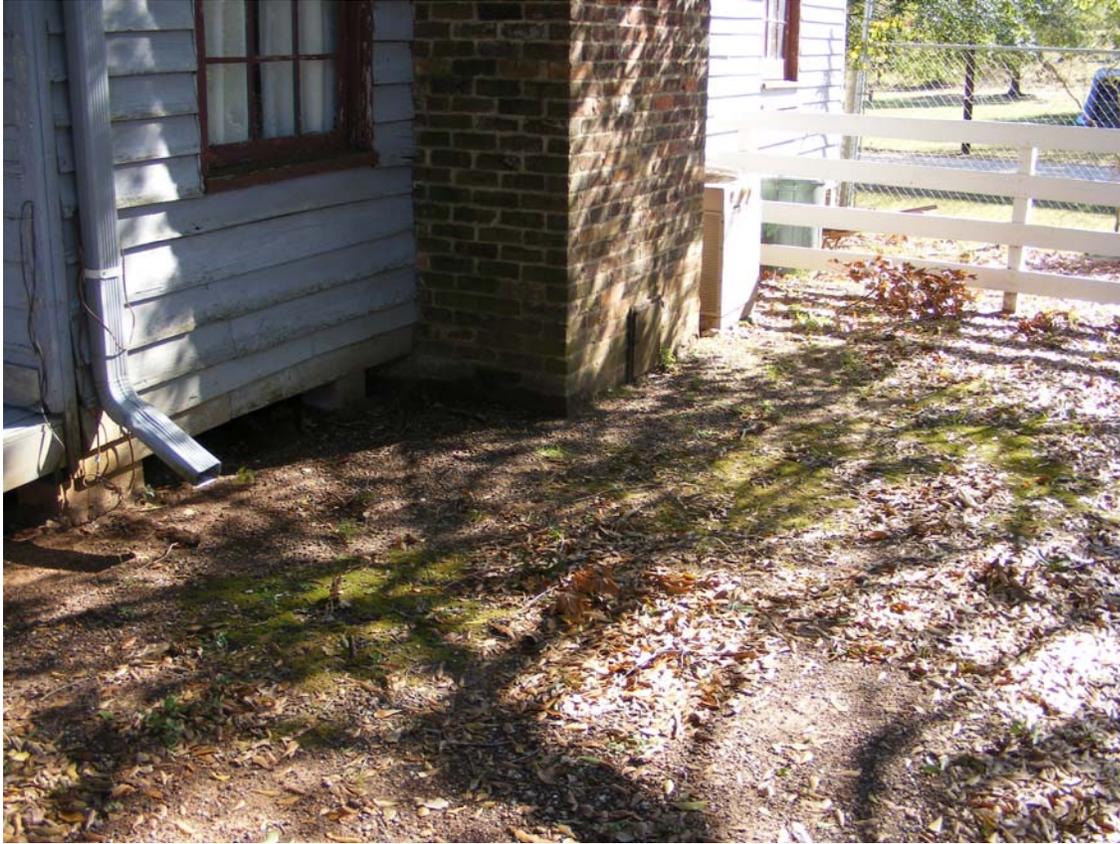
Fig. 3.015

<sup>45</sup> See Figure 3.015

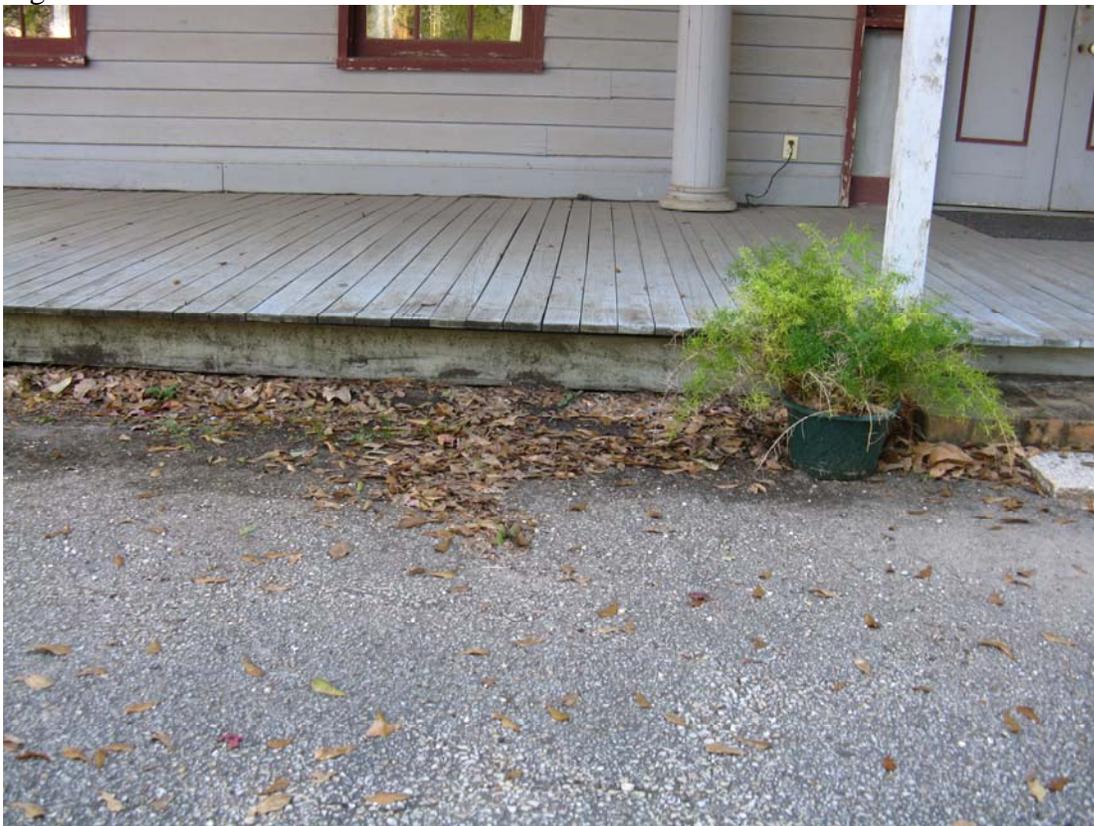
Fig. 3.017

<sup>47</sup> See Figure 3.017

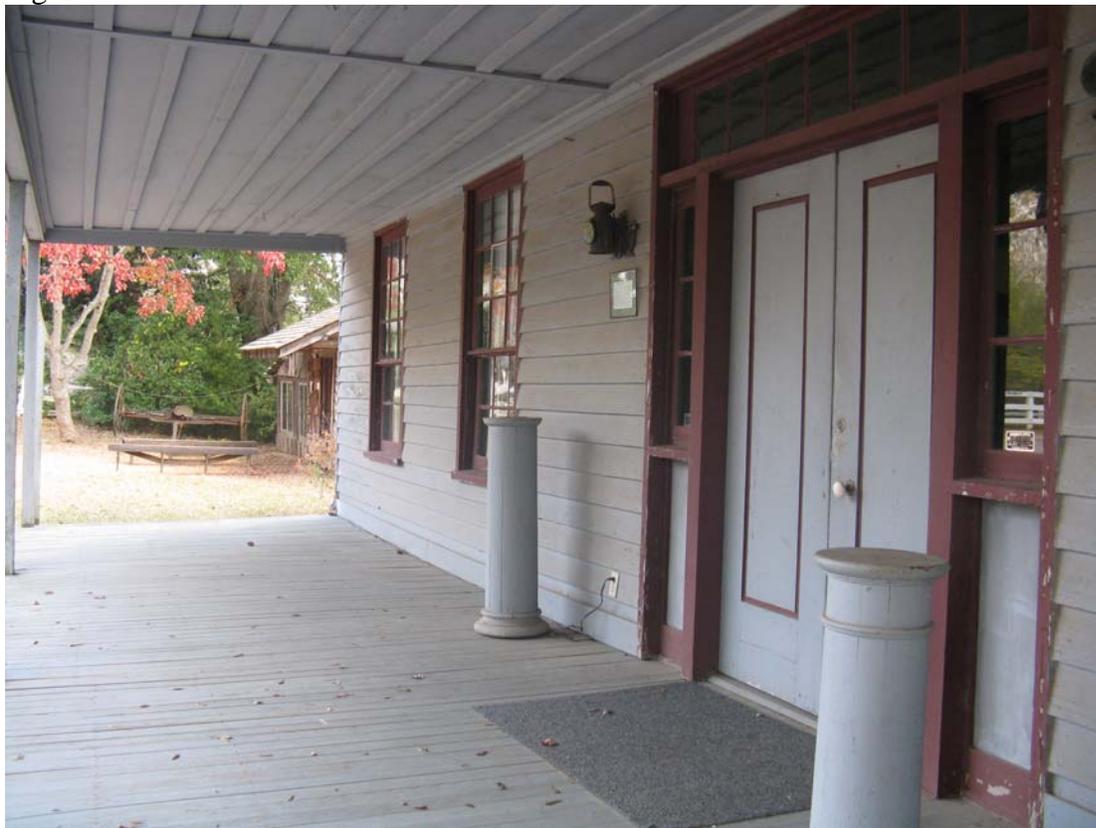
Fig. 3.018

<sup>48</sup> See Figure 3.018

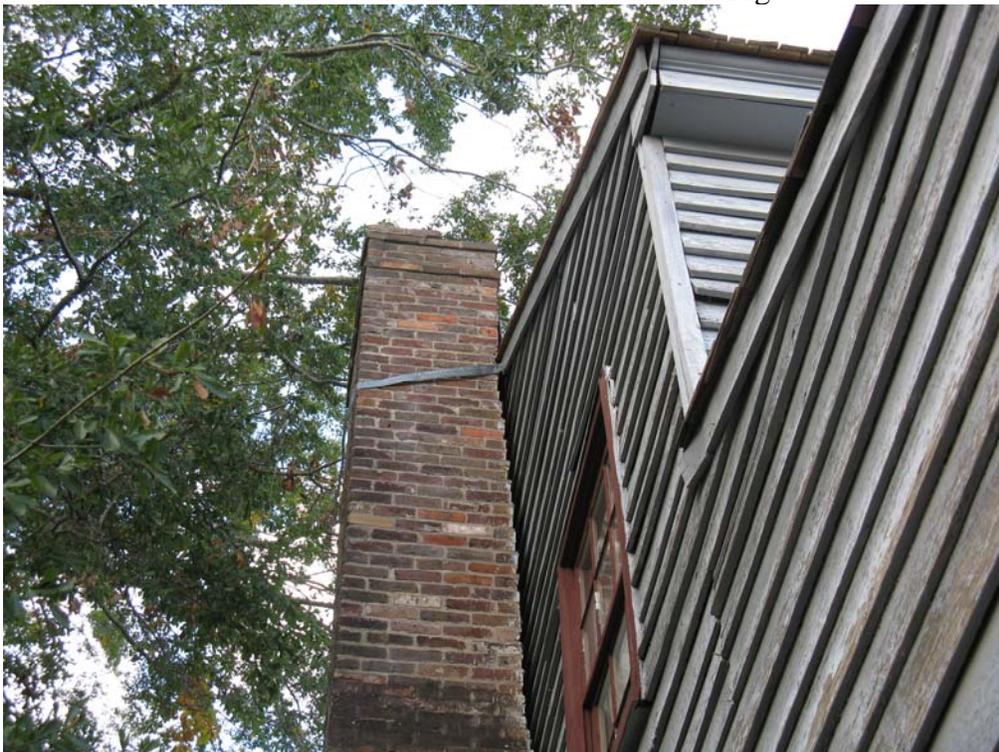
Fig. 4.008

<sup>52</sup> See Figure 4.008

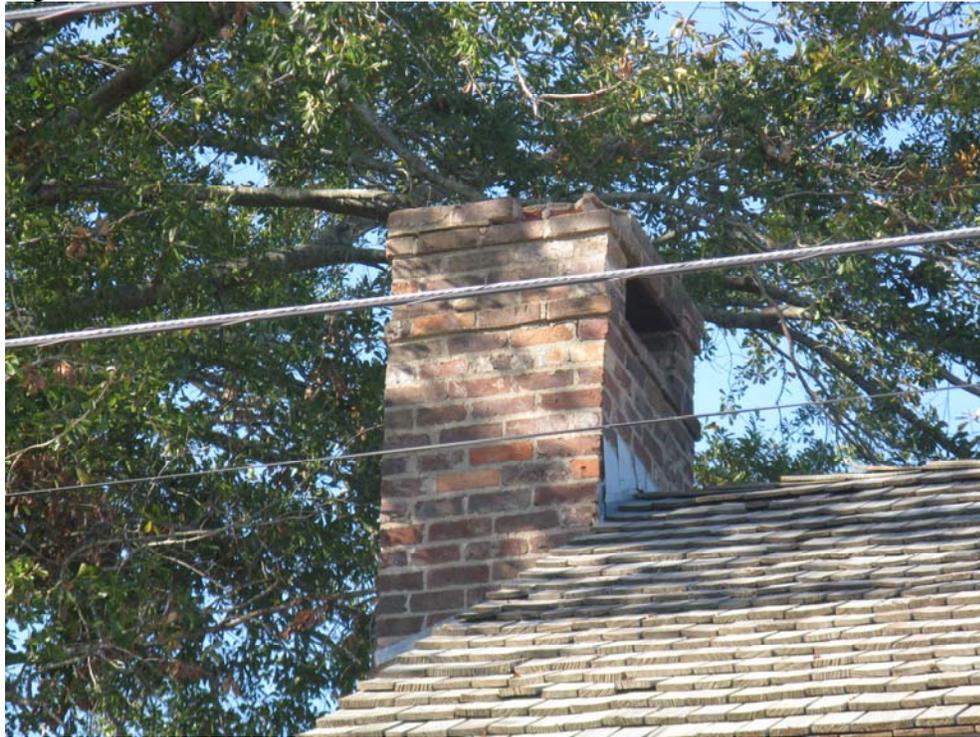
Fig. 4.009

<sup>53</sup> See Figure 4.009

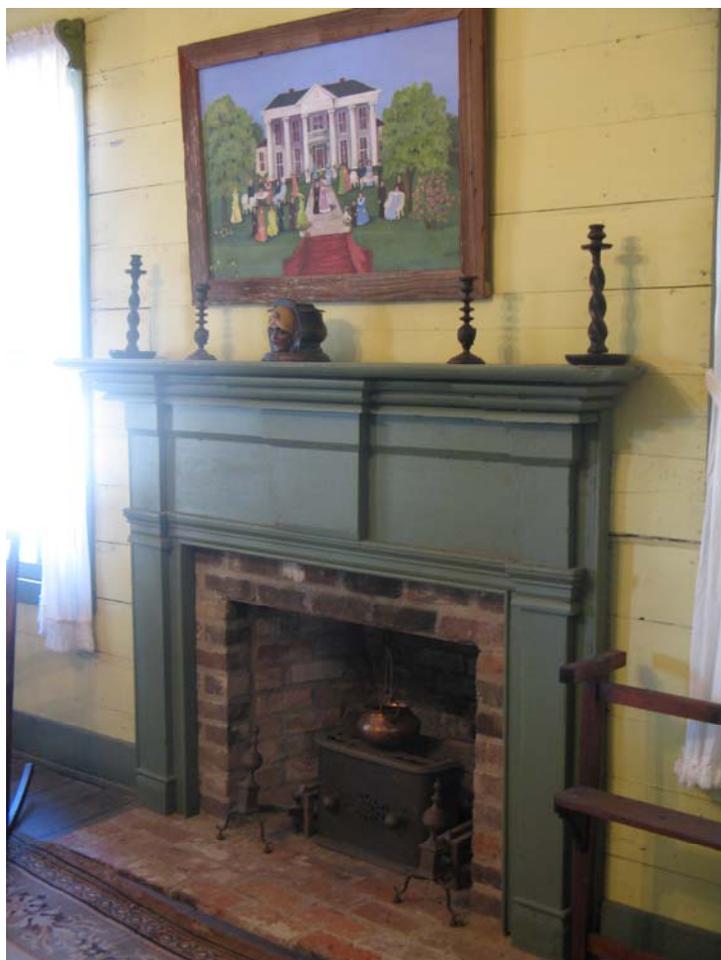
Fig. 4.010

<sup>54</sup> See Figures 4.010-4.013

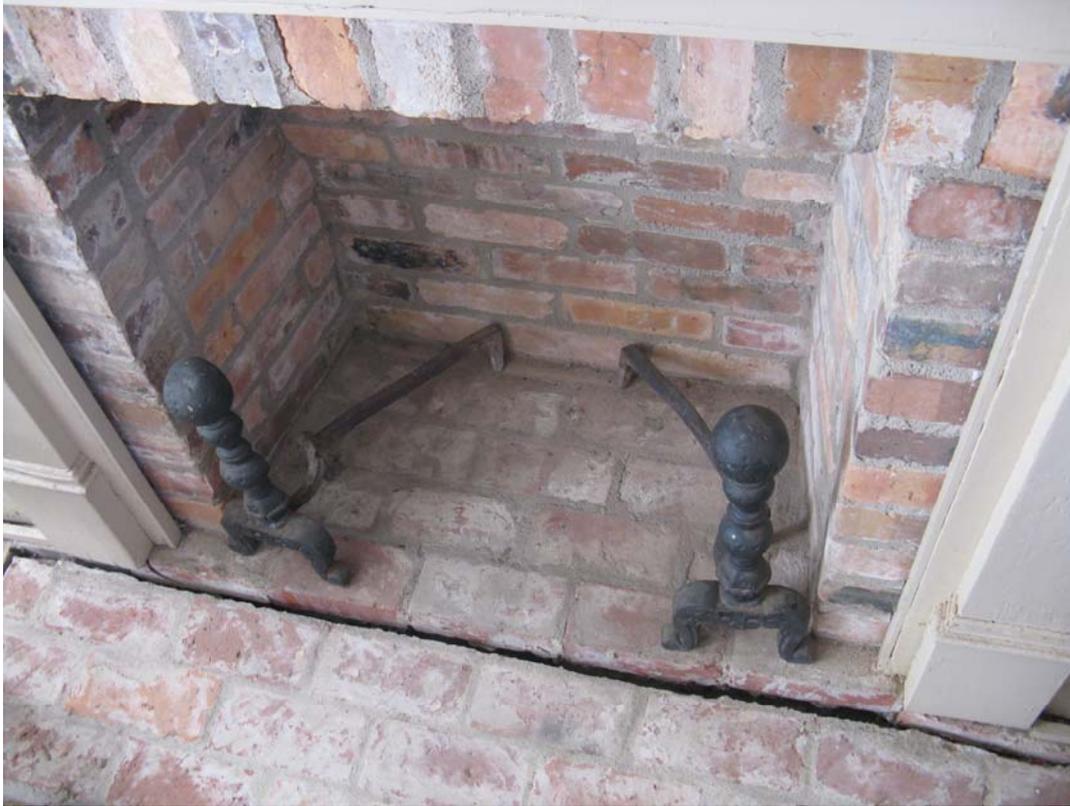
Fig. 4.014

4.14	Fireplace damage in wicker room.....	18
4.15	Fireplace damaged mortar in wicker room .....	18
4.16	Fireplace damaged mortar in wicker room .....	18
4.17	West room fireplace with minimal cracking in mortar .....	18

<sup>56</sup> See Figures 4.014-4.016

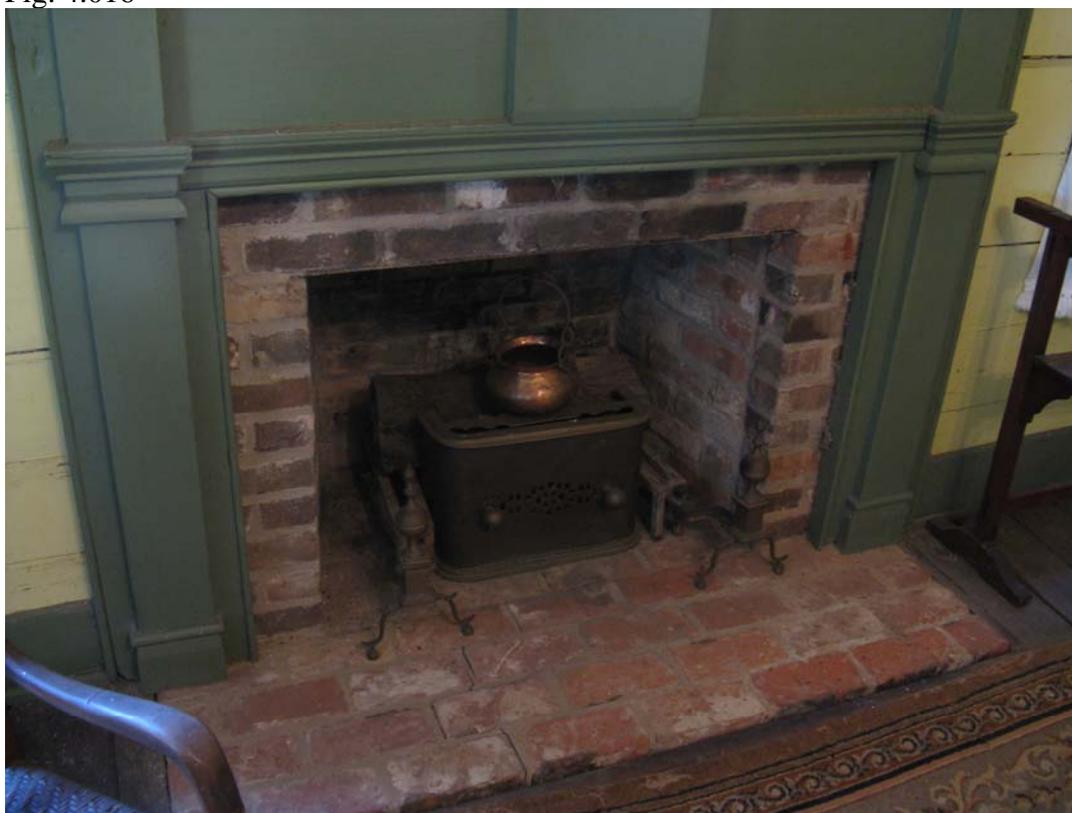
Fig. 4.017

<sup>55</sup> See Figure 4.017

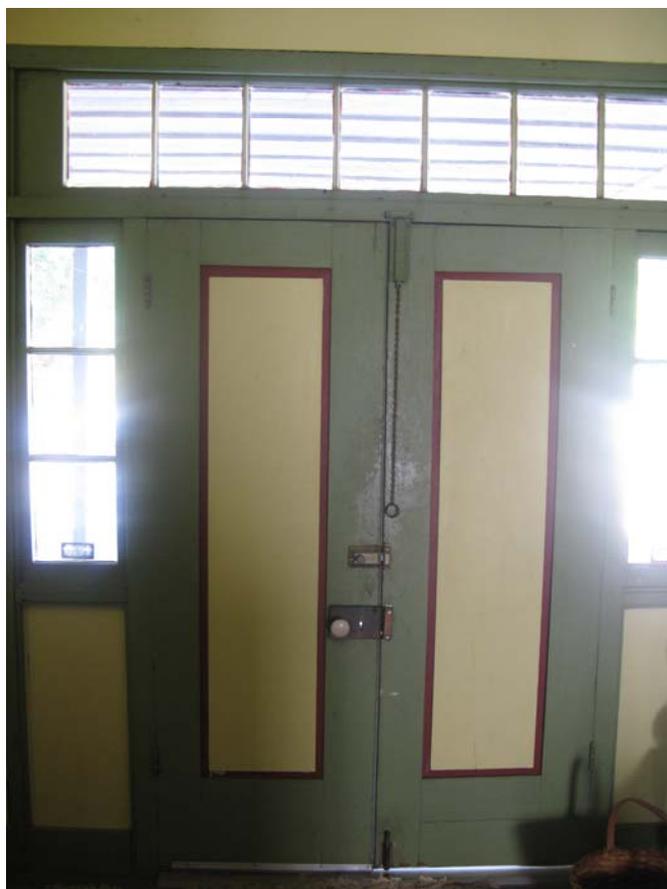
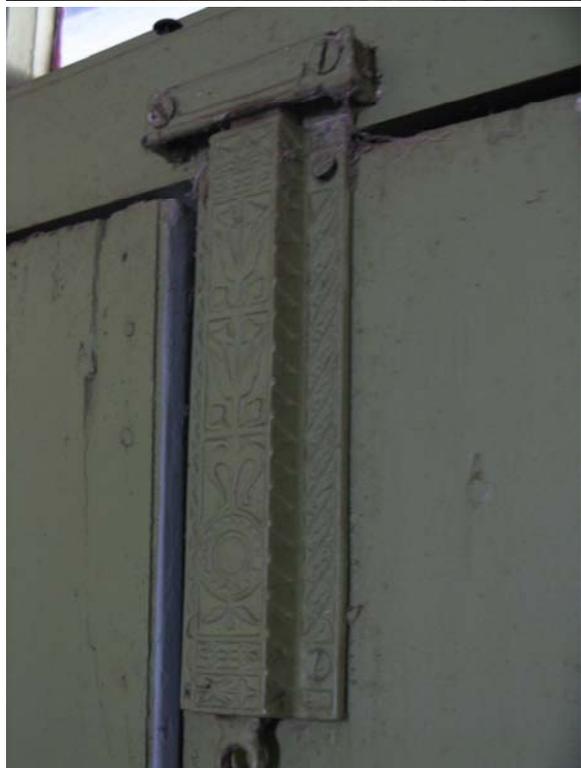
Fig. 4.018

<sup>57</sup> See Figures 4.018-4.019

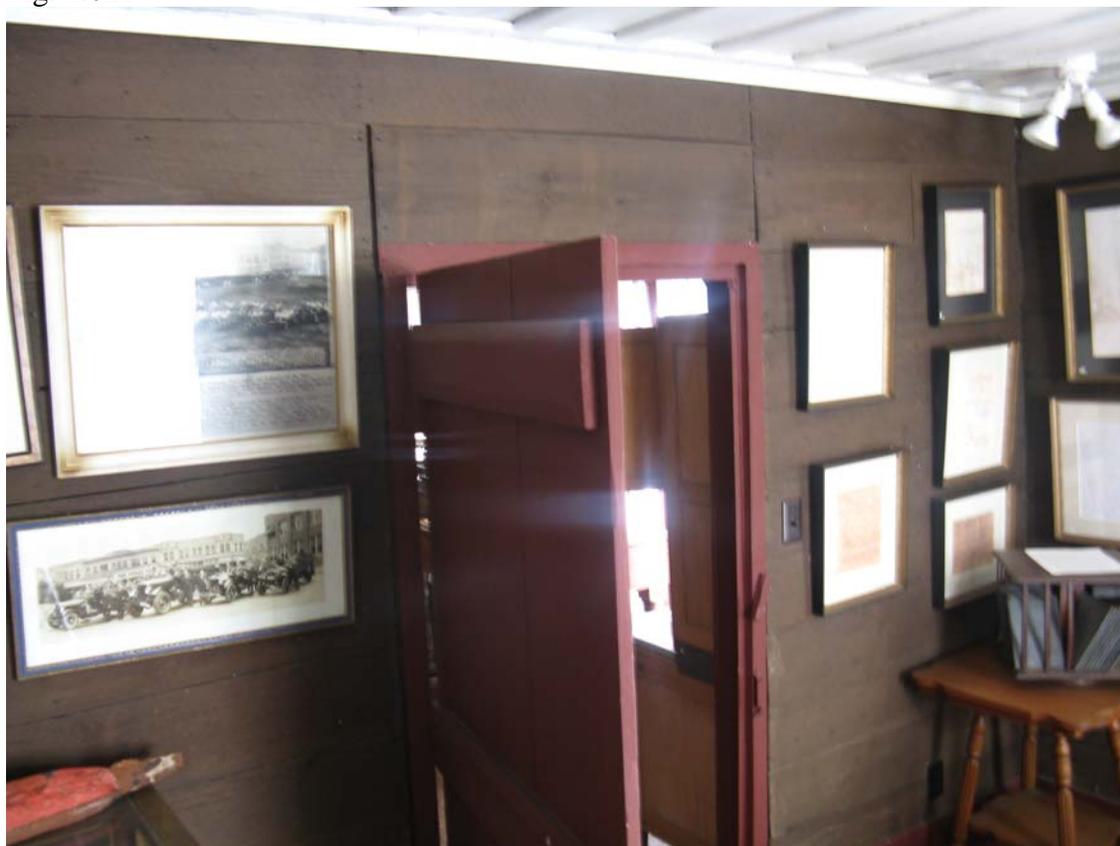
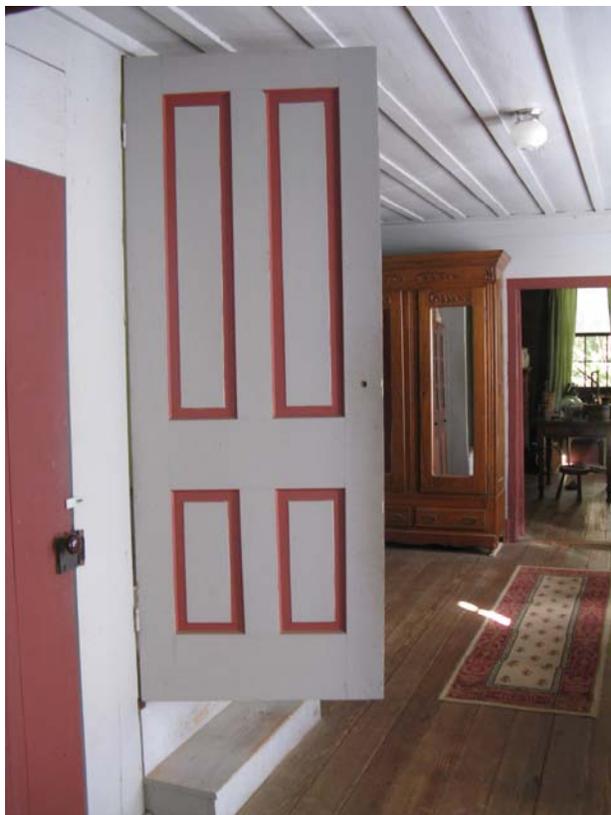
Fig. 4.021

<sup>59</sup> See Figure 4.021-4.022

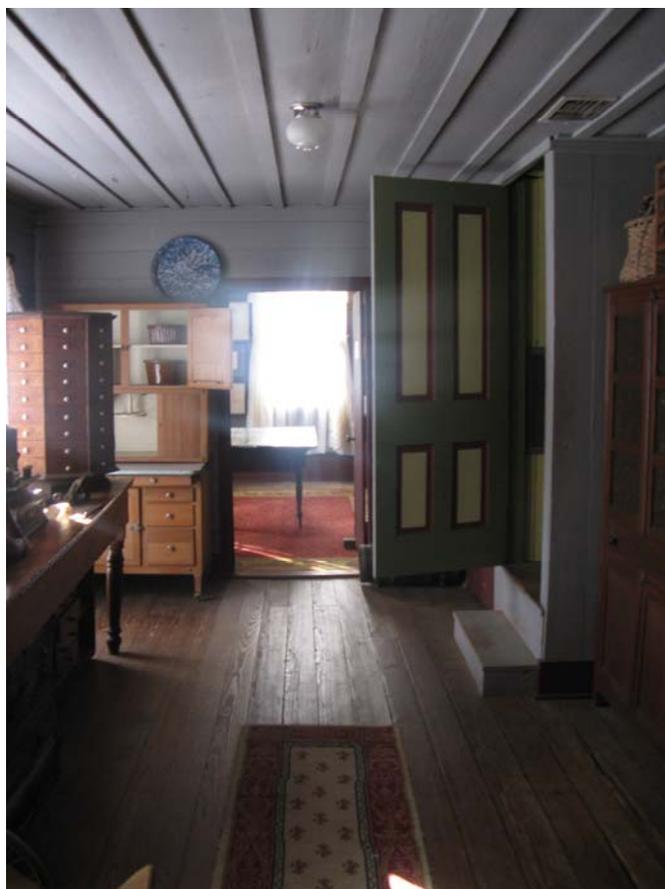
Fig. 4.023

<sup>60</sup> See Figure 4.023

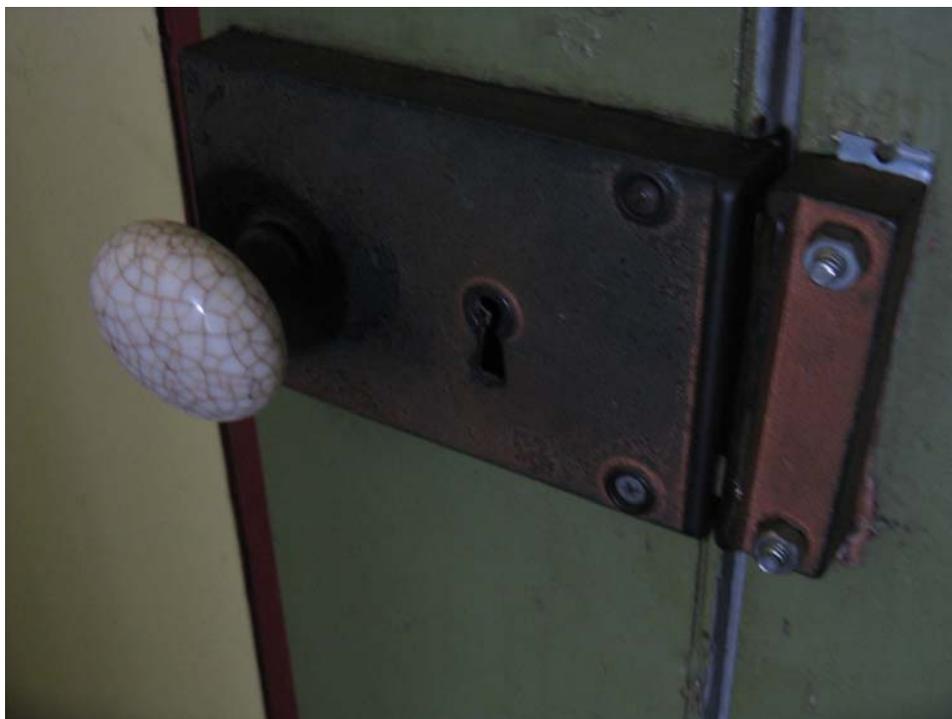
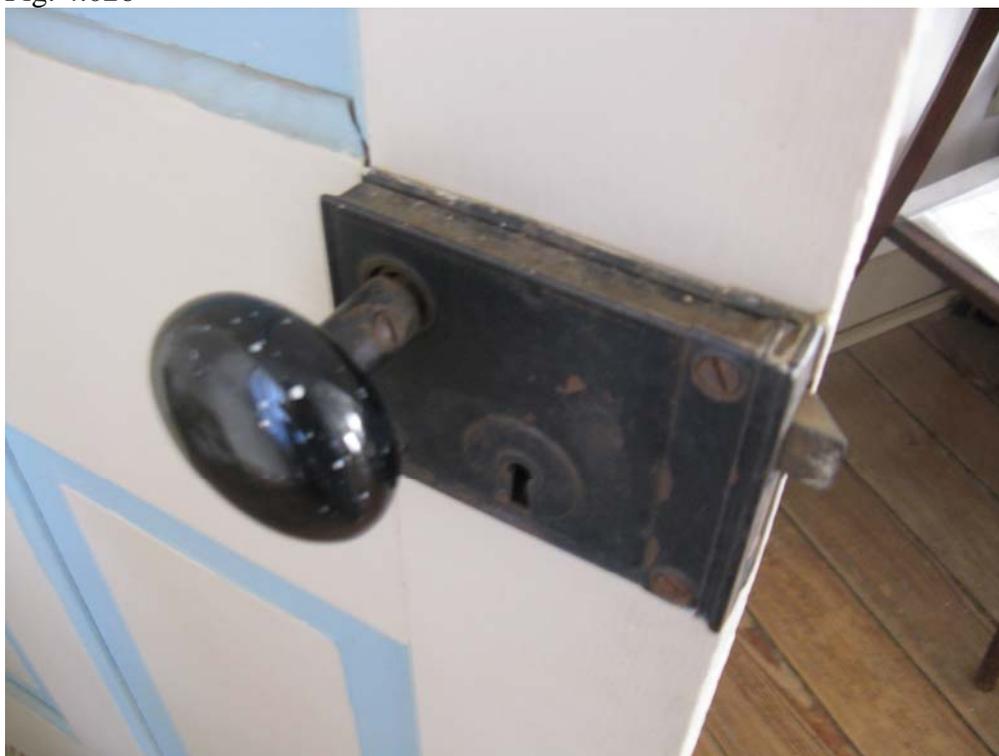
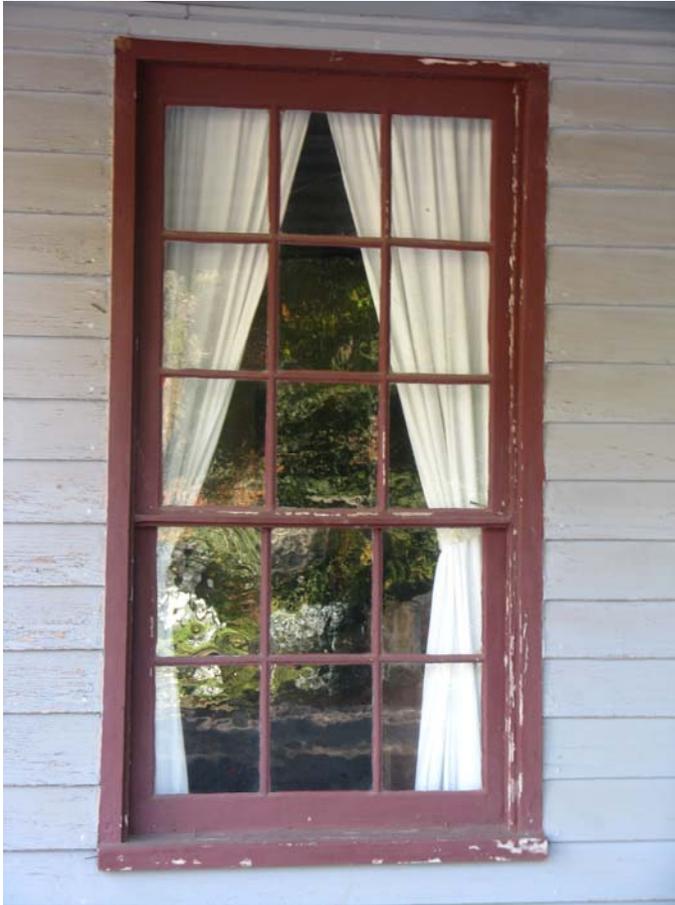
Fig. 4.025

<sup>61</sup> See Figure 4.025-4.027
