# MILLARD-LEE HOUSE HISTORIC STRUCTURE REPORT

Written and Compiled by  
Christopher Elzen and Sara Baker

Department of History  
Stephen F. Austin State University

8 December 2008

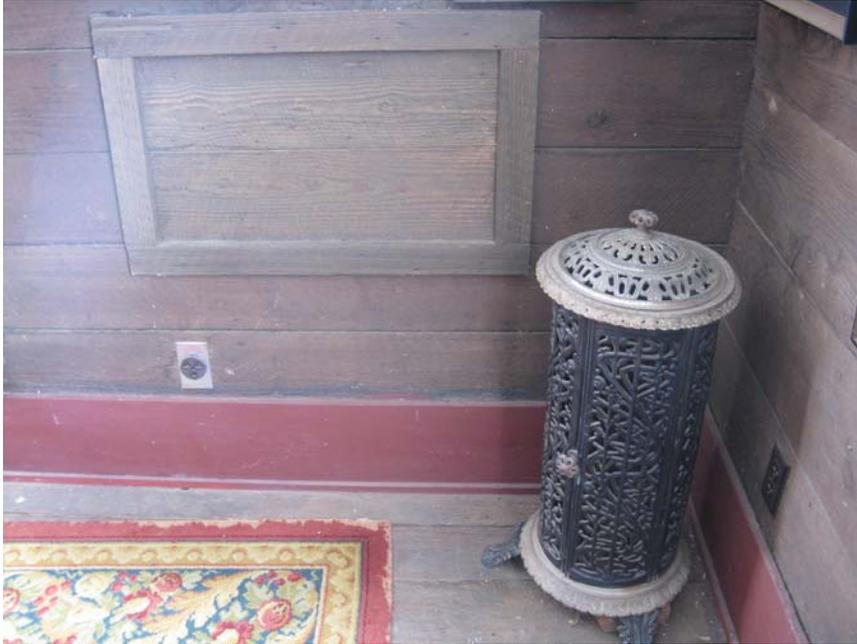
Fig. 4.037

rectangular patch in the wall where a box air conditioner unit once was, but though it is visible, it blends well and does not detract from the character of the room.<sup>74</sup>

<sup>74</sup> Chase, Sarah B. "Painting Historic Interiors." *Preservation Briefs 28*, U.S. Department of the Interior, National Park Service. Heritage Preservation Services; Park, Sharon C. "Controlling Unwanted Moisture Historic Buildings." *Preservation Briefs 39*, U.S. Department of the Interior, National Park Service. Heritage Preservation Services; Jandl, H. Ward. "Rehabilitating Interiors in Historic Buildings: Identifying and Preserving Character Defining Elements." *Preservation Briefs 18*. U.S. Department of the Interior, National Park Service. Heritage Preservation Services. See Figure 4.037

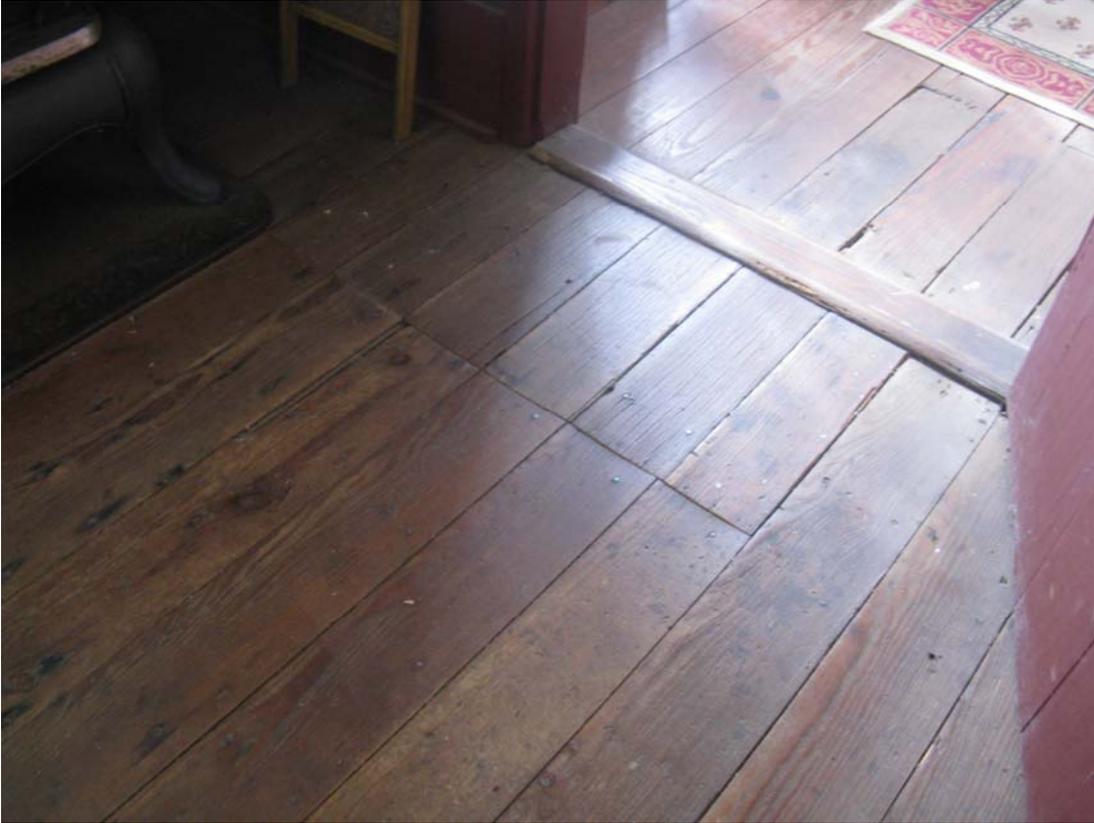
Fig. 4.039

<sup>76</sup> See Figure 4.039

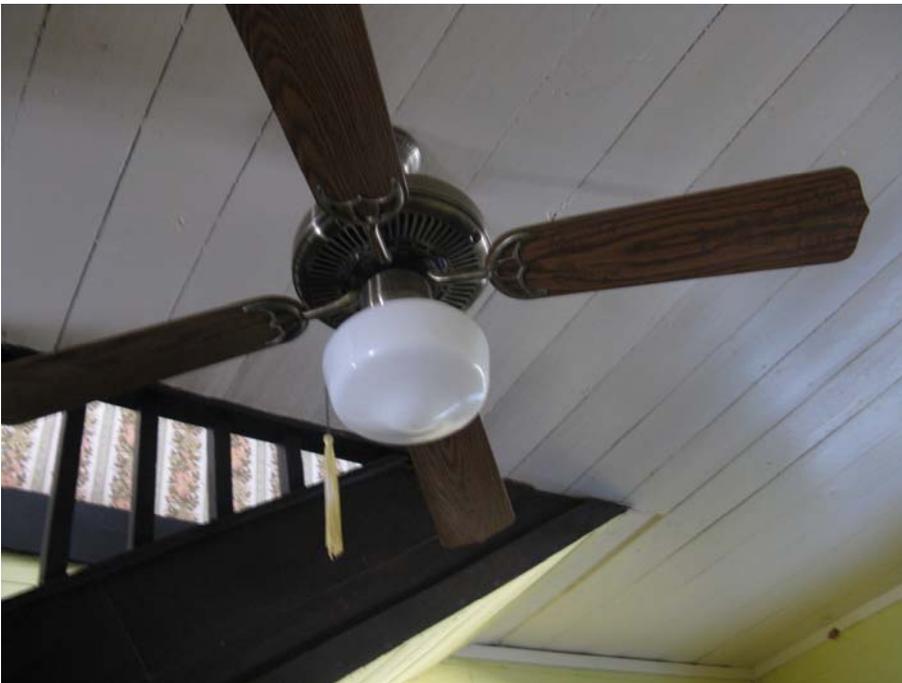
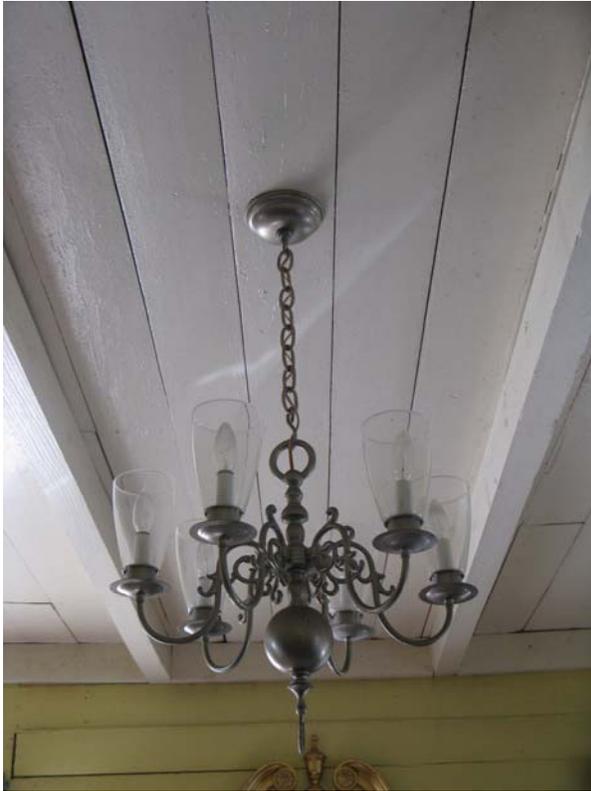
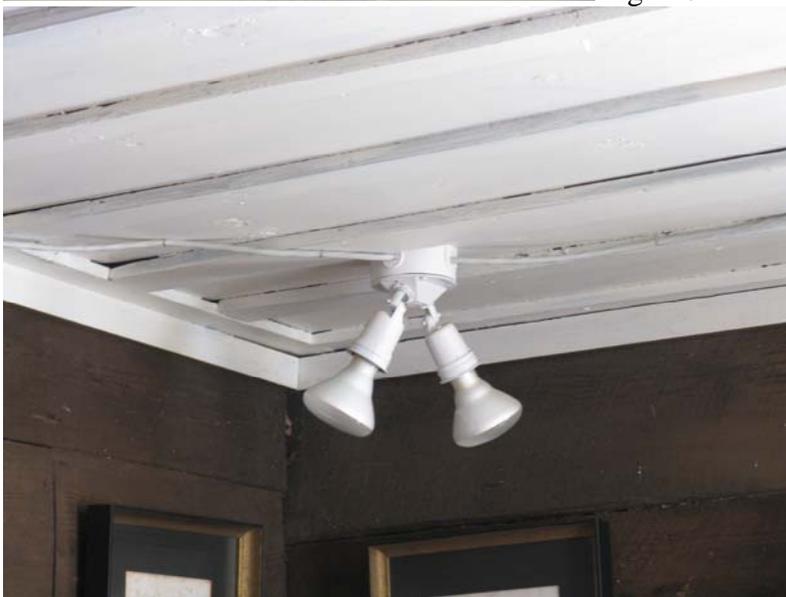
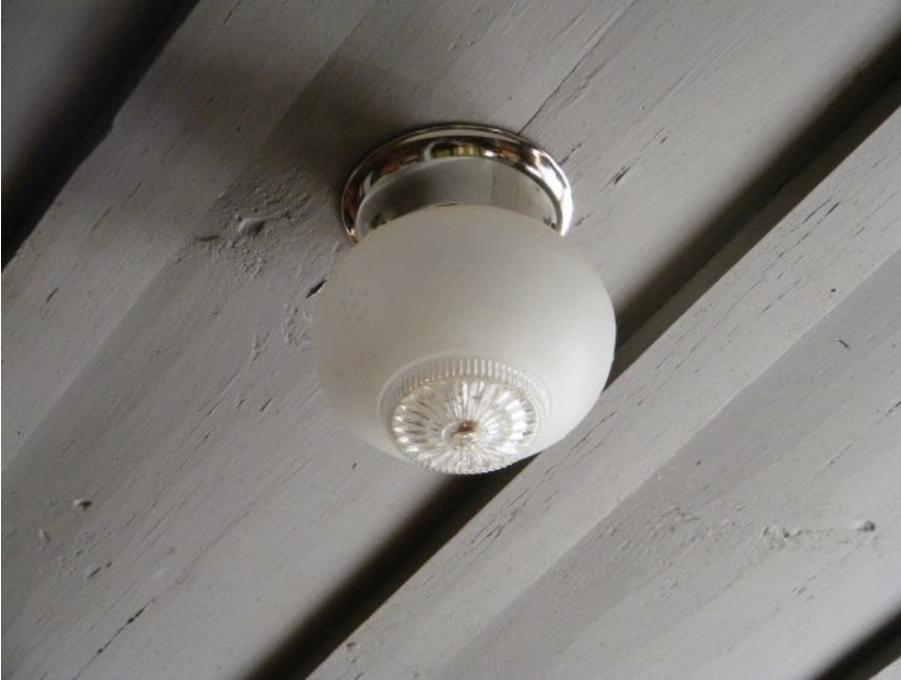
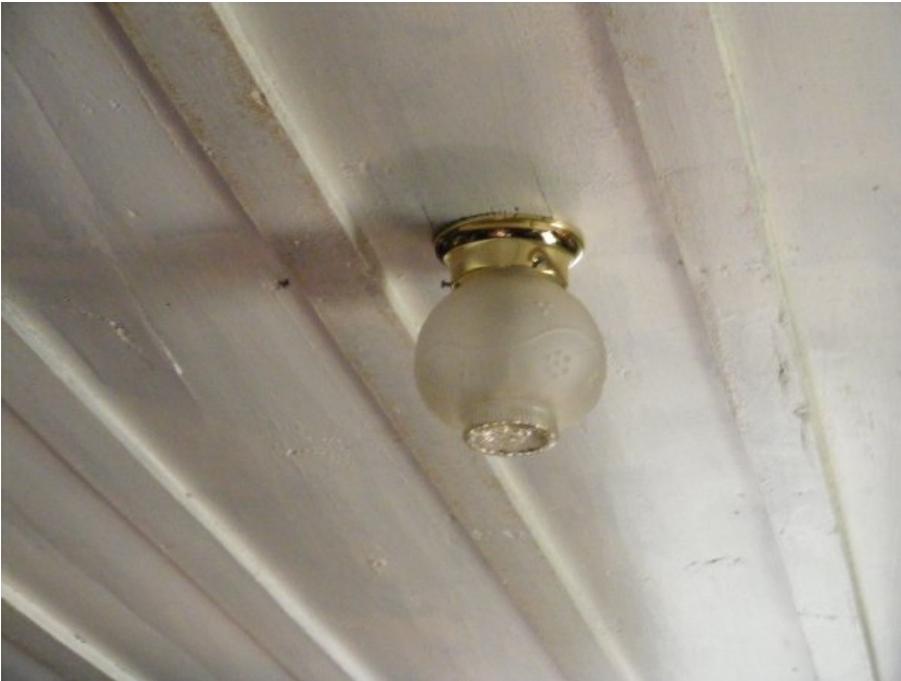
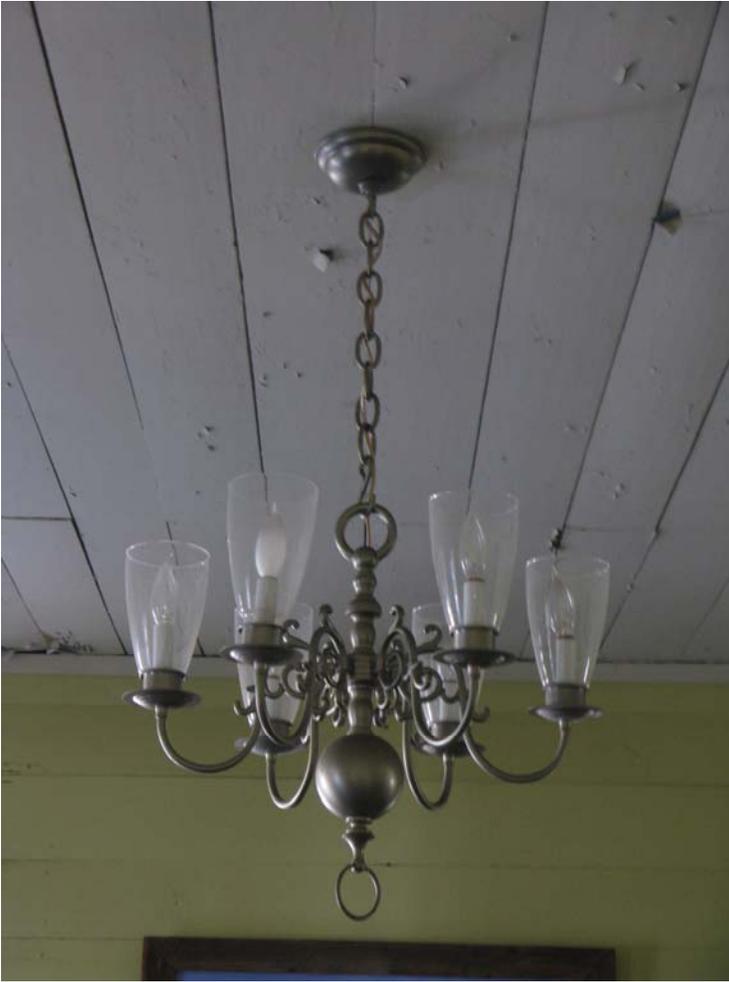
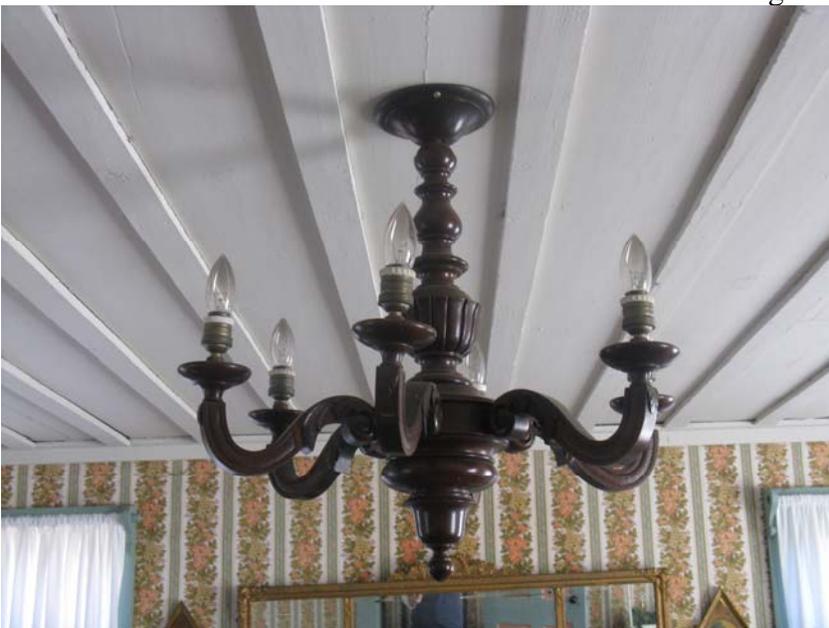
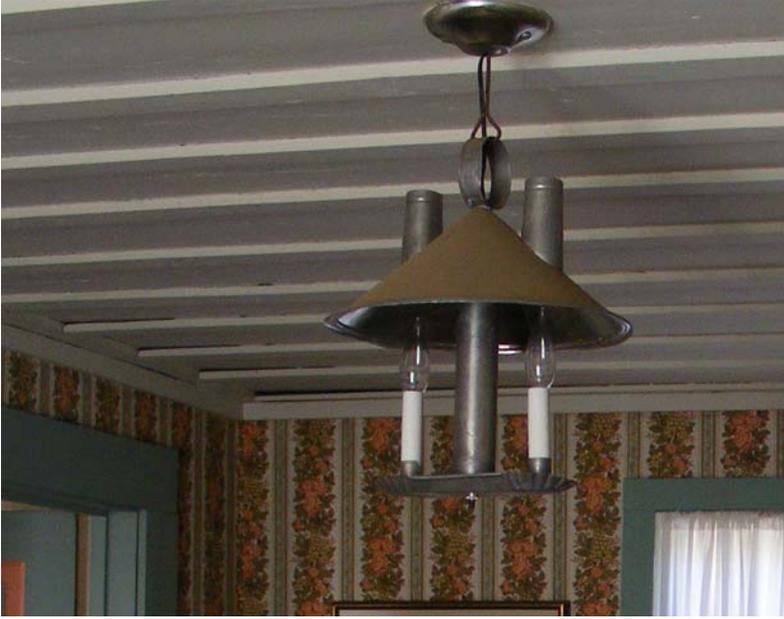
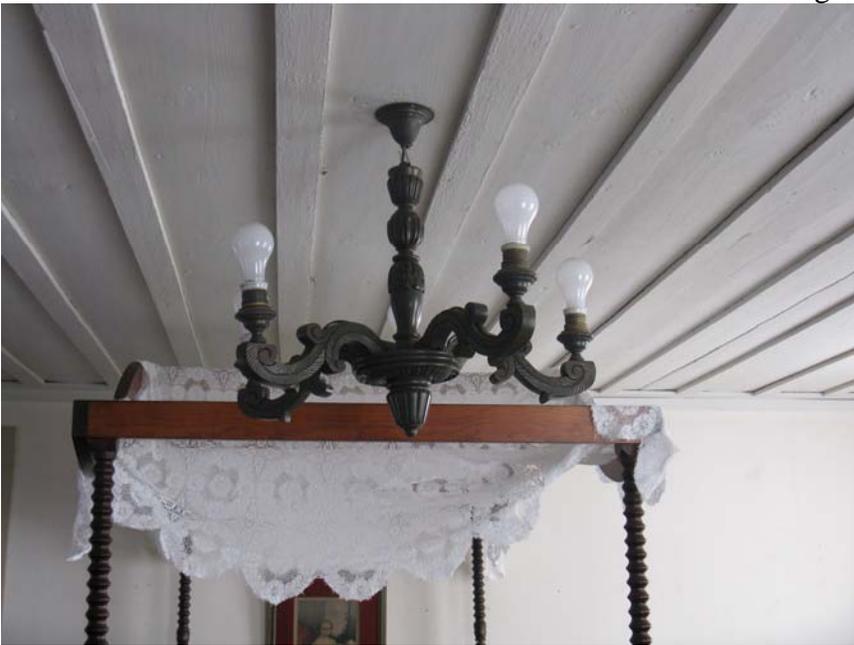
The current electrical systems have been added after the house was moved from its original site, and should be all modern and up-to-date. However, regular inspections should be part of the routine maintenance of the house, as electrical shorts are major cause of fire (one of the most detrimental types of damage to historic structures).<sup>77</sup>

<sup>78</sup> See Figures 4.040-4.048
